**ASSESSMENT AND REMEDIATION OF ABANDONED MINING EXPLORATION
SITES IN NUNAVIK**

**PROGRESS REPORT
FOR YEAR 2006-2007 OF THE PROJECT**

**Kativik Regional Government
Renewable Resources Department**

March 2007

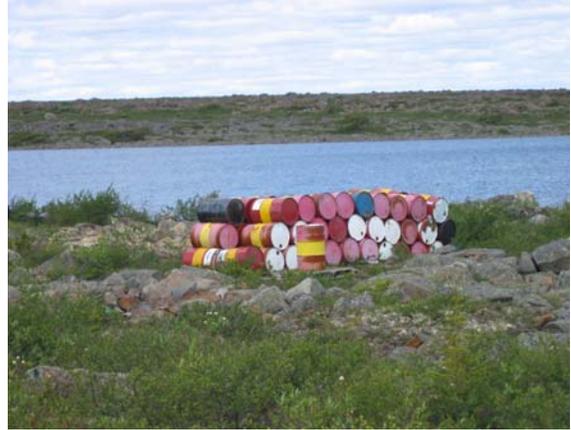
Picture 2: Barrels piled on site in 2005

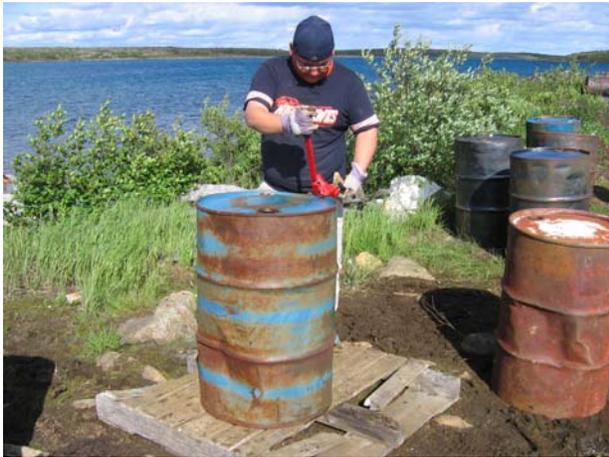
Picture 3: Barrels "deheading" station.

Once the barrels were emptied, they were “de-headed”, washed and decontaminated with a sodium carbonate/sodium metasilicate solution (VYTAC ACX product) and chemical absorbents. The clean barrels were cut in half, stowed (four barrels in one) and taken out by floatplane. A total of 308 empty barrels were moved out from the KAW-35 site to the Adoschaouna storage site in Schefferville before being definitely transported to an authorized treatment facility in Sept-Îles.

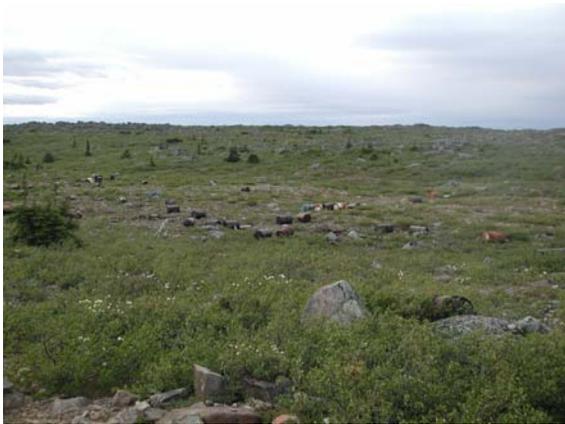
Picture 5: Scattered barrels (sector 2)

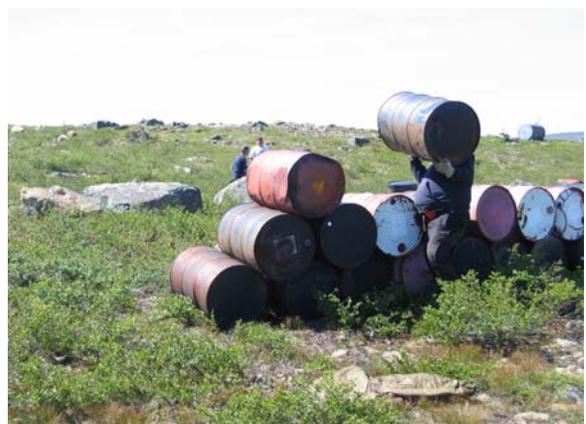
Picture 6: Scattered barrels piled on sector 2

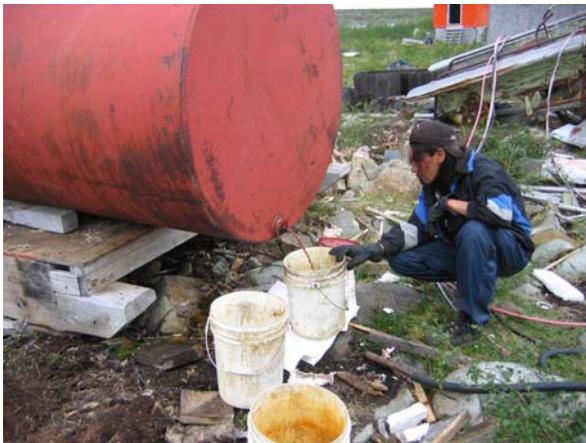
Picture 9: Draining of 4,400L tank (diesel)

A total of 820 litres (four barrels) of diesel and 410 litres (two barrels) of Jet-B fuel were collected and removed from the site. Approximately 100 litres of diesel was recovered from the 4,400 litre generator reservoir. Proper equipment and safety procedures were used while handling the barrels and transferring the hydrocarbons in new drums.

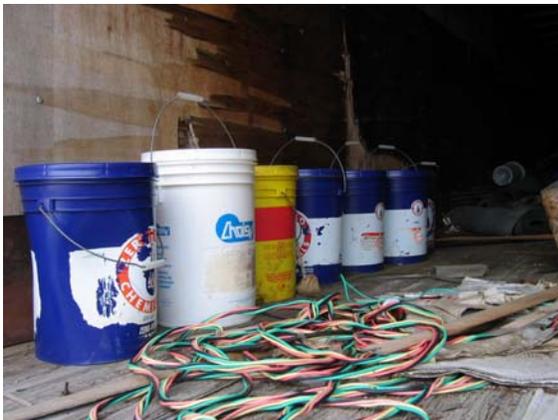
Picture 11: Hazardous waste collected from sector 3

The work team also collected various hazardous materials present on the site. Along with the hydrocarbon residues contained in barrels, hazardous material gathered in the previous year fieldwork (chemicals products, batteries) was collected, placed in safe containers, properly packaged and identified for their definitive removal from the site. All the hazardous material handling and packaging was done under the supervision of the project co-ordinator and with the collaboration of NORPAQ Air Charters for IATA air regulation. Under the supervision of Adoschaouna Naskapi services, all hazardous material was properly identified following Transport Canada regulations for transportation from Schefferville to Sept-Îles by train. Appropriate environmental clean-up measures were carried out during every step of hazardous materials handling and management.

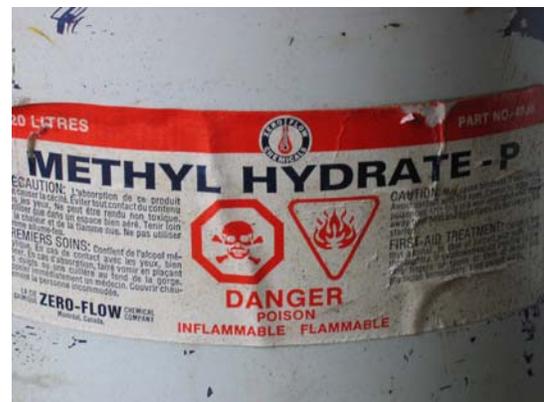
Picture 12: Chemical product "methyl-hydrate" collected from the site

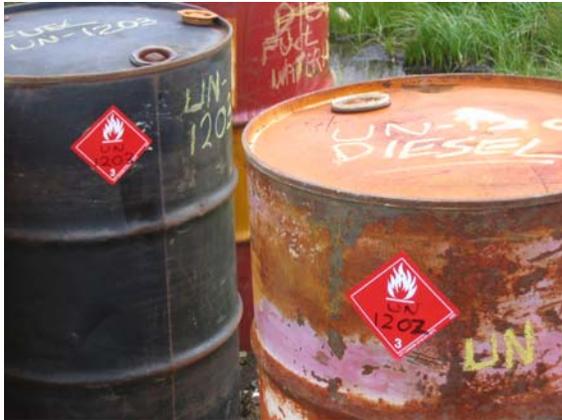
Picture 13: Hydrocarbons collected on site

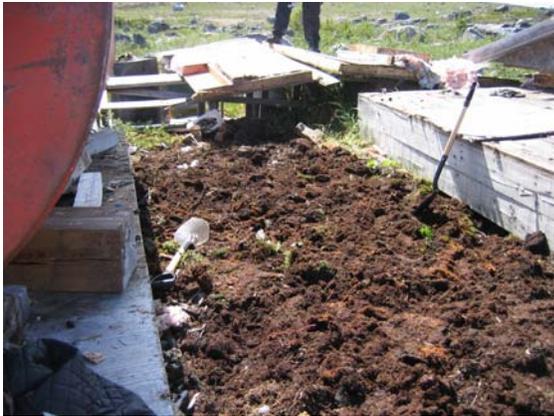
Bio-remediation was not applied on the contaminated zone (samples S-2, S-3) identified during the 2005 field campaign. The zone corresponded to the area under the generator reservoir where the assay results showed concentrations exceeding the C₁₀-C₅₀ concentrations limit for residential land use (Rf.: *Règlement sur la protection et la réhabilitation des terrains*, Gouvernement du Québec). The soil was less than 15 cm over the bedrock or stony substrate. The soil was also rocky (50% stone and rock) and too difficult to manipulate without machinery.

Picture 15: Contaminated area identified in 2005

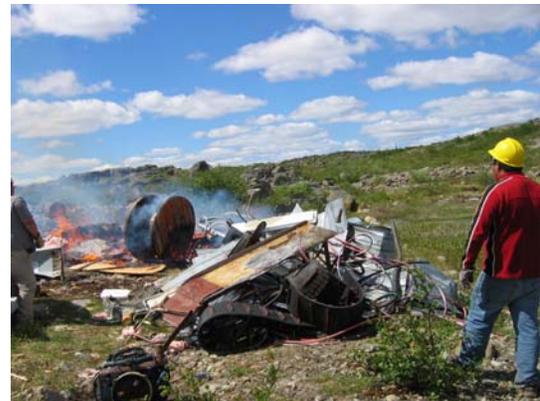
Picture 16: Combustible debris piled and burned on site

Metallic and non-combustible debris was collected and piled in various places on-site. Bulky and heavy debris was left where it was found. Some combustible debris was burned on site following MENV regulations.

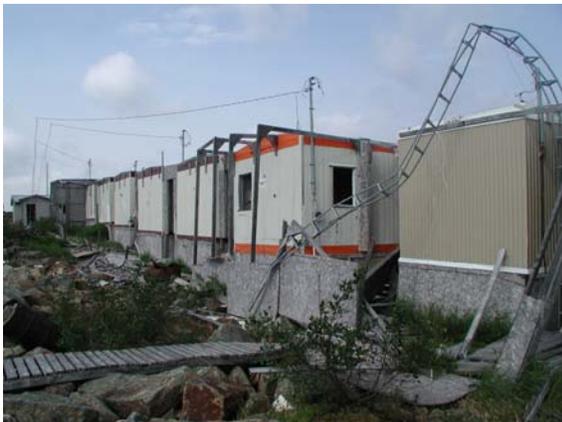
Picture 17: Dangerous structures identified in 2005

Unstable or dangerous components, such as metallic antennas, suspended wires and stairs were demolished. These structures were almost all part of the housing trailers located in sector 1 of the site. They no longer pose a threat for public safety.

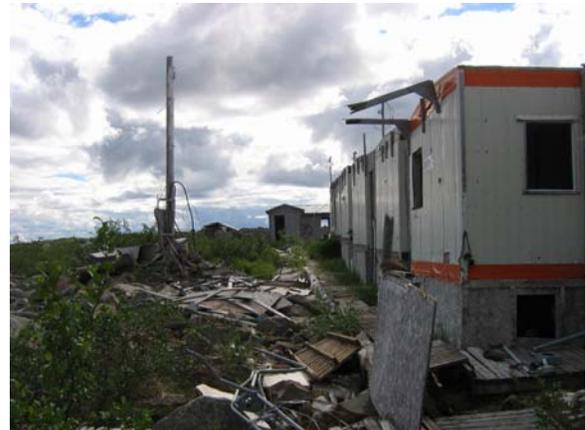
Picture 18: Structures dismantled in 2006

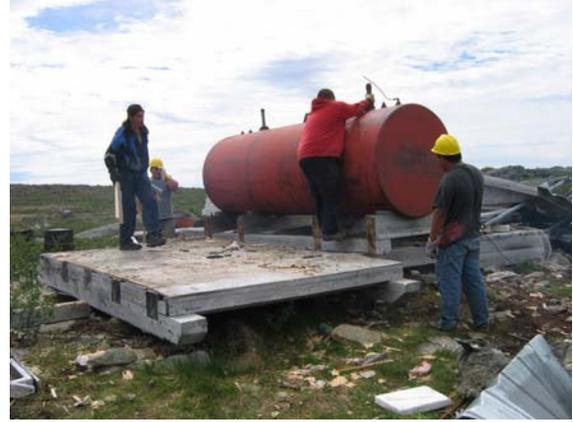
Picture20: Generator structures dismantled

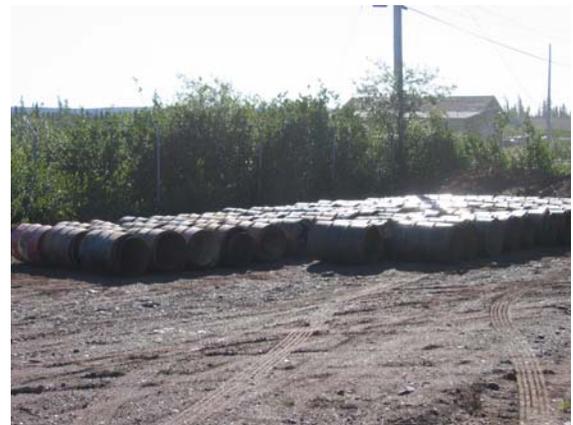
Picture 21: Stowed Barrels stored in Schefferville

All hazardous material was transported out of the site by floatplane to Schefferville where it was temporarily and securely stored at the Adoschaouna site before being brought by train to a treatment facility in Montreal (Appendix A, photos 12-14). A *Shipper's declaration of dangerous goods* form was attached to the hazardous materials, in accordance with the applicable Dangerous Goods regulation.

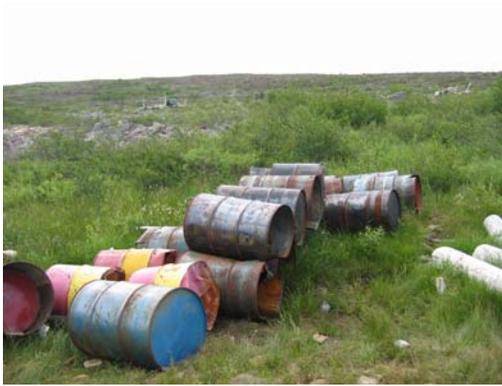
Picture 1: Remaining clean barrels on site (sector 1)

There are presently 20 barrels filled with barrel tops, ready to be taken out by floatplane or moved to the non-combustible material deposit. Some barrels (+/- 30) can be found scattered on site as their removal would not have been safe. These barrels potentially contain a certain amount of hydrocarbon residues. Any additional hazardous products found on site would have to be taken out and sent to a treatment centre.

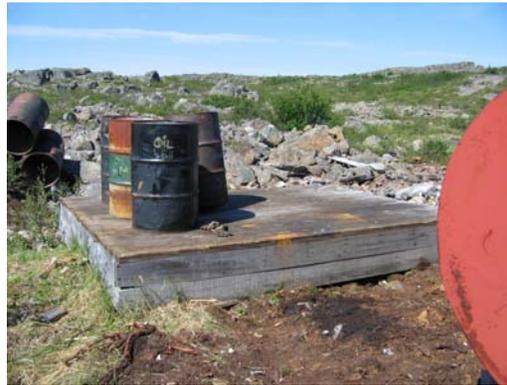
Picture 2: Remaining barrels on site (generator tank, sector 1)

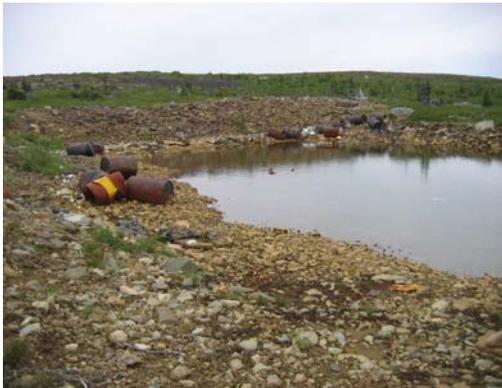
Picture 3: Scattered barrels (towards sector 3)

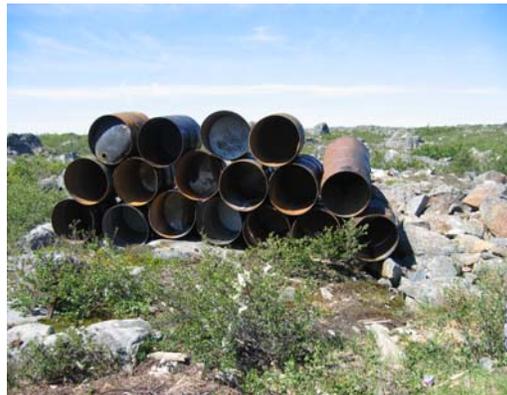
Picture 4: Clean barrels piled on site (behind generators)

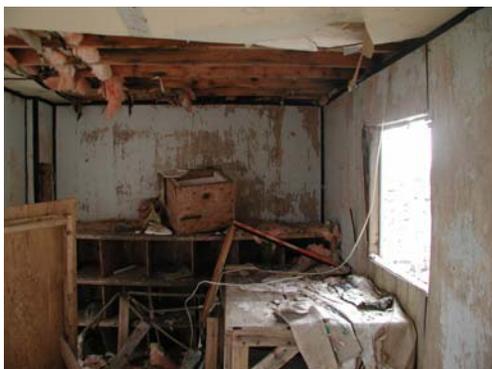
The condition of the buildings on-site is still poor, in deterioration and could eventually lead to issues of public safety. A future phase of clean-up measures on this site could involve the stabilization and/or demolition of these structures. All metallic and non-combustible debris could also be collected and placed in the non-combustible material deposit. Finally, any remaining combustible debris could be burned on site according to Environment Québec regulations. Pictures showing remaining materials and structures on site are presented in Appendix B.

Picture 5: View inside a trailer

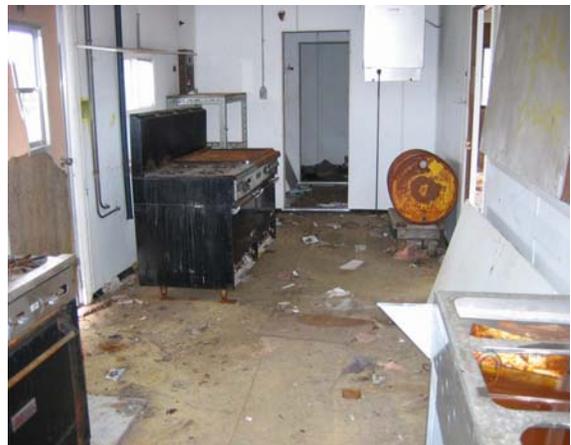
Picture 4: Kitchen trailer (first day)

The main kitchen trailer was cleaned and repaired at the beginning of the fieldwork. Broken windows and doors were repaired or replaced while waste collected inside was piled neatly outside with other debris. The trailer was used during the field campaign as a lunch room area. Appendix C of this report presents pictures of the fieldwork.

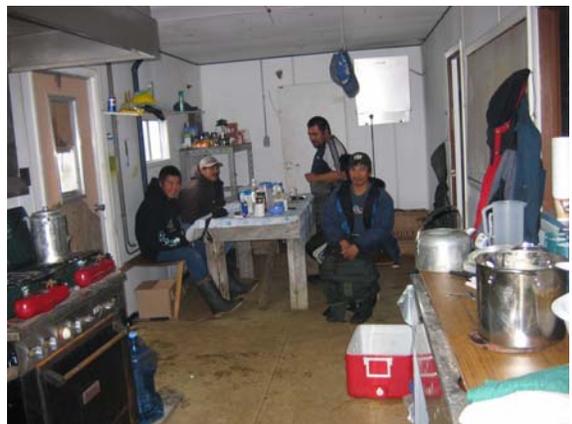
Picture 5: Kitchen after cleaning

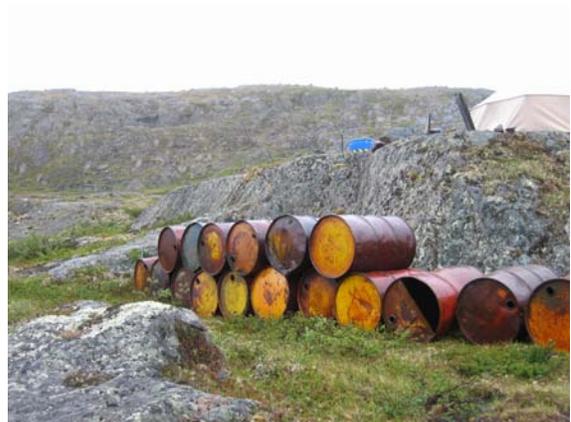
Picture 6: Scattered barrels piled on site; sector 5

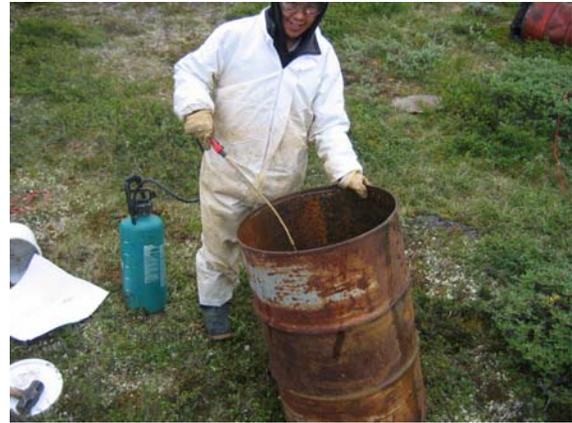
Picture 8: Barrel cleaning station, sector 5

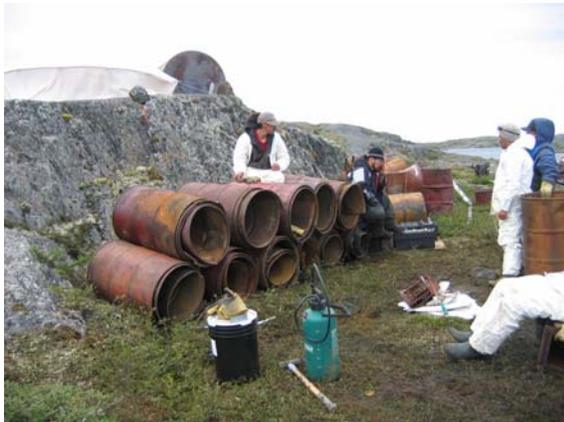
Picture 9: Cleaned barrels, piled, sector 5

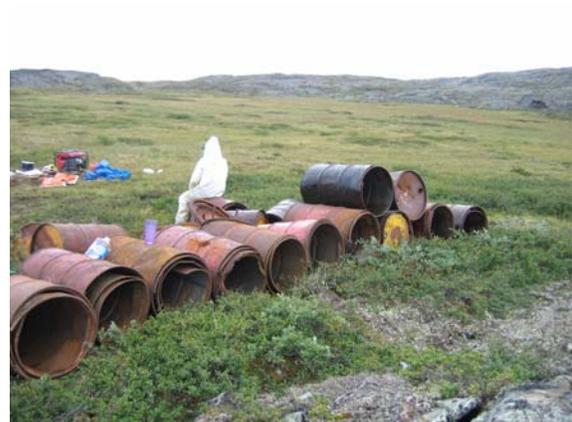
Picture 10: Cleaned barrels, piled, sector 6

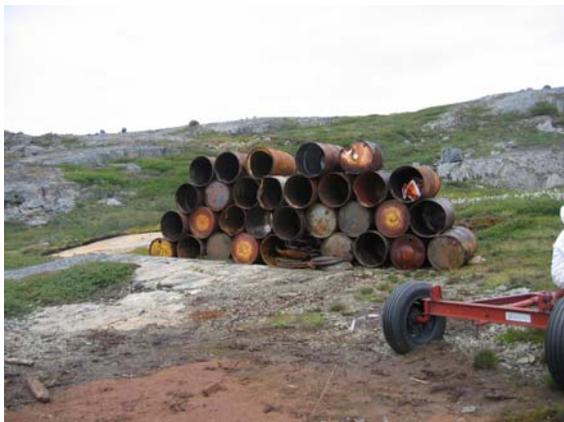
Picture 9: Cleaned barrels, piled, sector 4

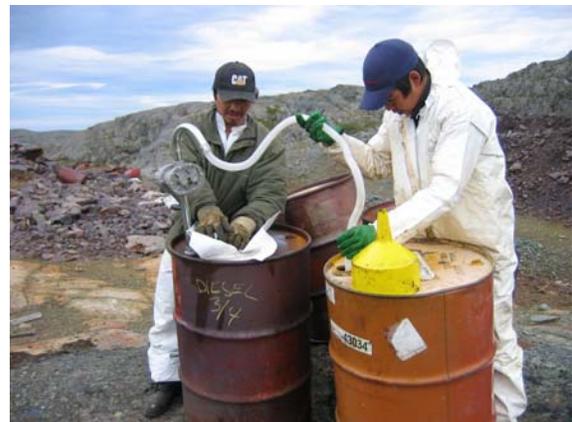
Picture 10: Residues transferred into new drums; sector 4

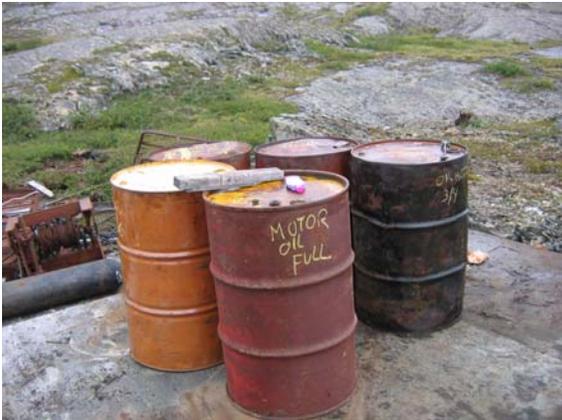
Picture 11: Residues collected and stored on site, sector 4

All of the hazardous material collected has been securely stored on site but will ultimately have to be taken out. Fourteen of the used batteries collected from sector 4 have already been transported to the village of Tasiujaq by helicopter and transported by sealift to an authorized hazardous waste management centre in southern Quebec (Appendix C, photos 12-17). The batteries left Tasiujaq by sealift to the port in Sainte-Catherine and were brought to Onyx Industries' treatment facility in Montreal. Residues contained in barrels were kept on site but should also be taken out. Some residues are still in their original barrels and will have to be transferred to watertight drums prior to any transportation or manipulation.

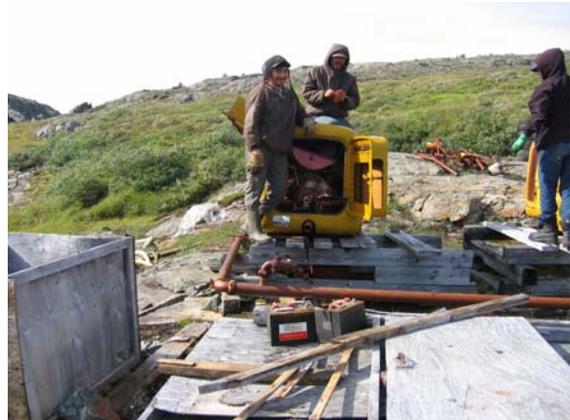
Picture 12: Batteries collected from generator units, sector 4

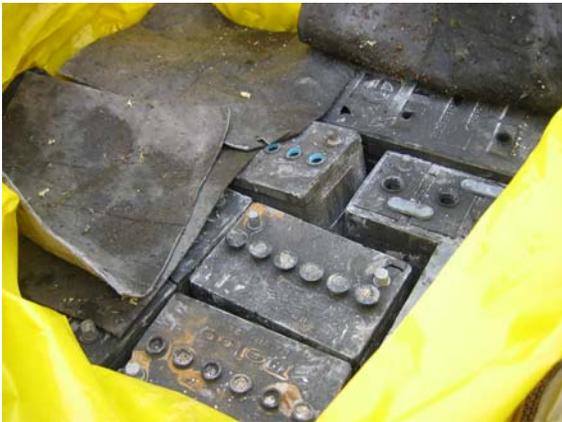
Picture 13: Batteries for disposal

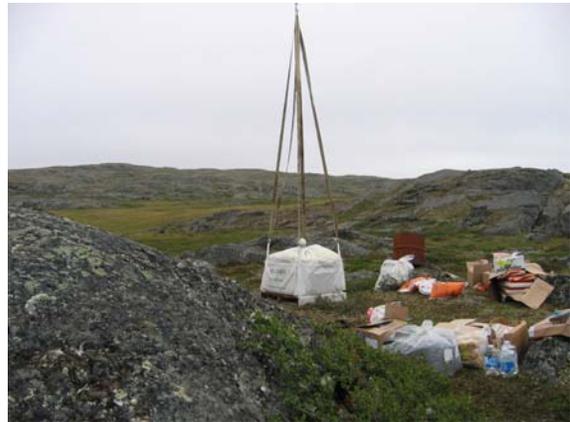
Picture 14: Batteries for disposal being hauled to Tasiujaq

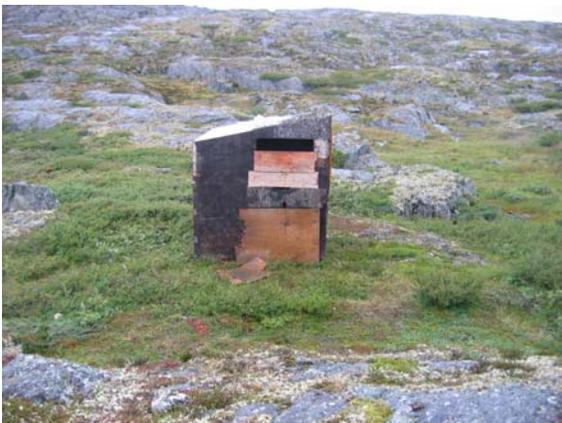
Picture 15: Hazardous material storage shed, sector 5

The team also collected various hazardous material scattered throughout the site. Along with the residues contained in barrels, pails of lubricant, batteries, lithium grease tubes, oil filters, paints and spray cans were carefully collected and safely stored on-site. Batteries were also removed from three generator units located in sector 4. Appropriate measures were applied during every step of the handling and management of this material. Subsequent clean up efforts would require proper packaging, labelling and transportation of this material to an authorized disposal centre. The hazardous materials collected from sectors 4, 5 and 6 were temporarily stored on site in a wooden shed near the house trailers in sector 5.

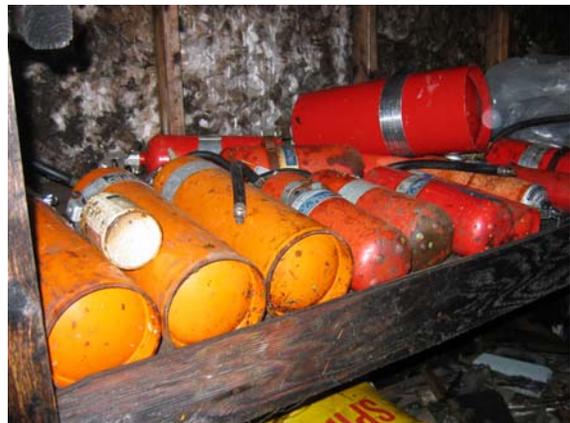
Picture 16: Extinguishers stored in the wooden shed

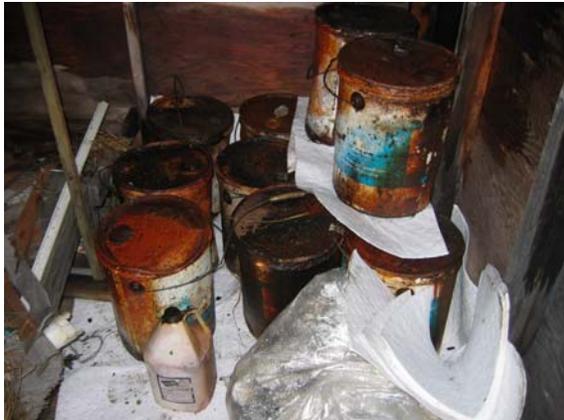
Picture 17: Lubricant pails and grease tubes stored (wooden shed sector 5)

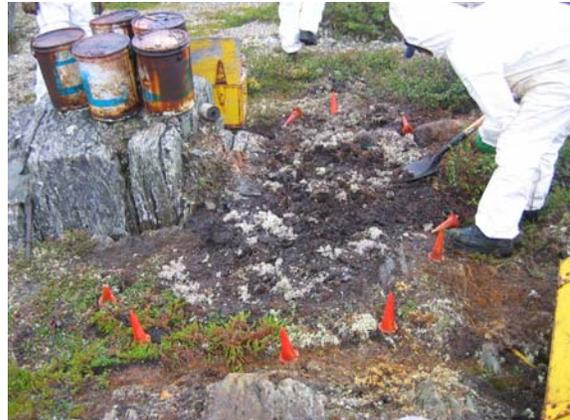
Picture 18: Soil remediation project (PJ-13 area, sector 6)

Bio-remediation efforts were conducted on two contaminated zones (PJ1-13, PJ1-20) which were identified during the 2001-2002 assessment. These two areas presented high levels of hydrocarbon (C₁₀-C₅₀) and APH (aromatic polycyclic hydrocarbons) concentrations. The work consisted in turning the contaminated soil with a shovel, and adding and mixing into the soil substances that accelerate the breakdown of the hydrocarbons. The substances employed were fertilizers, dolomite lime and organic material consisting of vegetation or moss found on site. The quantities employed were approximately 0,1 kg/m² of fertilizer, 0,5 kg/m² of dolomite and approximately 1kg/m² of sphagnum or moss. (Appendix C, photo 18, 19).

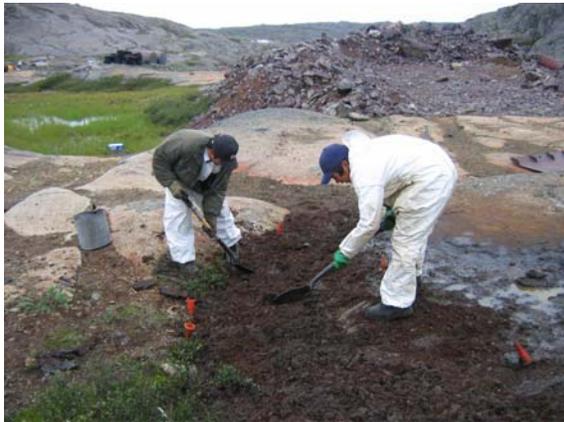
Picture 19: Soil remediation project (PJ-20 area, sector 4)

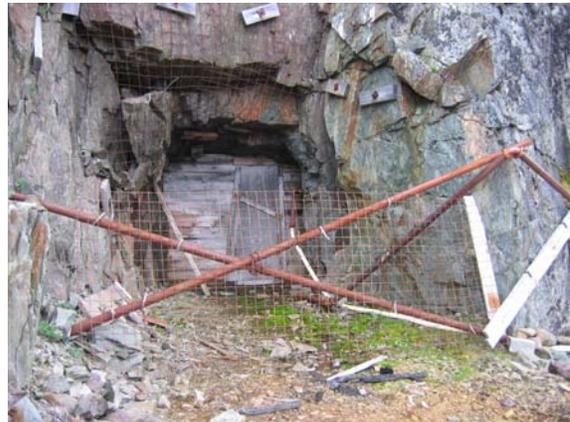
Picture 20: Metal fence installed for main gallery (sector 4)

Three mine shafts, located in sector 1 and leading to the main mining gallery, were closed with temporary fences. Two of the shafts were closed with steel and wood structures founded on site. The main gallery was completely closed off with wood and secured with a steel fence.

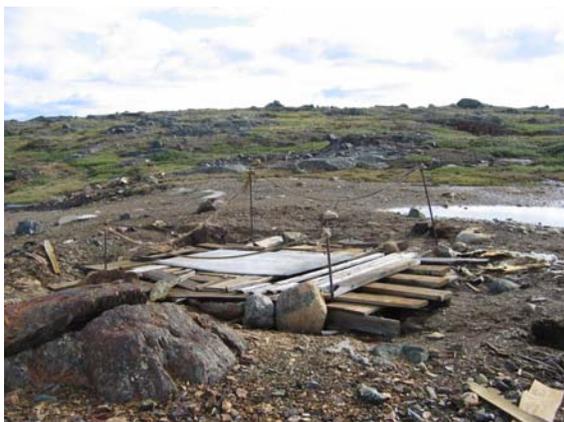
Picture 21: Mine shaft fence and cover installed

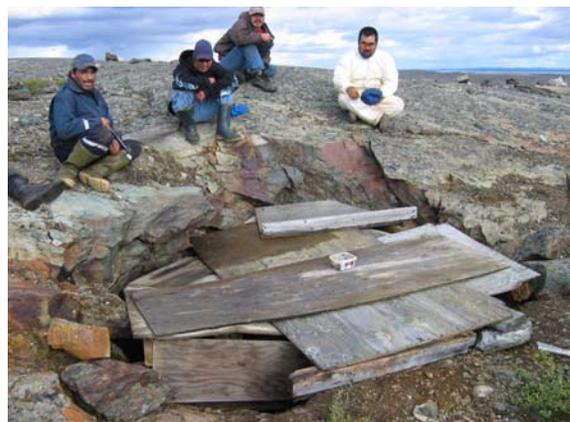
Picture 22: Mine shaft cover installed

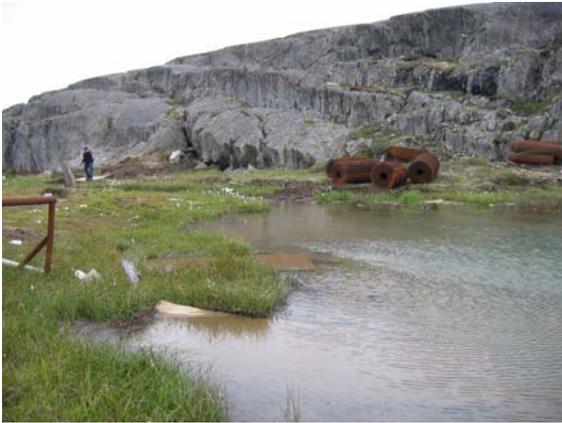
Picture 23: Rusted metal pieces retrieved from pond; sector 4

Metallic and non-combustible debris was collected and piled in various areas on-site. Metal parts and rusted barrels were removed from lakeshores and ponds. Bulky and heavy debris was left

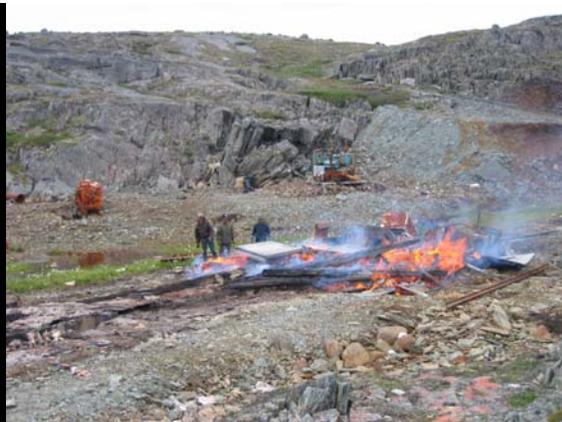
Picture 23: Combustible debris piled and burned; sector 4

where it was found since no equipment was available to remove it. Some combustible debris was burned on site according to MDDEP regulations.

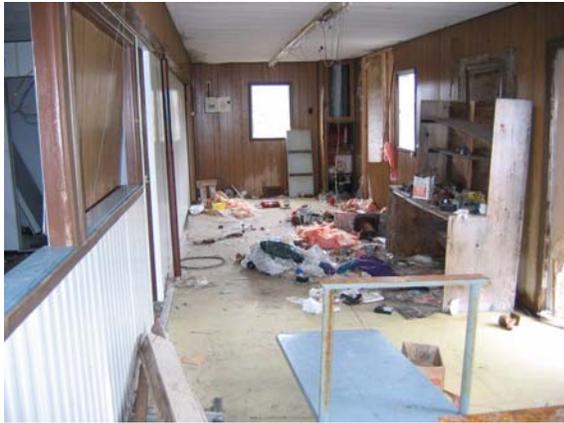
Picture 1: Trailer, sector 5

The condition of the buildings and dwellings is also still poor. The structures will continue to deteriorate and could pose problems in terms of safety. The next phases of the project should also include the stabilization and/or demolition of these buildings. All metallic and non-combustible debris should be collected and assembled together in a non-combustible material deposit. The disposal site will have to be established according to government regulations (*L.R.Q. c. Q-2, r.3.2*). Soil remediation should be continued on the PJ1-13 and PJ1-20 areas, as well as the other contaminated areas identified in the KRG 2001-2002 report. Finally, any debris burning on site must be done in accordance with MDDEP regulations.

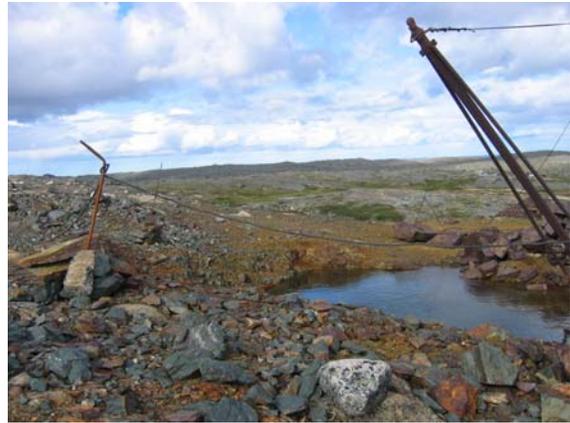
The condition of the three shafts leading to the main gallery is still poor but no longer presents any serious hazard for public safety. The fences and structures installed during the fieldwork

Picture 2: Temporary fence installed around mine shaft

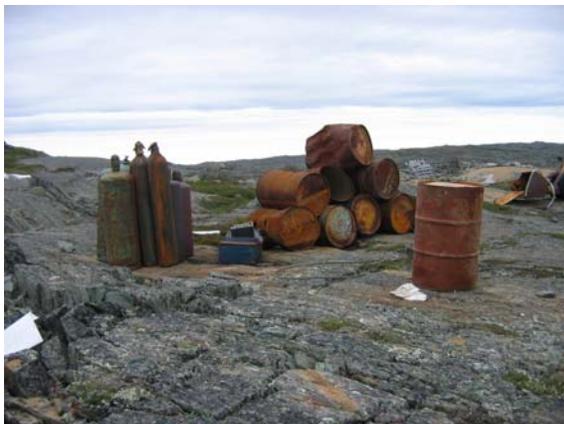
Picture 3: Barrels and propane tank piled, sector 4

There are presently twelve barrels full of oil, diesel and anti-freeze properly stored on site in watertight drums. These barrels will eventually have to be removed from the site. There are also 170 clean barrels piled on site (sectors 4, 5 and 6) and ready to be moved to a non-combustible deposit. Approximately 240 additional barrels are scattered throughout the site in sectors 1, 2, 3, 8a, 8b and 9. These barrels still contain a certain amount of residues that weren't removed during the field campaign. These would have to be gathered, cleaned and taken out of the site. All other hazardous material should be transported to an authorized disposal facility for treatment. Table 5 describes what materials remain on site. Appendix D presents the pictures showing this material.

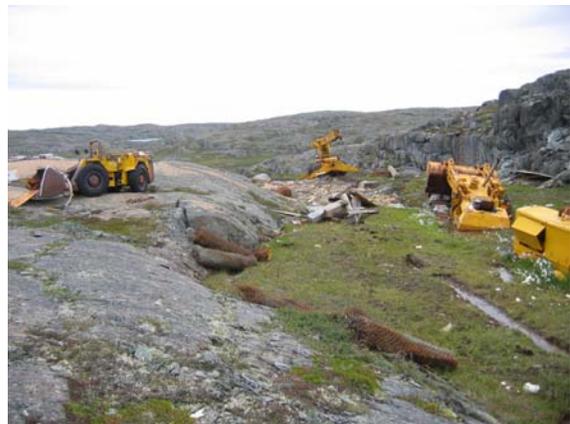
Picture 4: Remaining heavy equipment, sector 4

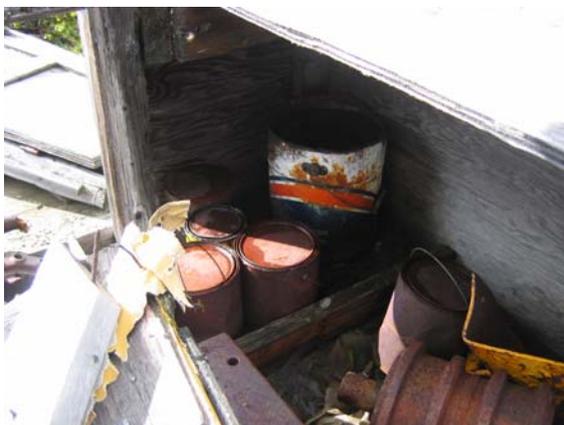
Picture 5: Remaining hazardous material; sector 2

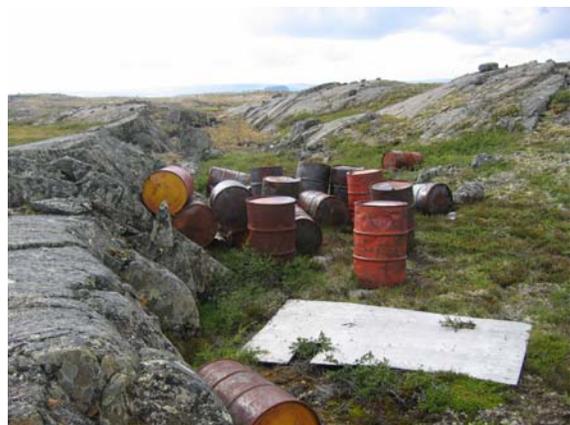
Picture 6: Scattered barrels; sector 2
