**SUMMARY REPORT
ON REHABILITATION WORK
AT THE 18 “MAJOR” ABANDONED MINERAL
EXPLORATION SITES IN NUNAVIK
CARRIED OUT IN THE SUMMER OF 2008
AND
UPDATE ON THE GENERAL RESPONSE PLAN**

Kativik Regional Government

**Renewable Resources, Environmental
and Land Use Planning Department**

December 2008

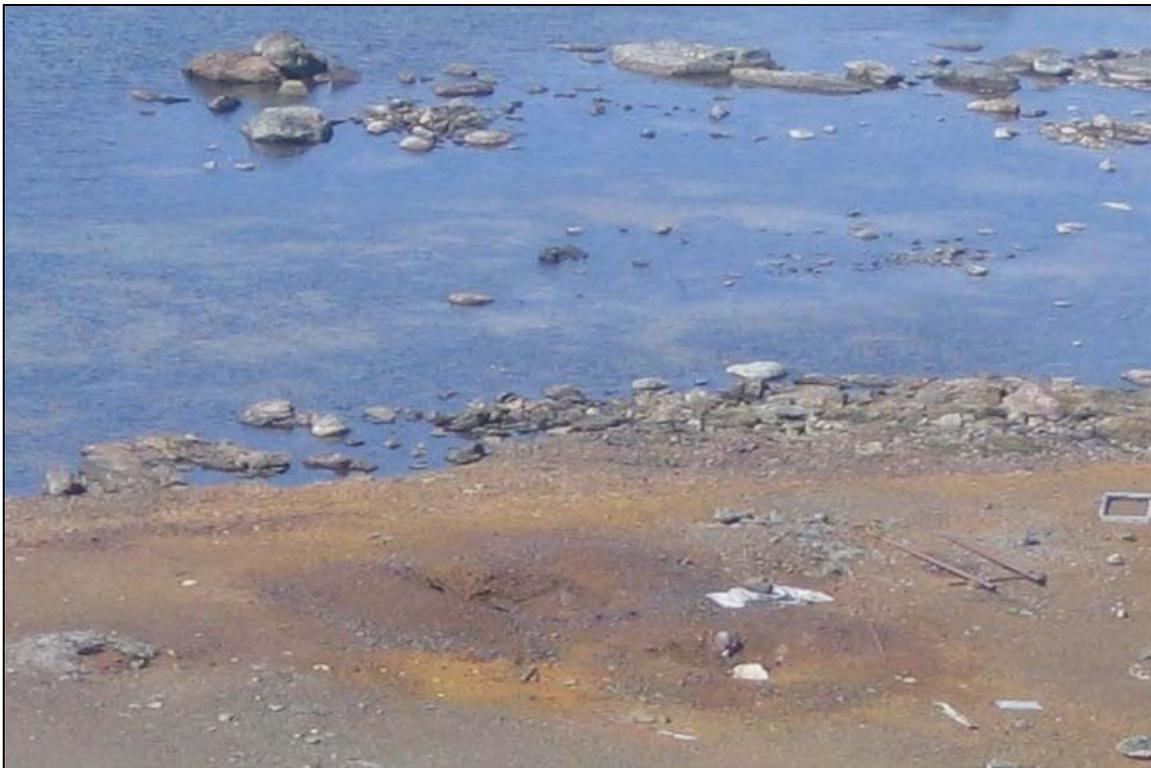
Figure 4: Rock waste with a potential for acid mine drainage near Lake Twin at the site TW (photo credit: Anne-Marie LeBlanc).

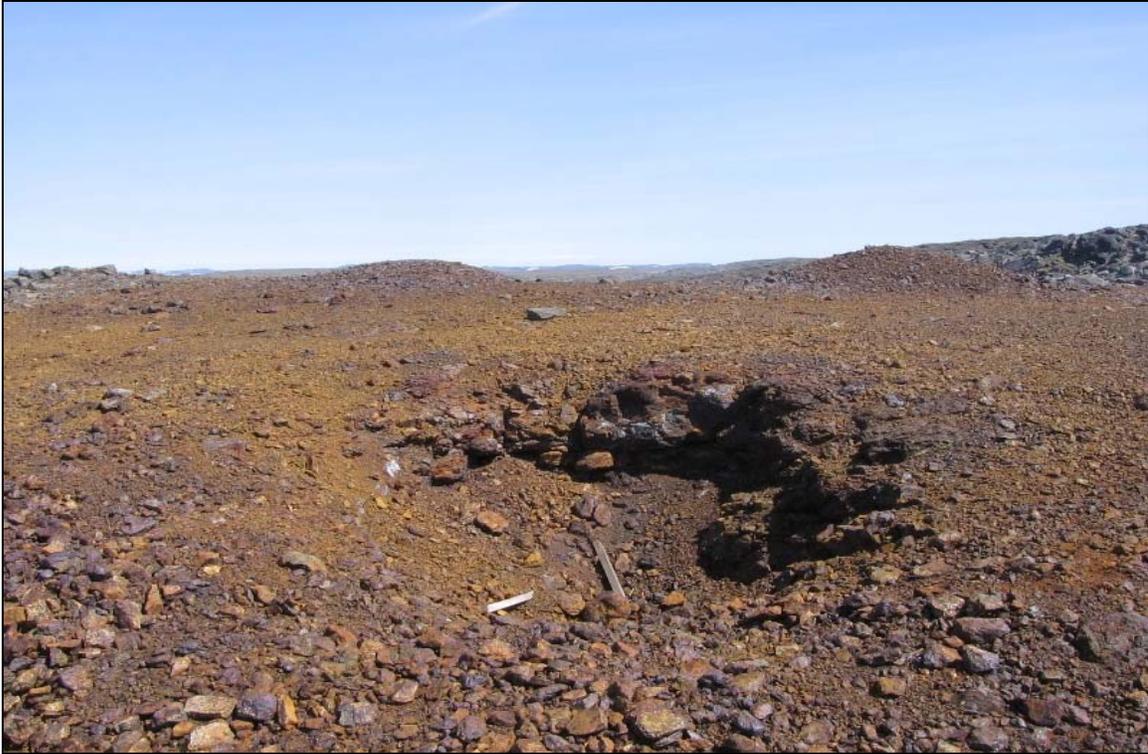
Sampling was conducted in cooperation with the MDDEP in June. Two rock-waste samples were taken (Figure 5 and Table 1) and two water samples were taken to evaluate potential acid mine drainage (Table 2). The CEAE analyzed the samples.

Figure 5: Close-up of rock waste that has a potential for acid mine drainage at the site TW (photo credit: Anne-Marie LeBlanc).

Based on the results and in the opinion of MDDEP specialists (Table 1), the analysis results should be checked against the mining industry directive 019 (http://www.mddep.gouv.qc.ca/milieu_ind/directive019/directive019.pdf). A TCLP leaching test is recommended for the material at the site TW-1 that presents acid-generating potential. Leaching results should be checked against the concentrations shown in Table 1 (mining effluents, metals only) and the criteria of directive 019 (Table 1, Appendix 2) related to the leaching of high-risk mine tailings. New samples will need to be taken for this purpose since the CEAE discarded the original samples.

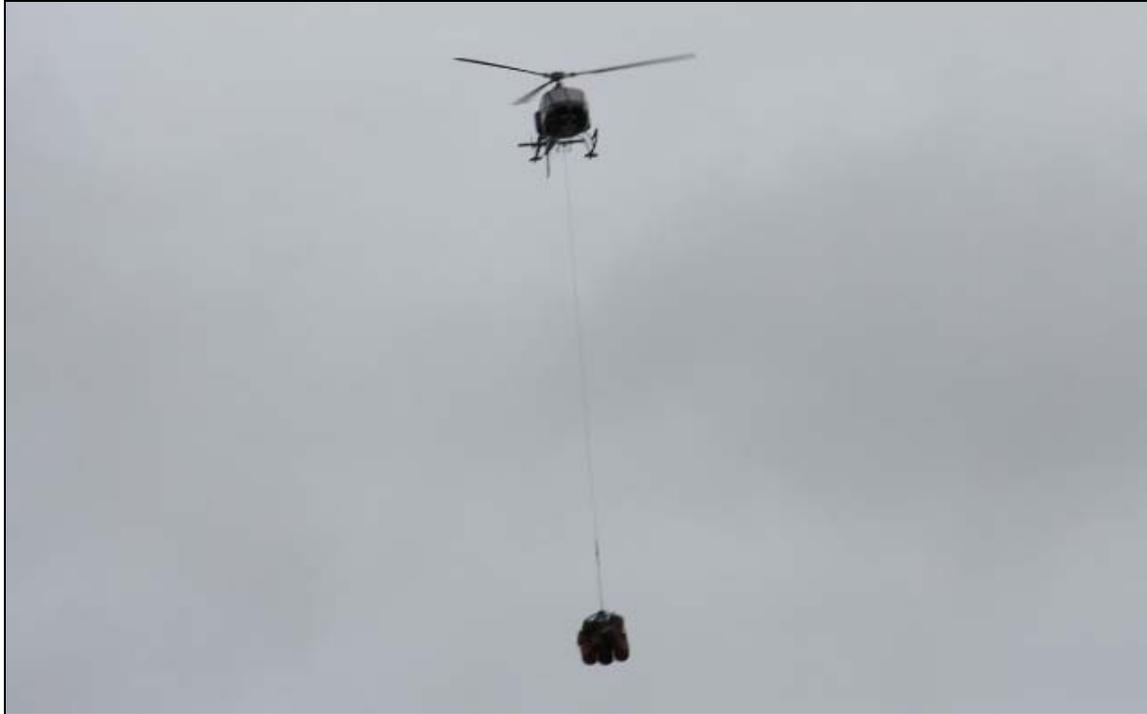
Figure 6: Barrels and waste being removed from the site TW to a temporary storage site (photo credit: Martin Tremblay).

In June, all the barrels at the site TW were slung by helicopter, crushed using a power shovel and placed at a temporary storage site at Kangirsuk (Figures 6, 7 and 8). In total, 83 barrels (13 containing petroleum-hydrocarbon waste), 11 propane tanks, 100 L of grease and several pieces of metal waste were placed in temporary storage. All combustible material was burned. Only a few pieces of metal waste were left at the site (Figure 9). This waste was gathered together in preparation for its transportation in the winter by snowmobile and *qamutiik*. Between four and five snowmobile trips will be necessary to complete the clean-up. A container has been available in Kangirsuk since November to store the waste before its shipment south for recycling or processing.

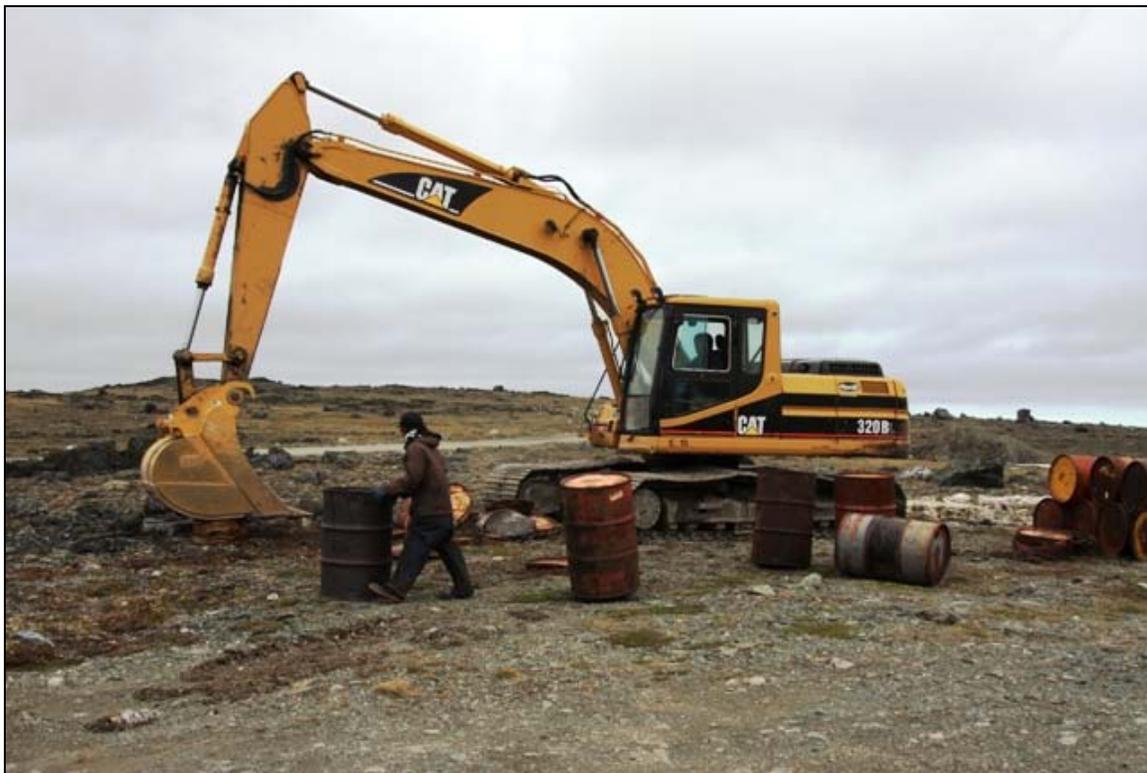
Figure 7: Barrels were crushed using a power shovel at the temporary storage site. This work was carried out in cooperation with the Northern Village of Kangirsuk (photo credit: Martin Tremblay).

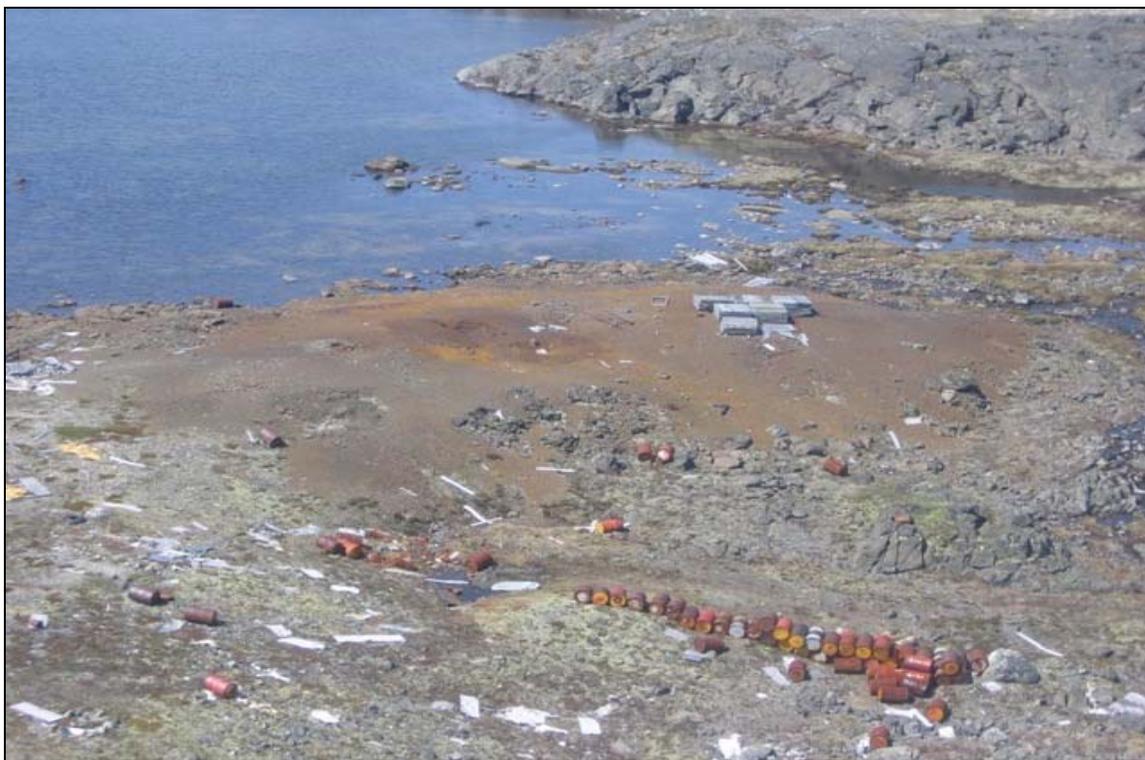
Figure 8: The site TW, prior to rehabilitation work (photo credit: Anne-Marie LeBlanc).

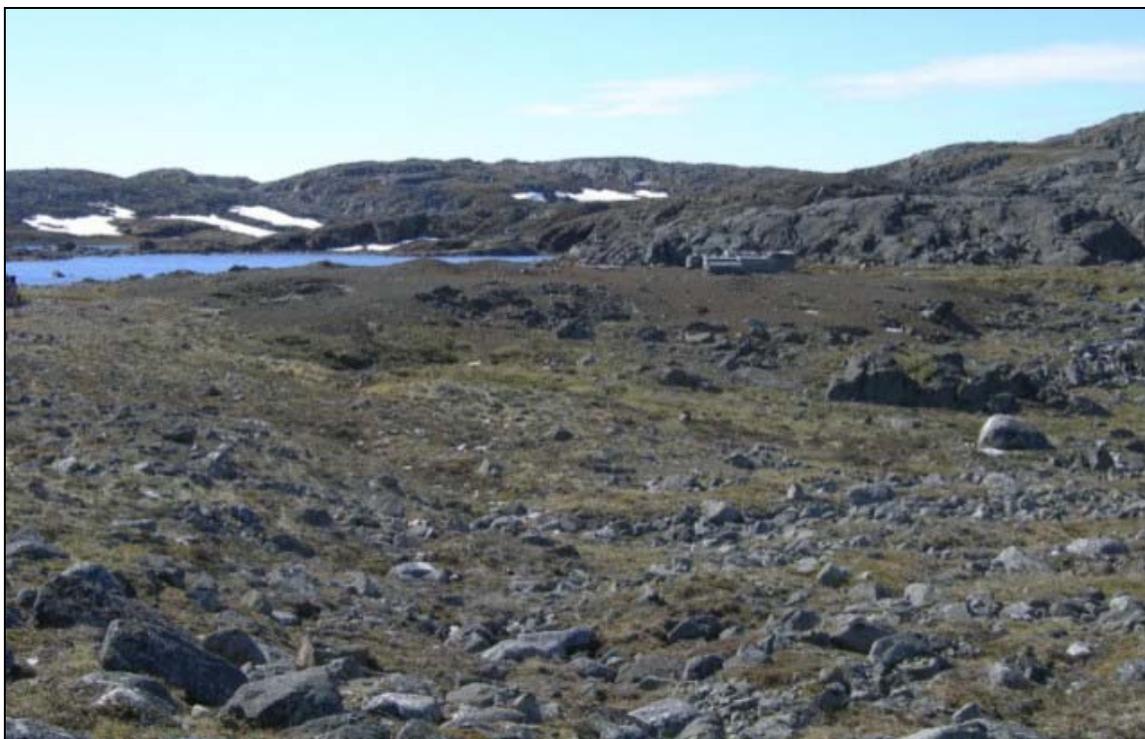
Figure 9: The site TW, following rehabilitation work (photo credit: Alexandre Gaudreau).

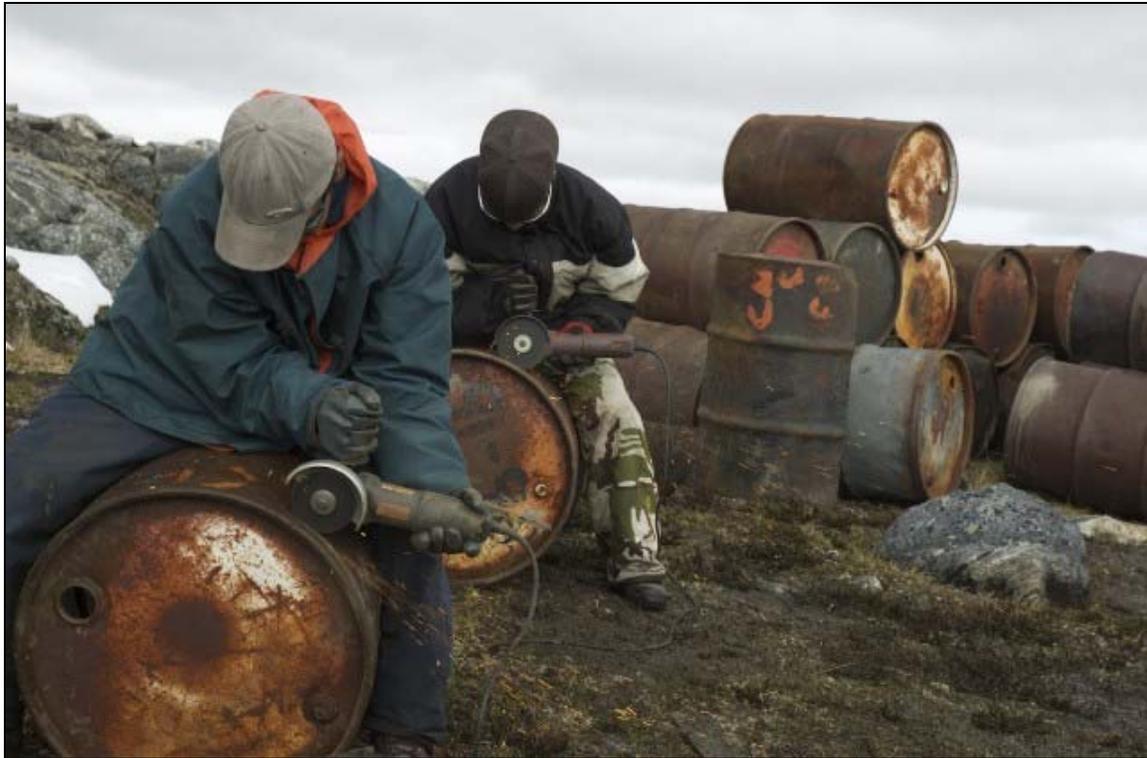
Figure 10: Barrels being cut up at the site WB-3 (photo credit: Alexandre Gaudreau).

All the barrels at the site WB-3 were emptied, cut up using a grinder, transported by helicopter sling and placed at a temporary storage site near the waste disposal area at Kangiqsujaq in July (Figures 10, 11, 12 and 13). All combustible material was burned. Only a few metal rods and sheets remain to be transported by snowmobile and *qamutiik*. This metal waste could not be slung by helicopter due to the risk of damage to the sling. It was instead gathered together in preparation for its transportation in the winter. Four or five snowmobile trips will be necessary to complete the clean-up. A container has been available in Kangiqsujaq since November to store the waste before its shipment south for recycling or processing. Since the container arrived on the season's last ship, it will be kept in the village until the summer of 2009 and receive the waste transported by snowmobile in the winter. The exploratory drilling samples, which are located on stands, were not disturbed during the rehabilitation work. The circular wooden platform (Figures 12 and 13), which was in good condition, was tidied up and left intact for future use.

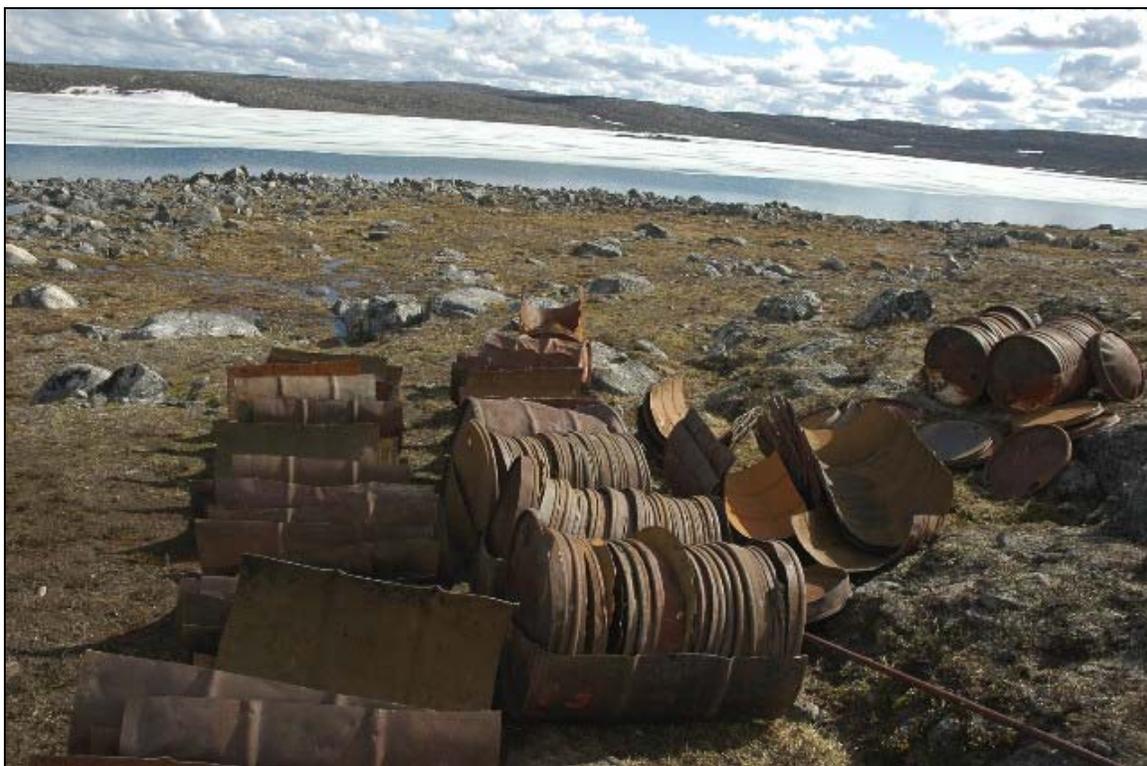
Figure 11: Cut-up barrels at the site WB-3 (photo credit: Alexandre Gaudreau).

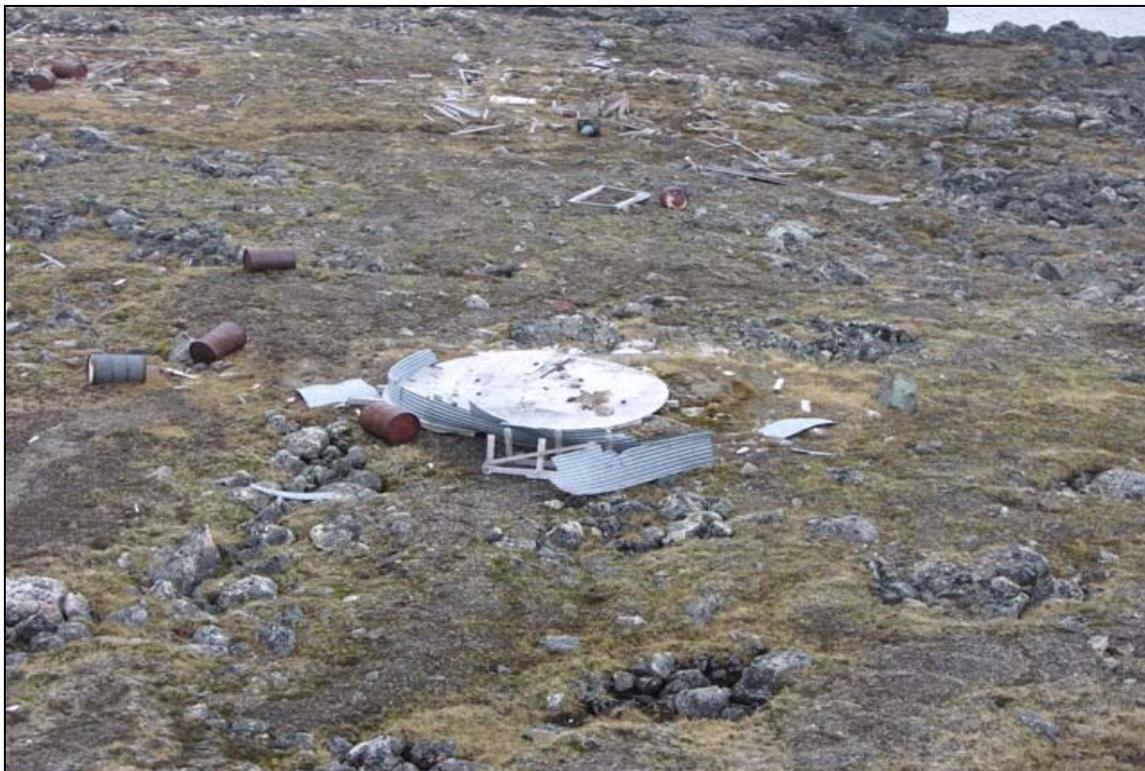
Figure 12: The site WB-3, prior to rehabilitation work (photo credit: Anne-Marie LeBlanc).

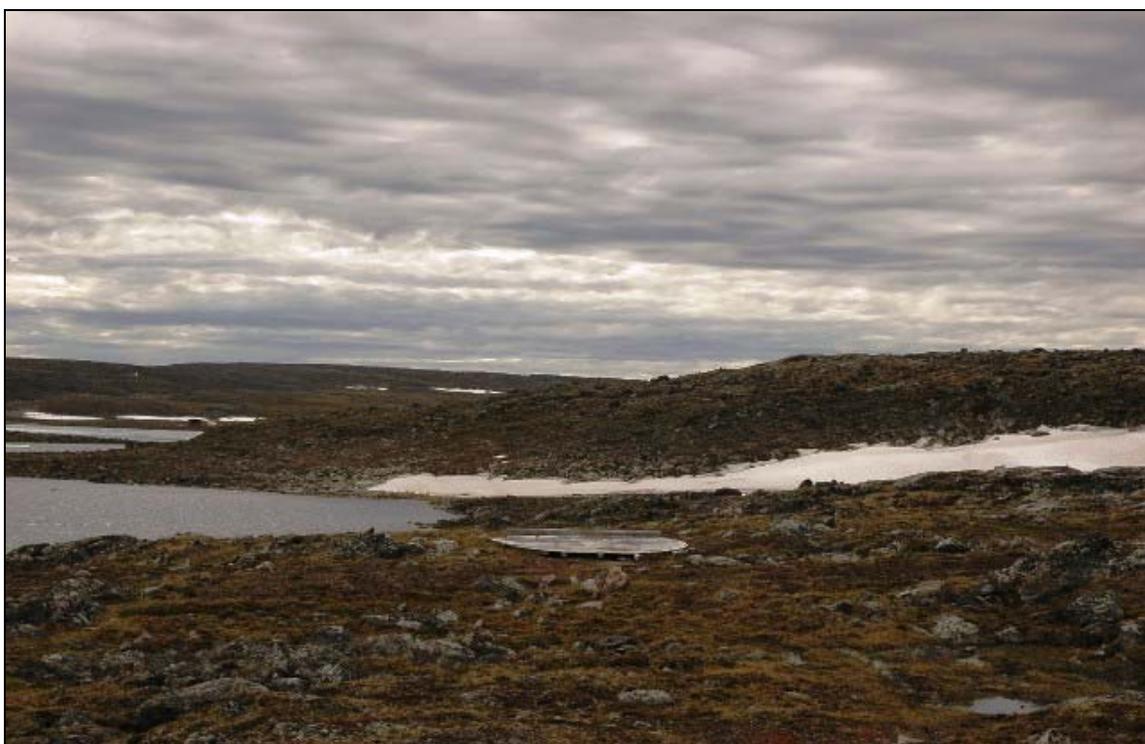
Figure 13: The site WB-3, following rehabilitation work (photo credit: Alexandre Gaudreau).

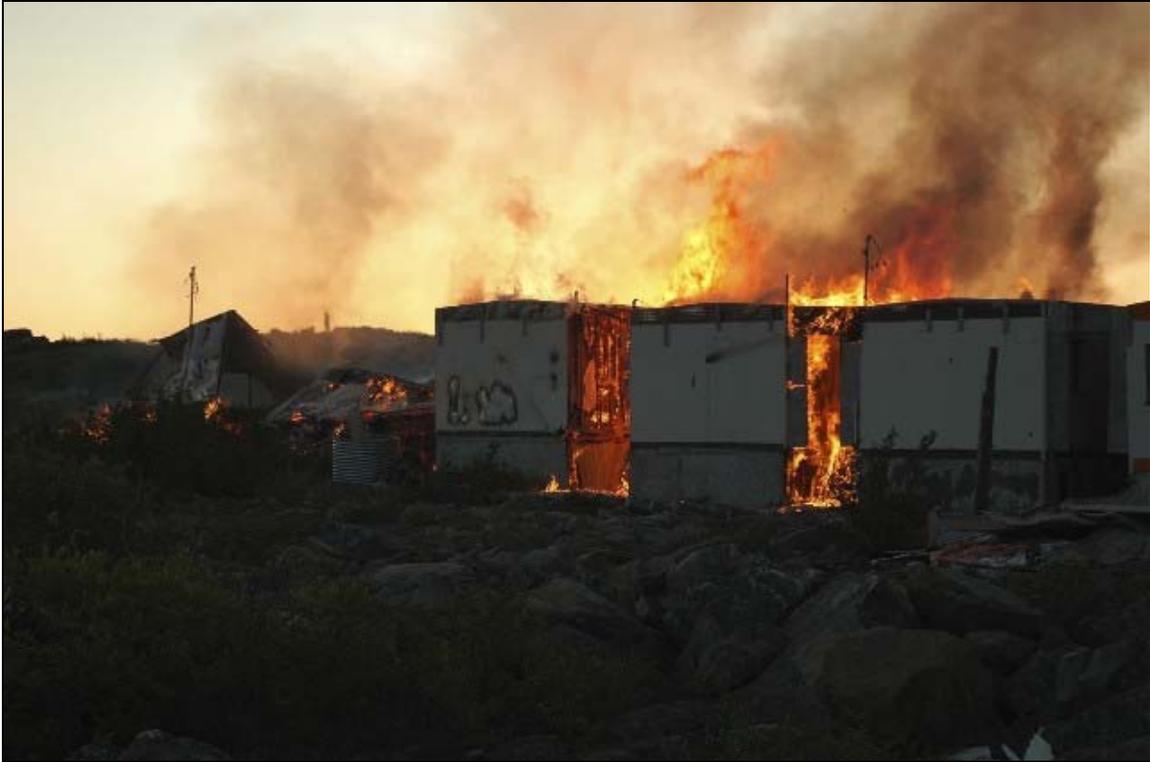
Figure 15: Buildings were burned at the site KAW-35 (photo credit: Alexandre Gaudreau).

The rehabilitation work was carried out in July. Non-combustible material was removed from the eight buildings and seven were burned (Figure 15). Following burning, the buildings' metal siding was cut and folded in preparation for transportation (Figure 16). Only the metal building structures and other metal waste that could not be removed from the buildings before burning remain (Figure 17). It should be noted that certain wooden buildings were not burned since they are being used to store some work equipment and to house the kitchen (Figure 18). The buildings will be used by the workers that return to the site to complete the rehabilitation work. It is recommended that these buildings be burned only once the rehabilitation work has been completely finished.

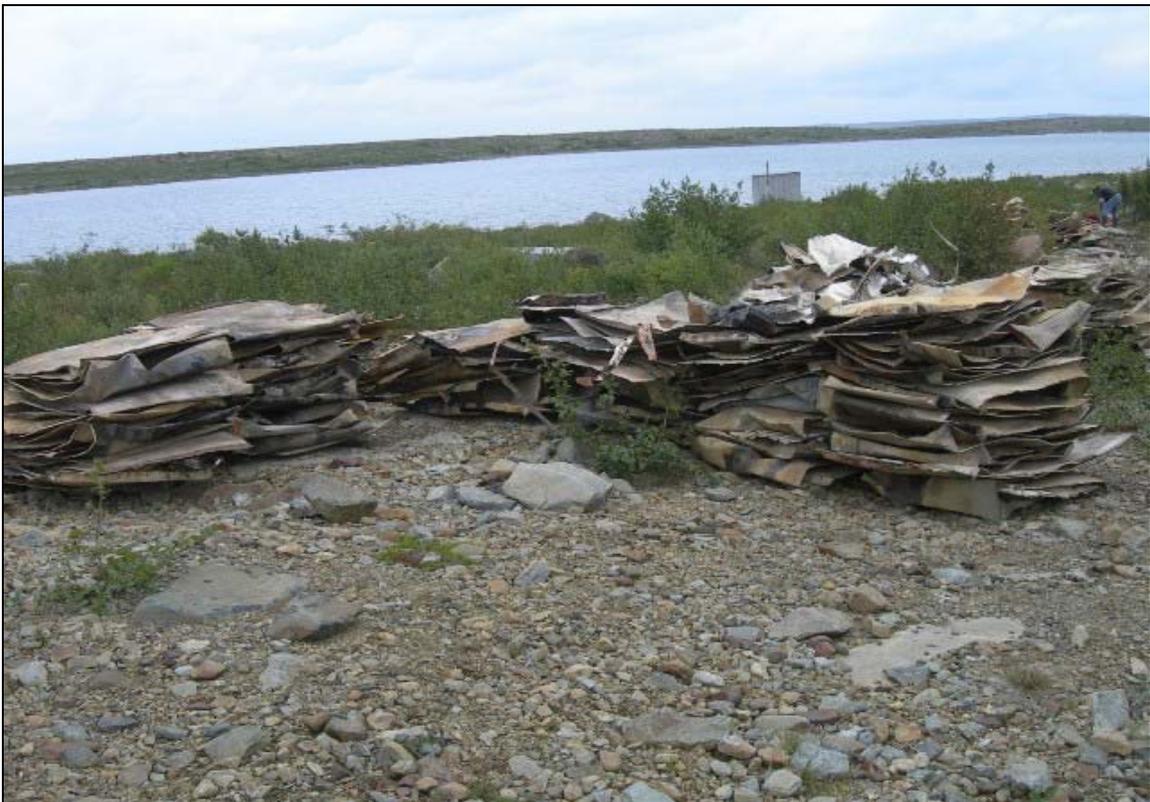
Figure 16: Metal siding was cut up and folded in preparation for transportation (photo credit: Alexandre Gaudreau).

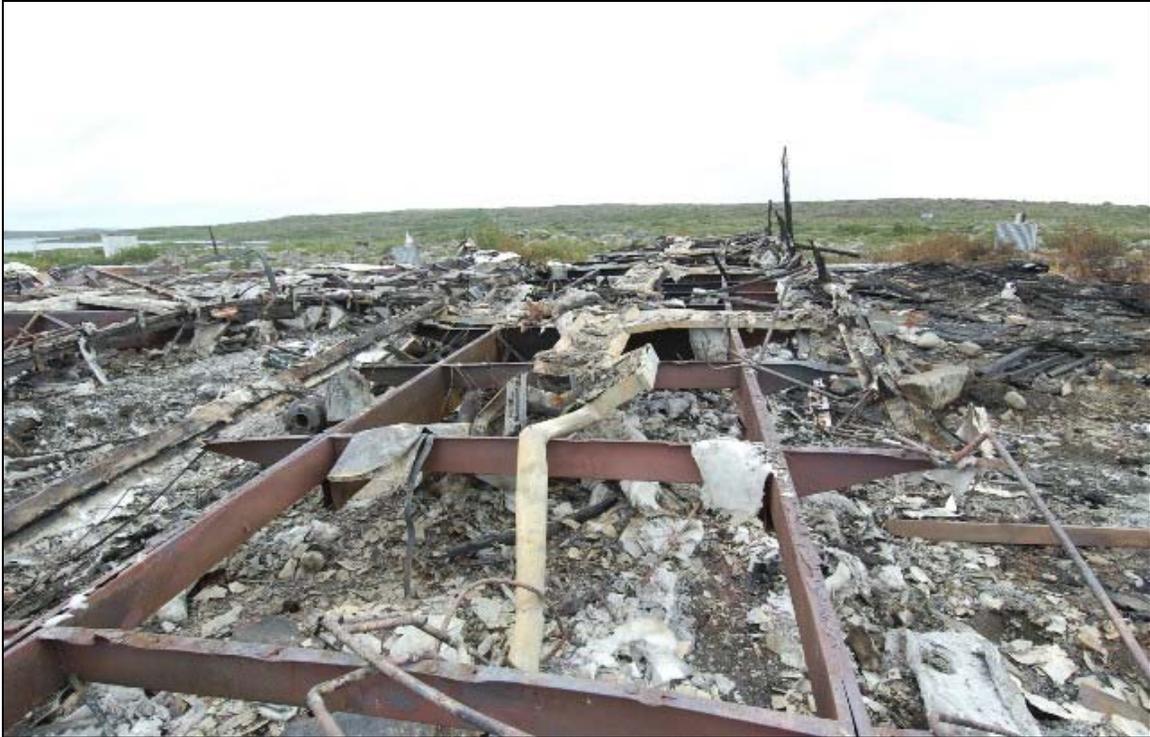
Figure 17: Waste from the buildings at the site KAW-35 (photo credit: Alexandre Gaudreau).

Significant work remains to be carried out at the site KAW-35. The metal building structures (Figure 17) and the six empty fuel reservoirs (Figure 20) should be cut up by a welder. It has been estimated that roughly one day for each reservoir and one day for each metal building structure will be required to complete this work. It is recommended that two welders be hired for this purpose and that each be assisted by two workers. The workers could move the cut-up metal to a temporary storage site in preparation for its shipment to a recycling centre. Some other waste material must also still be removed from the site, specifically a barrel containing anti-freeze and other metal waste (building structures, rods, siding, etc.). The contaminated soil remains to be characterized and treated (refer to Section 8).

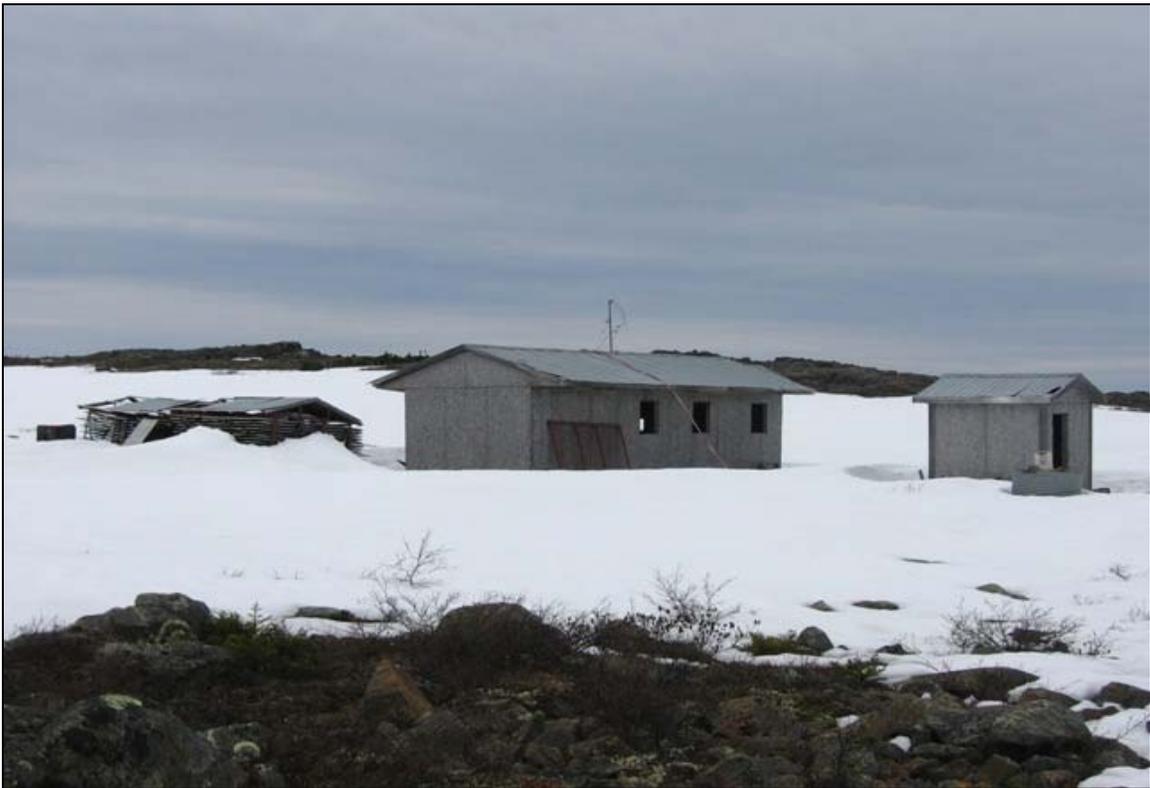
Figure 18: The building at centre was cleaned and is serving as a storage site until the continuation of rehabilitation work at the site KAW-35 (photo credit: Anne-Marie LeBlanc).

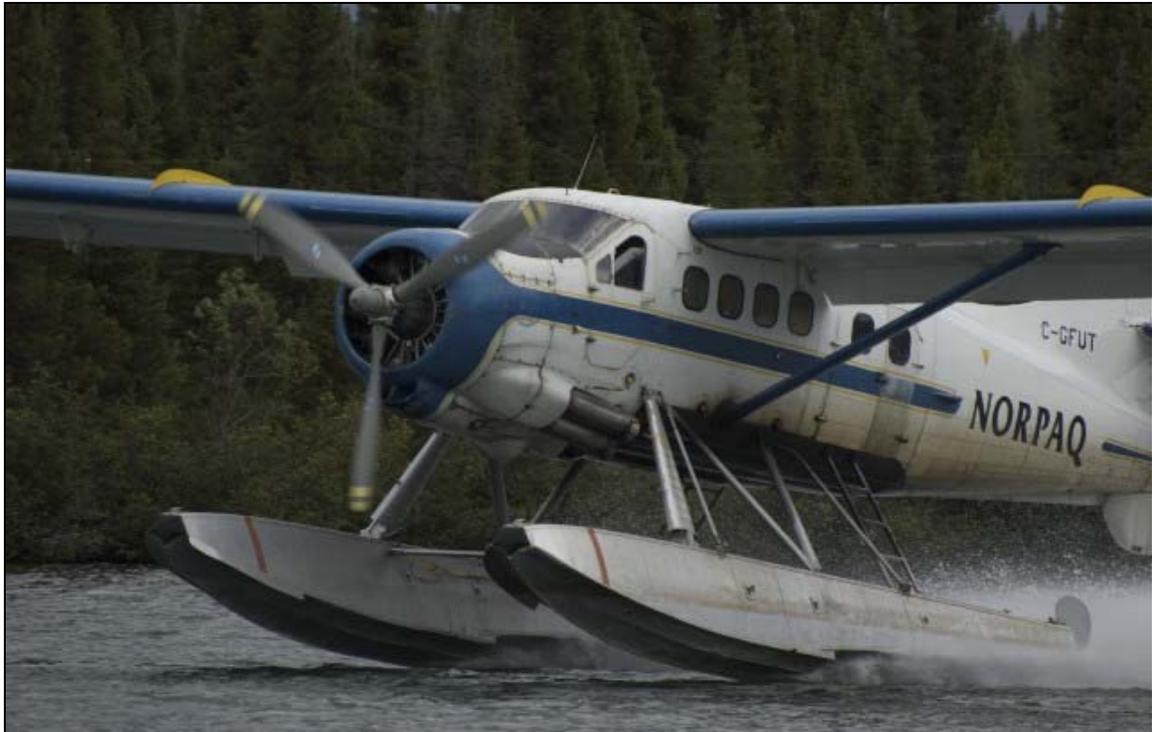
Figure 19: Waste from the sites KAW-35 and KAW-45 was removed by NORPAQ Adventures using a Single Otter floatplane (photo credit: Alexandre Gaudreau).

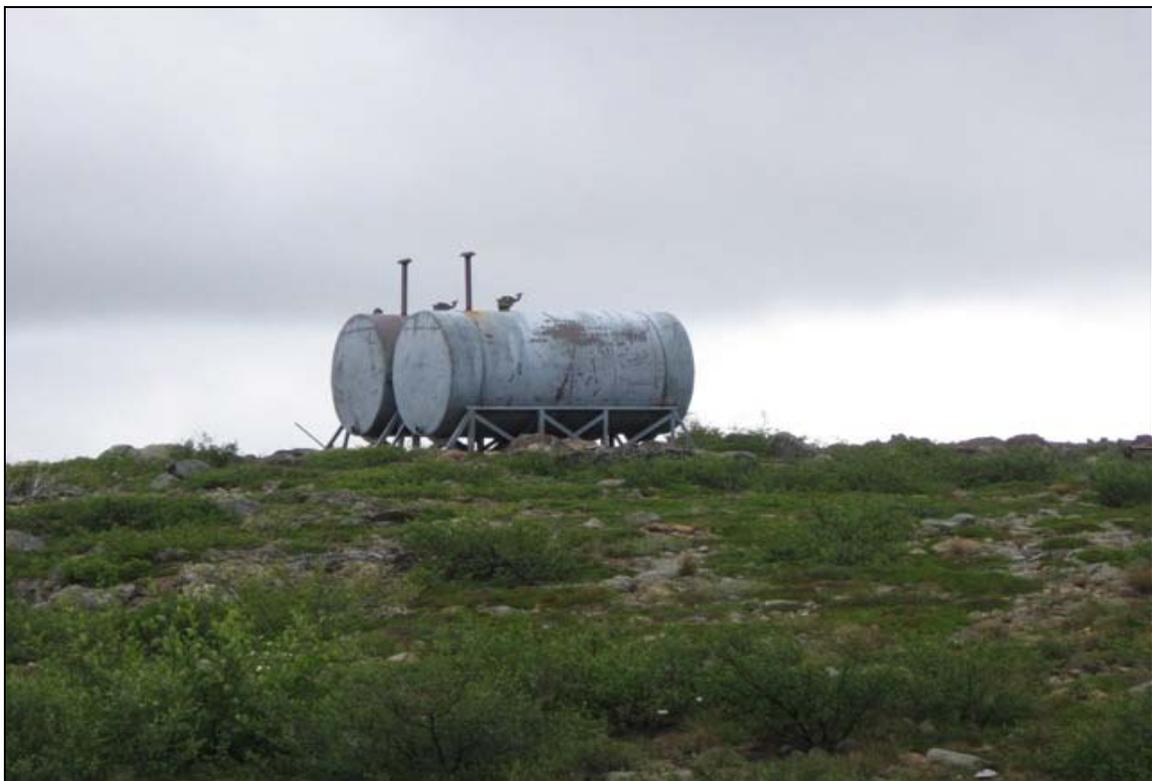
Figure 20: Empty fuel reservoirs at the site KAW-35 (photo credit: Anne-Marie LeBlanc).

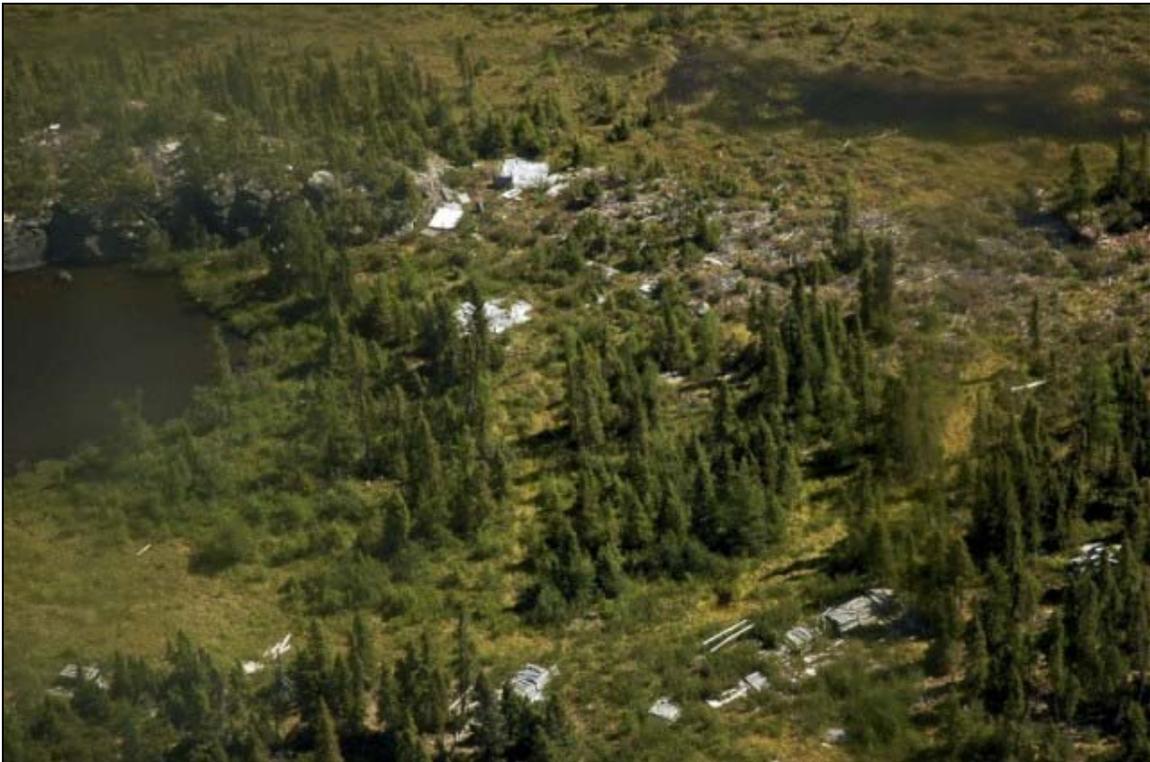
Figure 21: Aerial view of the site KAW-45, prior to rehabilitation work (photo credit: Alexandre Gaudreau).

Through July, the workers burned all the combustible material at the site KAW-45 (Figures 21 and 22). The empty barrels were cut up using a grinder. The waste was transported to the temporary storage site at Schefferville by NORPAQ Adventures using a Single Otter floatplane. The waste was shipped via train by Services Naskapi Adoschaouna to appropriate recycling and processing centres. Metal was shipped to Sept-Îles while the petroleum-hydrocarbon waste was shipped to Baie-Comeau. This completes the rehabilitation work at the site KAW-45. No further action is required.

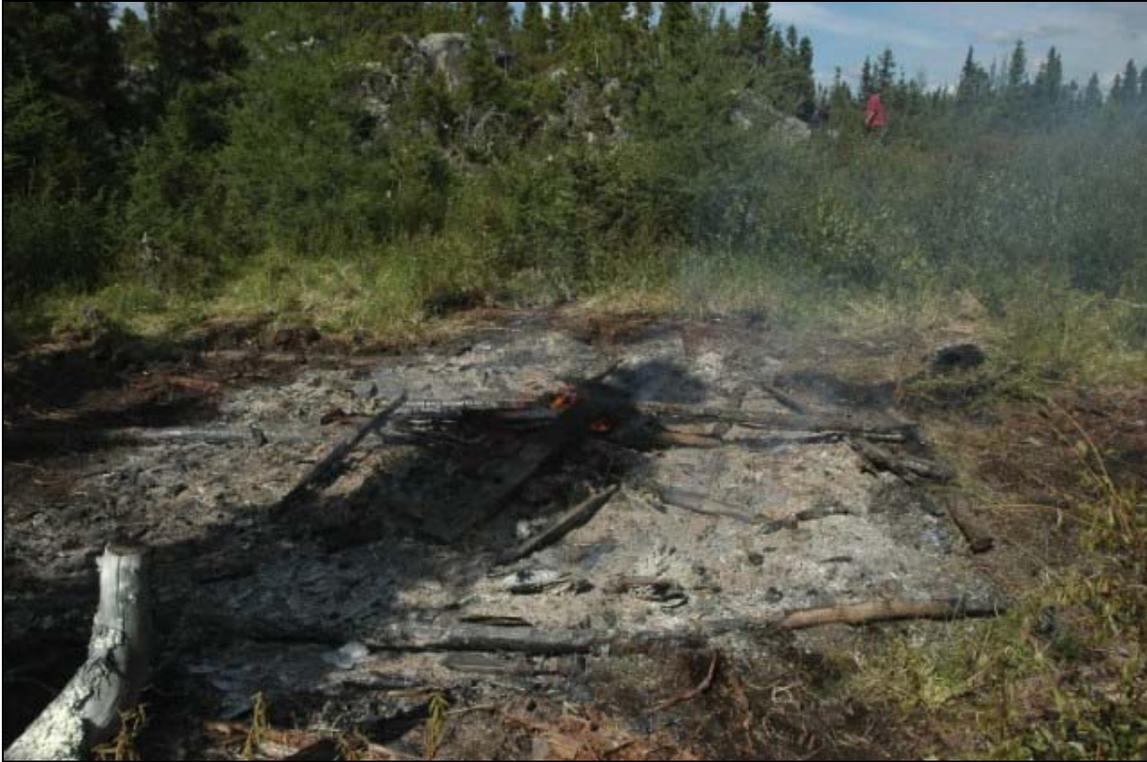
Figure 22: The burning of combustible material at the site KAW-45 (photo credit: Alexandre Gaudreau).

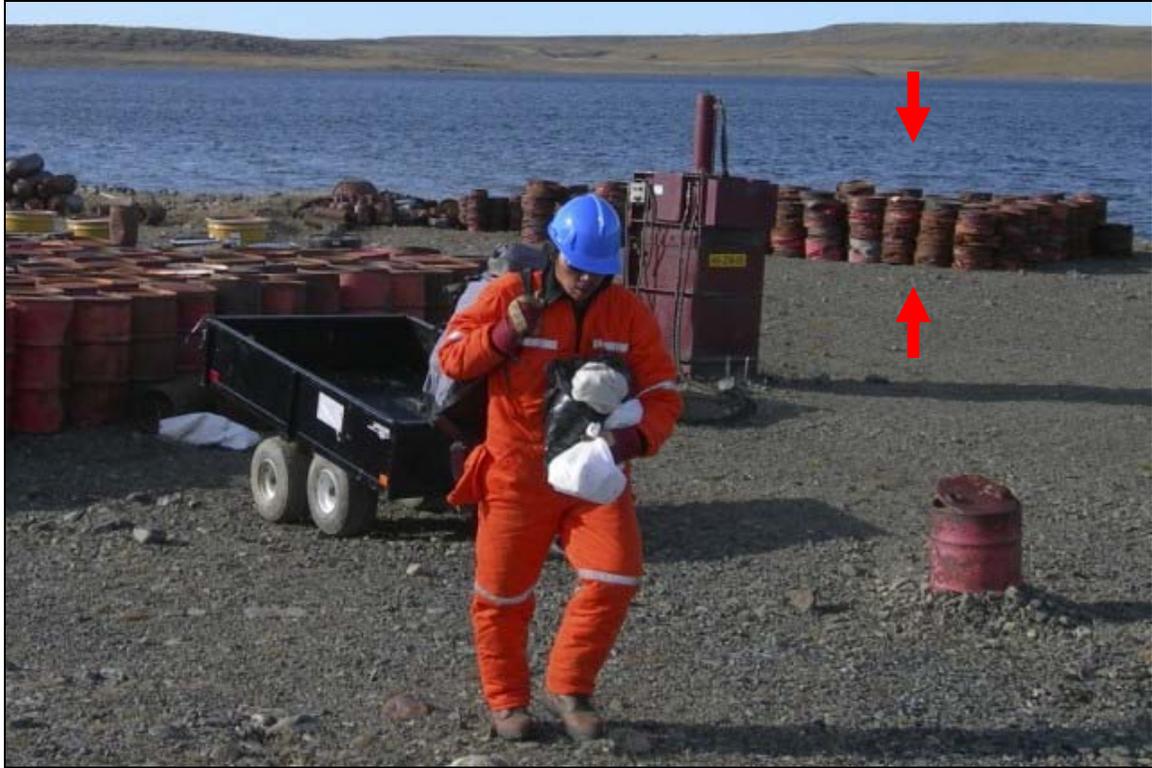
Figure 24: Crushed barrels at the site SW-34 (photo credit: Alexandre Gaudreau).

This rehabilitation work was carried out in August. Close to 3000 L of petroleum-hydrocarbon waste was transferred to barrels in good condition. Of the 700 barrels found at the site, 520 were crushed and then stored with propane tanks, next to the lake (Figure 24). Metal waste (70 m³) was gathered at 25 locations. Combustible material was also gathered together and then burned (Figure 25). The quantity of metal waste and combustible material was underestimated in the 2001–2002 inventory. The waste from the former disposal area was recovered, placed in not less than 50 gunny sacks in preparation for removal from the site.

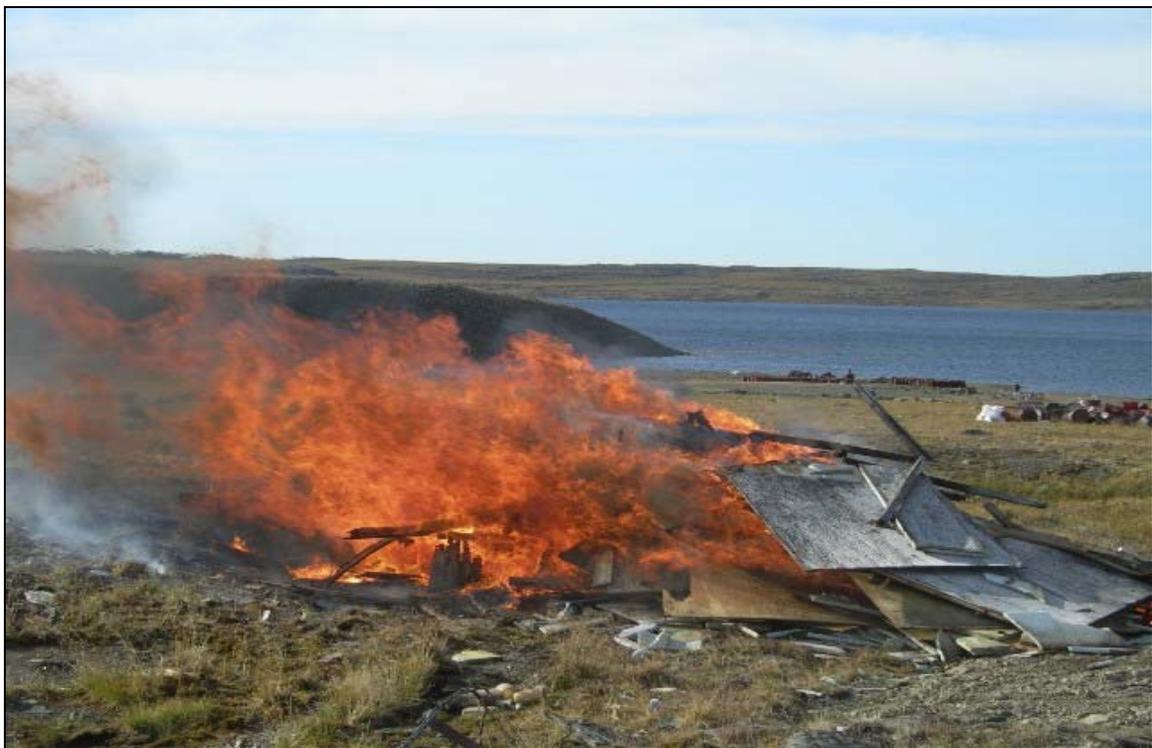
Figure 25: The burning of combustible material at the site SW-34 (photo credit: Alexandre Gaudreau).

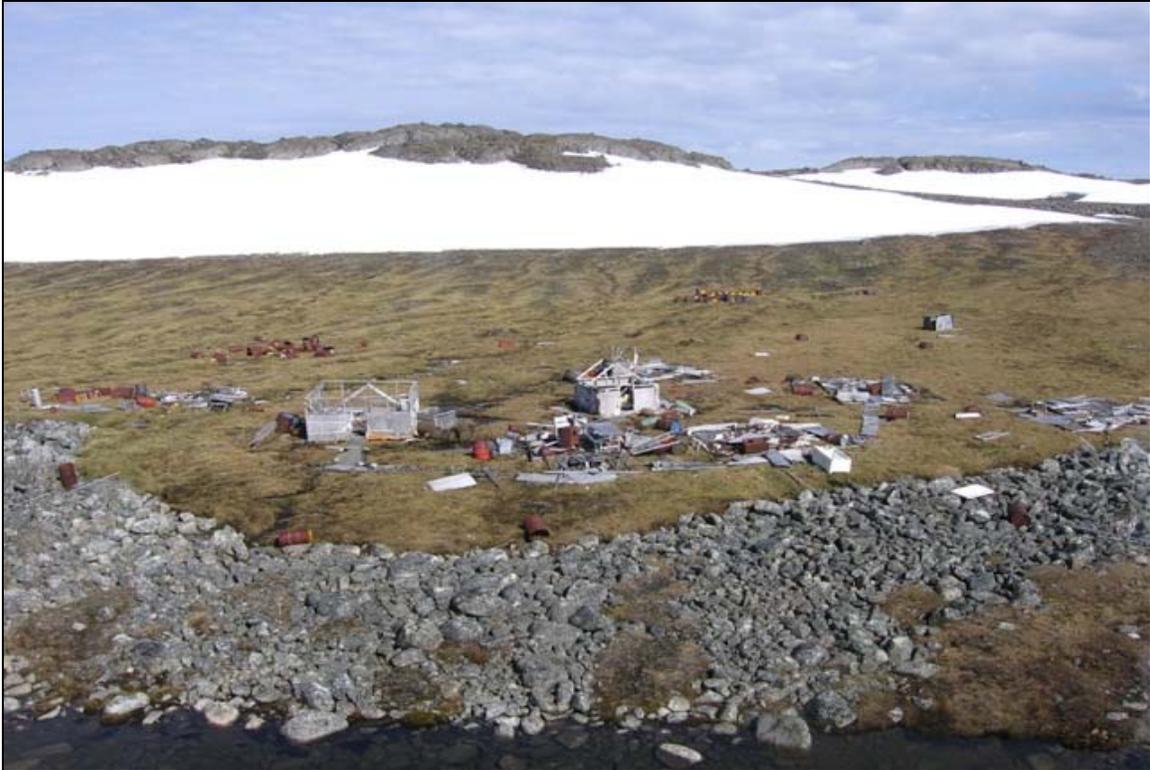
Figure 26: The site SAL-1, prior to rehabilitation work (photo credit: Anne-Marie LeBlanc).

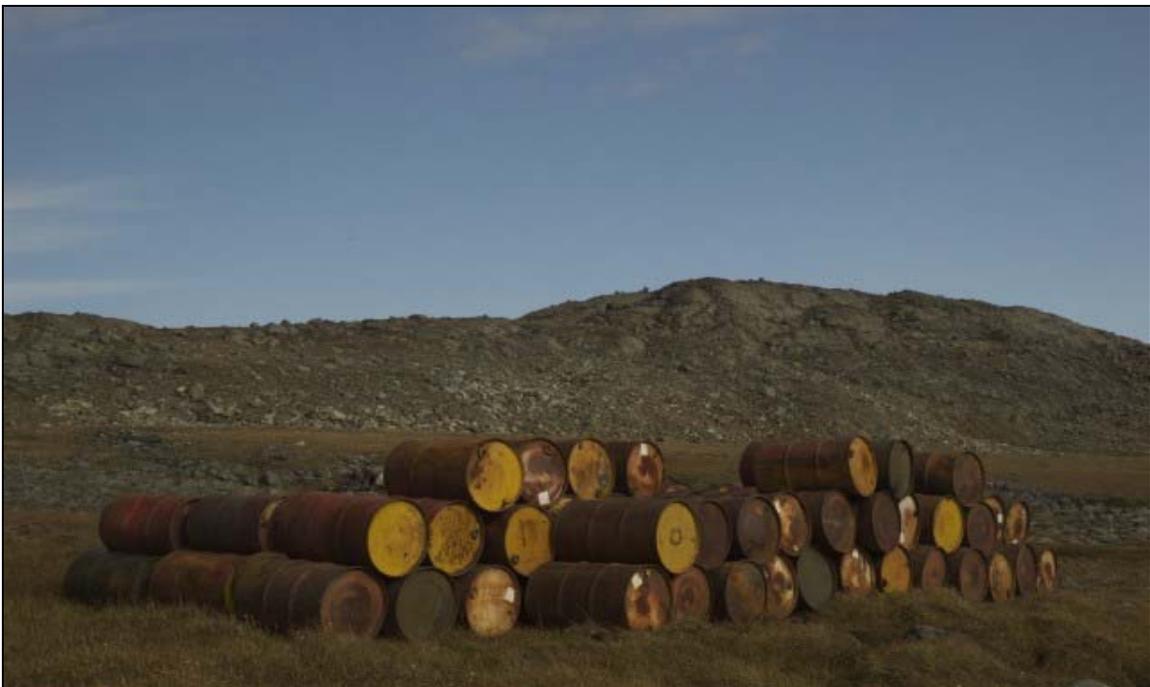
Figure 27: Empty barrels at the site SAL-1 ready for crushing (photo credit: Alexandre Gaudreau).

The rehabilitation work was carried out in August. The contents of the 320 barrels containing petroleum-hydrocarbons were transferred into 33 barrels (Figure 27). The contents of three of these barrels, which are safely stored for the time being, should nonetheless be transferred to new barrels in good condition. The combustible material was burned (Figure 28). Non-combustible material was removed from the buildings and placed in seven barrels and a dozen or so garbage bags. Other waste was gathered in one spot (oven, heating stove, etc.), along with four batteries, a fire extinguisher and 15 propane tanks. The barrels could not be crushed because the crusher broke down.

The remaining rehabilitation work at the site SAL-1 will involve transferring the contents of the three barrels into barrels in good condition and crushing the empty barrels. The waste will need to be removed from the site in the winter by snowmobile and *qamutiik*. It should be noted that the petroleum-hydrocarbon waste will be burned in the incinerator at the Bélanger camp or it will be transported to the Northern Village of Salluit where the municipal garage furnace is certified to burn this kind of waste. It will nonetheless be necessary to advise the parties concerned prior to transporting the petroleum-hydrocarbon waste. Among the hazardous material, four batteries, a fire extinguisher and 15 propane tanks will have to be removed from the site. The empty barrels will need to be crushed or cut up using a grinder, prior to their transportation.

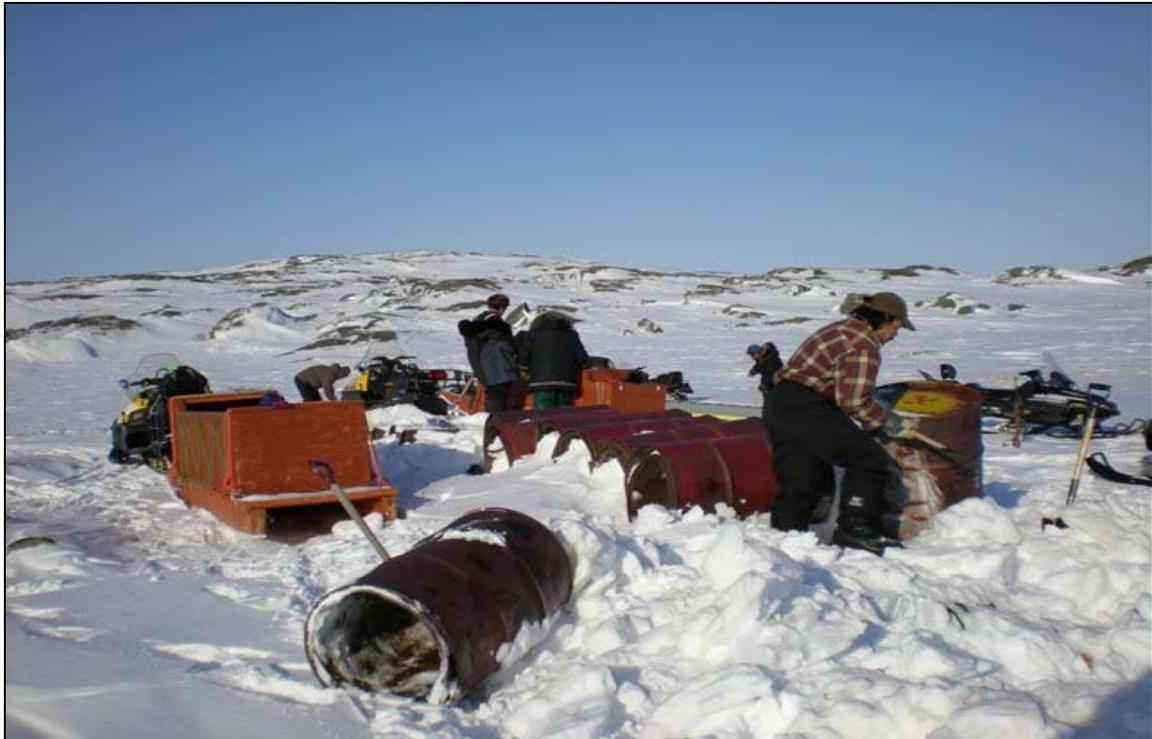
Figure 29: This waste was stored at the site PJ-1 in the summer of 2007 in preparation for transportation in the winter. The waste had to be dug out of the snow before being transported.
