**SUMMARY REPORT
ON REHABILITATION WORK
AT THE 18 “MAJOR” ABANDONED MINERAL
EXPLORATION SITES IN NUNAVIK
CARRIED OUT IN THE SUMMER OF 2008
AND
UPDATE ON THE GENERAL RESPONSE PLAN**

Kativik Regional Government

**Renewable Resources, Environmental
and Land Use Planning Department**

December 2008

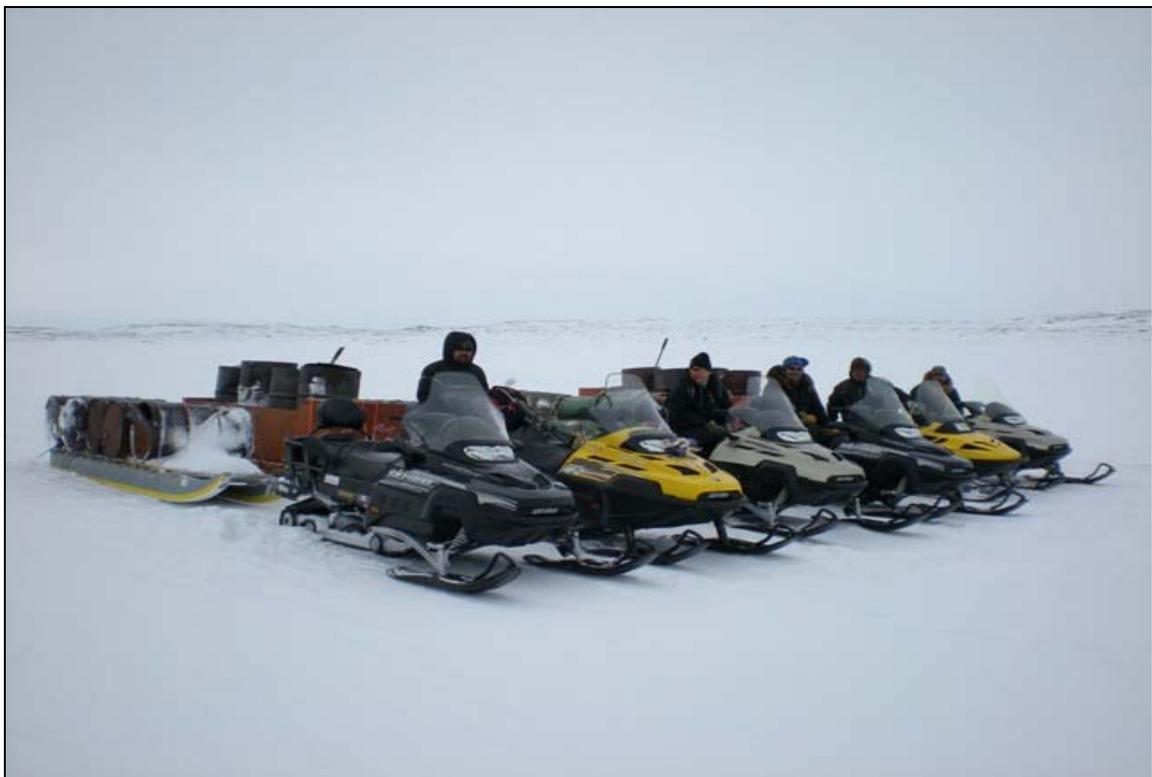
Figure 30: Waste being transported by snowmobile and *qamutiik* from the site PJ-1 to the temporary storage site at Aupaluk (photo credit: Mark T. Gordon).

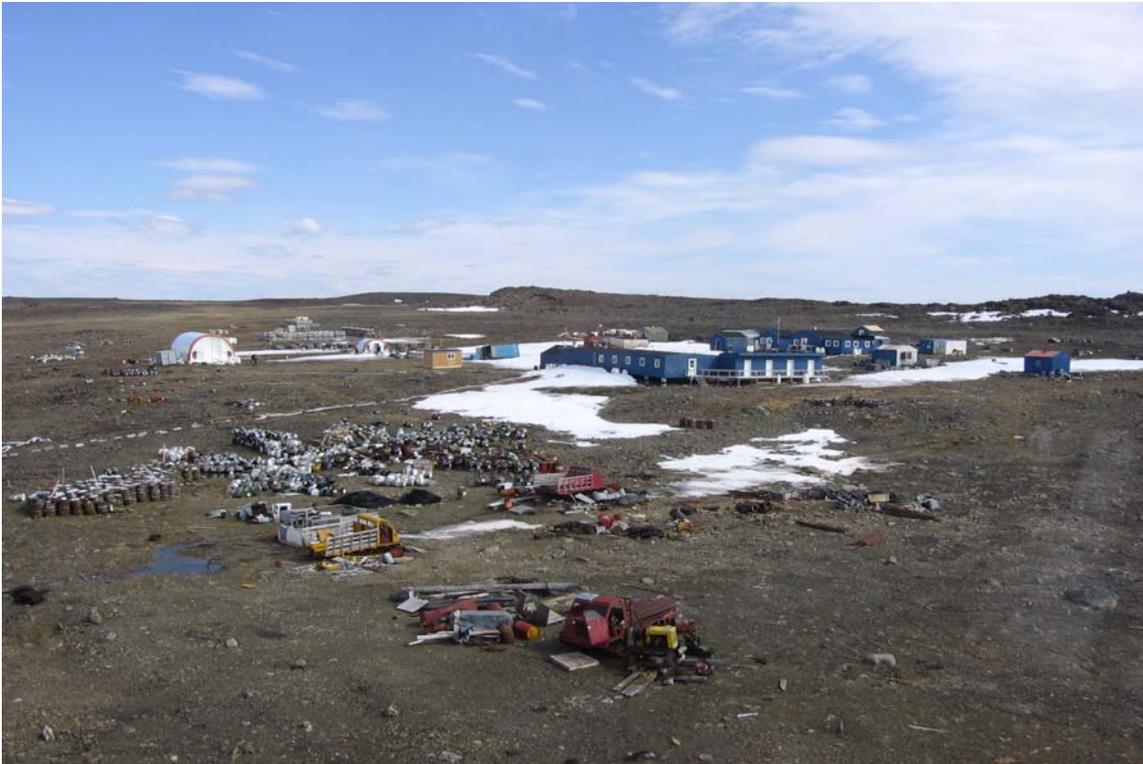
Figure 31: Canadian Royalties is carrying out the rehabilitation work at the site K61 (photo credit: Anne-Marie LeBlanc).

During the summer of 2008, Canadian Royalties carried out rehabilitation work at the sites K61 and K28 (Figures 2, 31 and 32). Roughly 50% of the rehabilitation work was completed at the site K61 and 90% at the site K28 (Appendix E). At the site K61, more than 3600 barrels were collected and shipped in containers to a processing centre. Hazardous material was removed from the site. The contaminated soil at Expo camp was recuperated and combustible material was burned. At the site K28, the camp was closed and the barrels and other waste were removed from the site. The rehabilitation work will be continued by Canadian Royalties over the coming summers. It should be noted that the FRAN will not contribute directly to funding the rehabilitation work at these sites as originally planned.

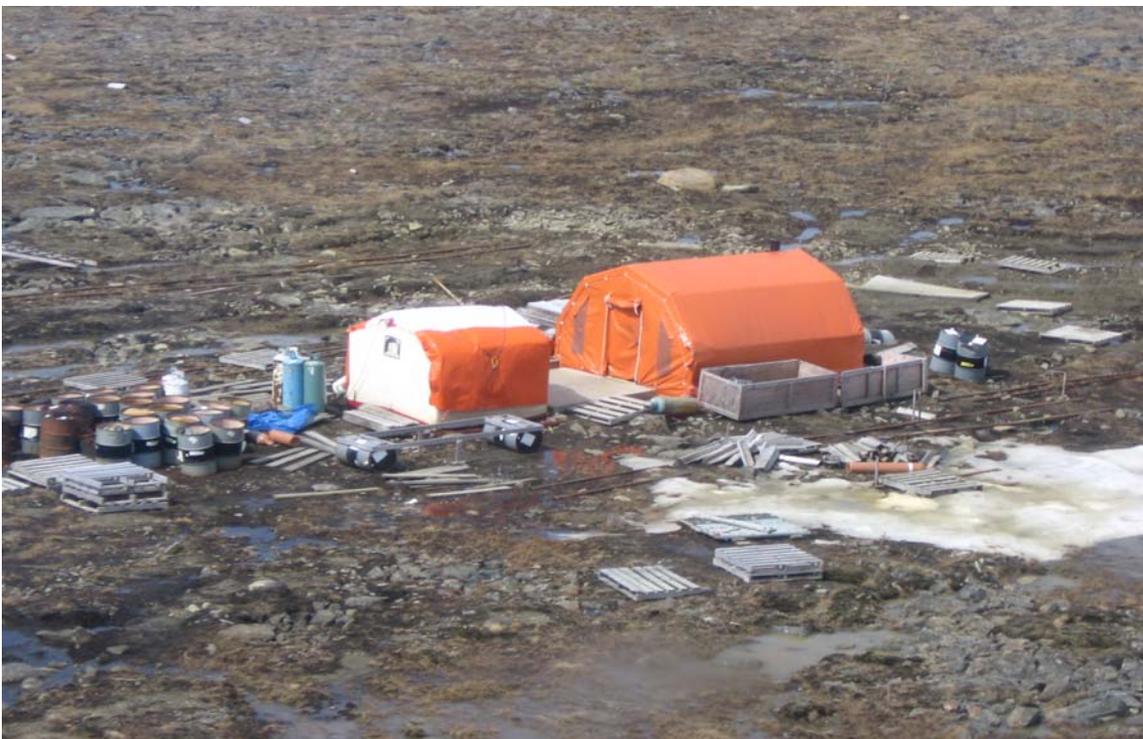
Figure 32: Canadian Royalties is carrying out the rehabilitation work at the site K28 (photo credit: Anne-Marie LeBlanc).
