**ASSESSMENT AND REMEDIATION OF ABANDONED MINING
EXPLORATION SITES IN NUNAVIK**

**PROGRESS REPORT
FOR YEAR 2005-2006 OF THE PROJECT**

**Kativik Regional Government
Renewable Resources Department**

MARCH 2006

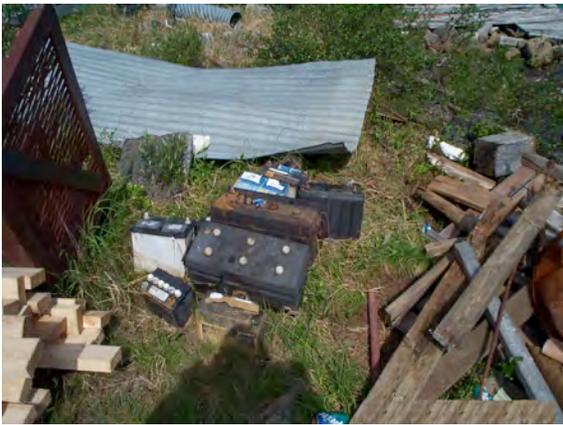
Picture 3. Batteries and debris near lake.

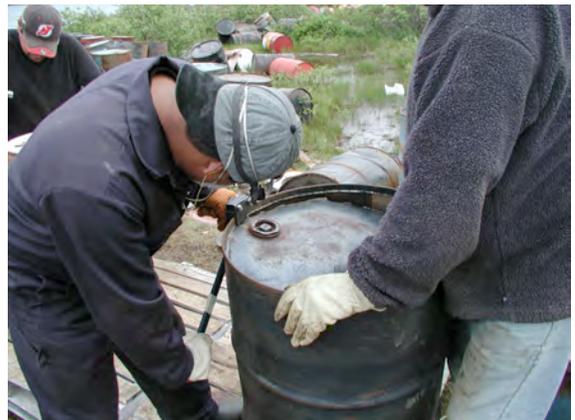
Picture 6. Manual barrel “deheader”.

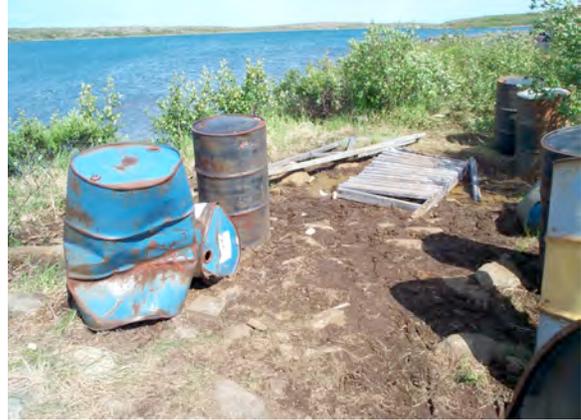
Picture 12. Lakeshore sector, contaminated soil sampling station.

The second contaminated area is located under the piles of barrels observed near the lakeshore. Three samples (S-6, S-8, S-9) collected near the site's dock showed traces of petroleum products (diesel, Jet-B fuel) contamination slightly above the limit for residential land use (Rf.: *Règlement sur la protection et la réhabilitation des terrains* du Gouvernement du Québec). The C_{10} - C_{50} concentrations are higher a few centimeters deep in the soil than they are on the surface. The contaminated surface is limited and not continuous. It affects an area of approximately 20 m² and is strictly localized under the barrels observed on the lakeshore.

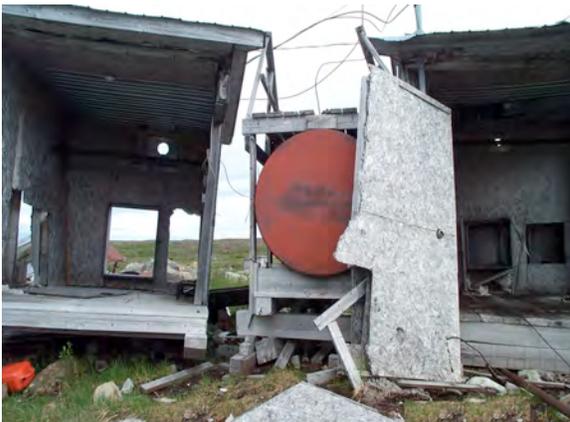
Picture 13. Generator sector, contaminated soil sampling station.

Out of the 22 soil samples, only 5 samples showed significant contamination above regulation standards. Anomalous samples delineate two specific zones. The first zone (samples S-2, S-3) corresponds to the area under a generator where the assay results exceed the C_{10} - C_{50} concentrations limit for an residential land use (Rf.: *Règlement sur la protection et la réhabilitation des terrains* du Gouvernement du Québec). The area around the generator floor was surveyed. It is suspected that an equivalent contamination level should be found not only around floor edges but also underneath the generator floor. If this is the case the contaminated surface is estimated to 48m² and soil remediation should be performed on this area during a following remediation phase of the pilot project.

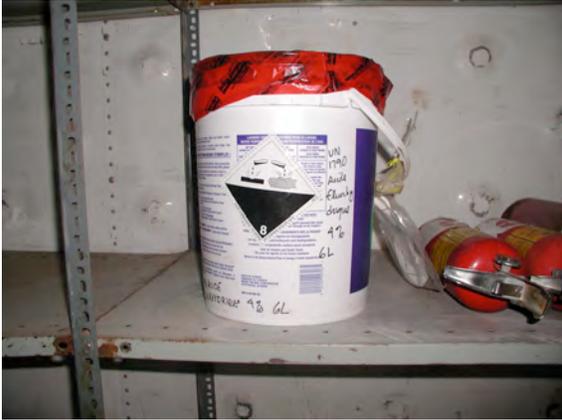
Picture 17. Proper identification and labeling of hazardous materials collected. (HF acid 4%, UN 1790, 12X500ml)

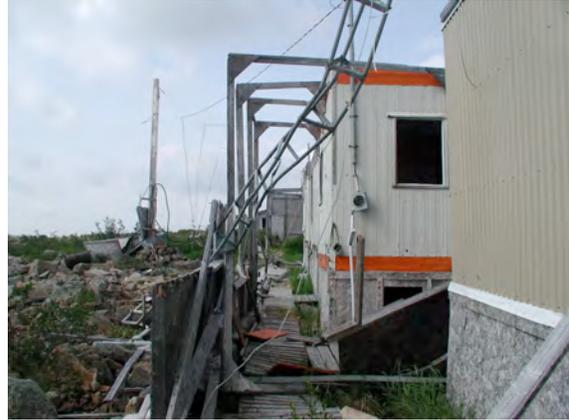
Picture 2. Hazardous metal and wood
debris.

The condition of the buildings and dwellings observed on-site is poor, in deterioration and may eventually leads to issues of public health and safety. Unstable metallic antennas, suspended wires and unsafe trailers could pose a serious threat (Appendix B, photos 1-3). The second phase of remedial measures on the KAW-35 site should also involve the stabilization and/or demolition of these buildings and the dismantling of any hazardous wires and antennas. All metallic and non-combustible debris should be collected and gathered in the above-mentioned projected non-combustible materials deposit. Finally, combustible debris should be burned on site according to MENV regulations.

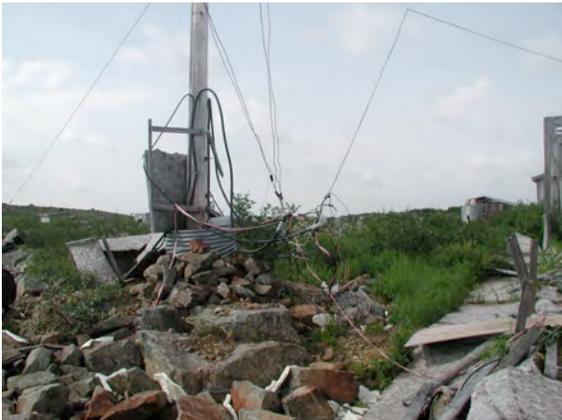
Picture 3. Hazardous suspended wires.

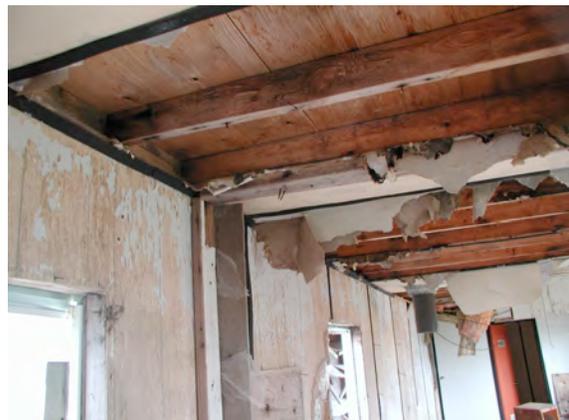
Picture 6. Damaged structures of trailer.

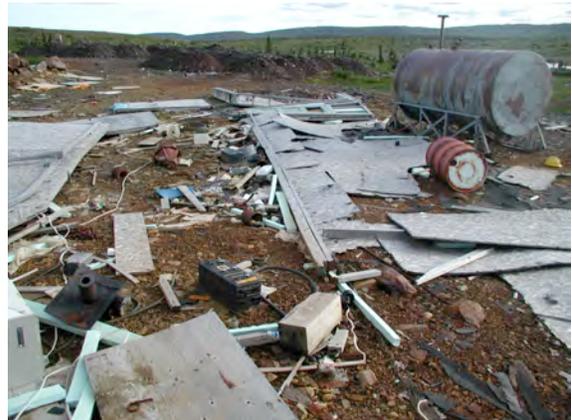
Picture 14. 4,400 L tank and residual materials on sector #2.

No trace of hydrocarbon concentrations has been detected in the water of the Blue Lake nor under the five (5) 4,400L reservoirs located along the trail leading to the mine and at the excavated gallery. During a previous soil sampling survey carried out in 2002 where scattered batteries were observed, no trace of metal concentrations had been observed either. The five anomalous soil samples numbers (S-2, S-3, S-6, S-8, S-9) locations and values for the 2005 survey on the KAW-35 site are presented in Table 2. The complete analysis report of the twenty-two (22) soil samples is presented in Appendix H. Analysis results of the four (4) water samples taken in the Blue Lake are also presented in the report; no anomalous trace of hydrocarbon was detected.

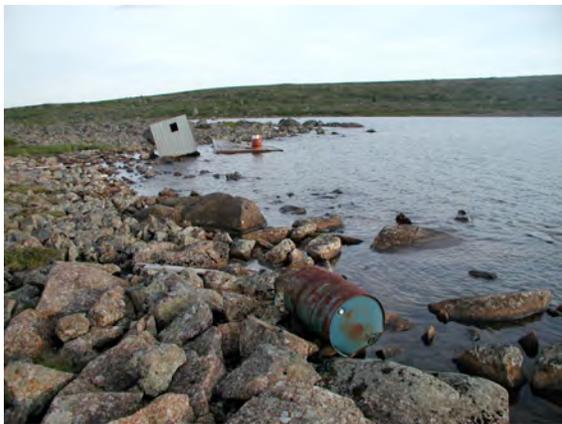
Picture 19. Empty barrels and dwelling in lake (south end of Blue Lake).

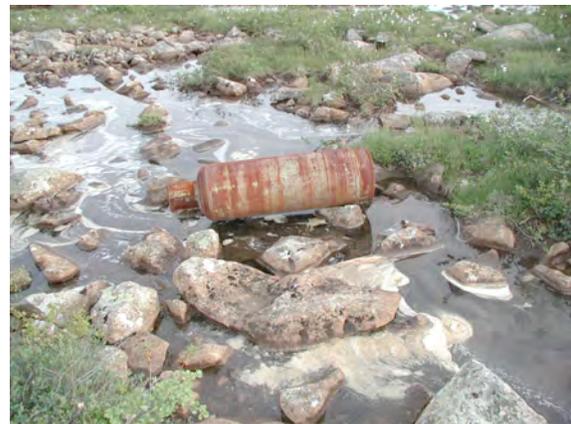
Picture 20. Propane cylinder in southern discharge of the Blue Lake.

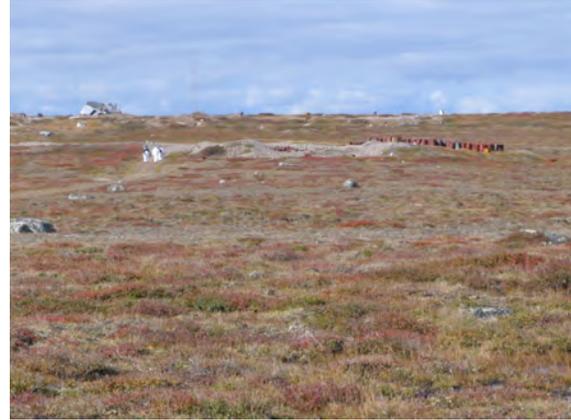
Picture 2. Collapsed building and empty barrels (site PJ-17)

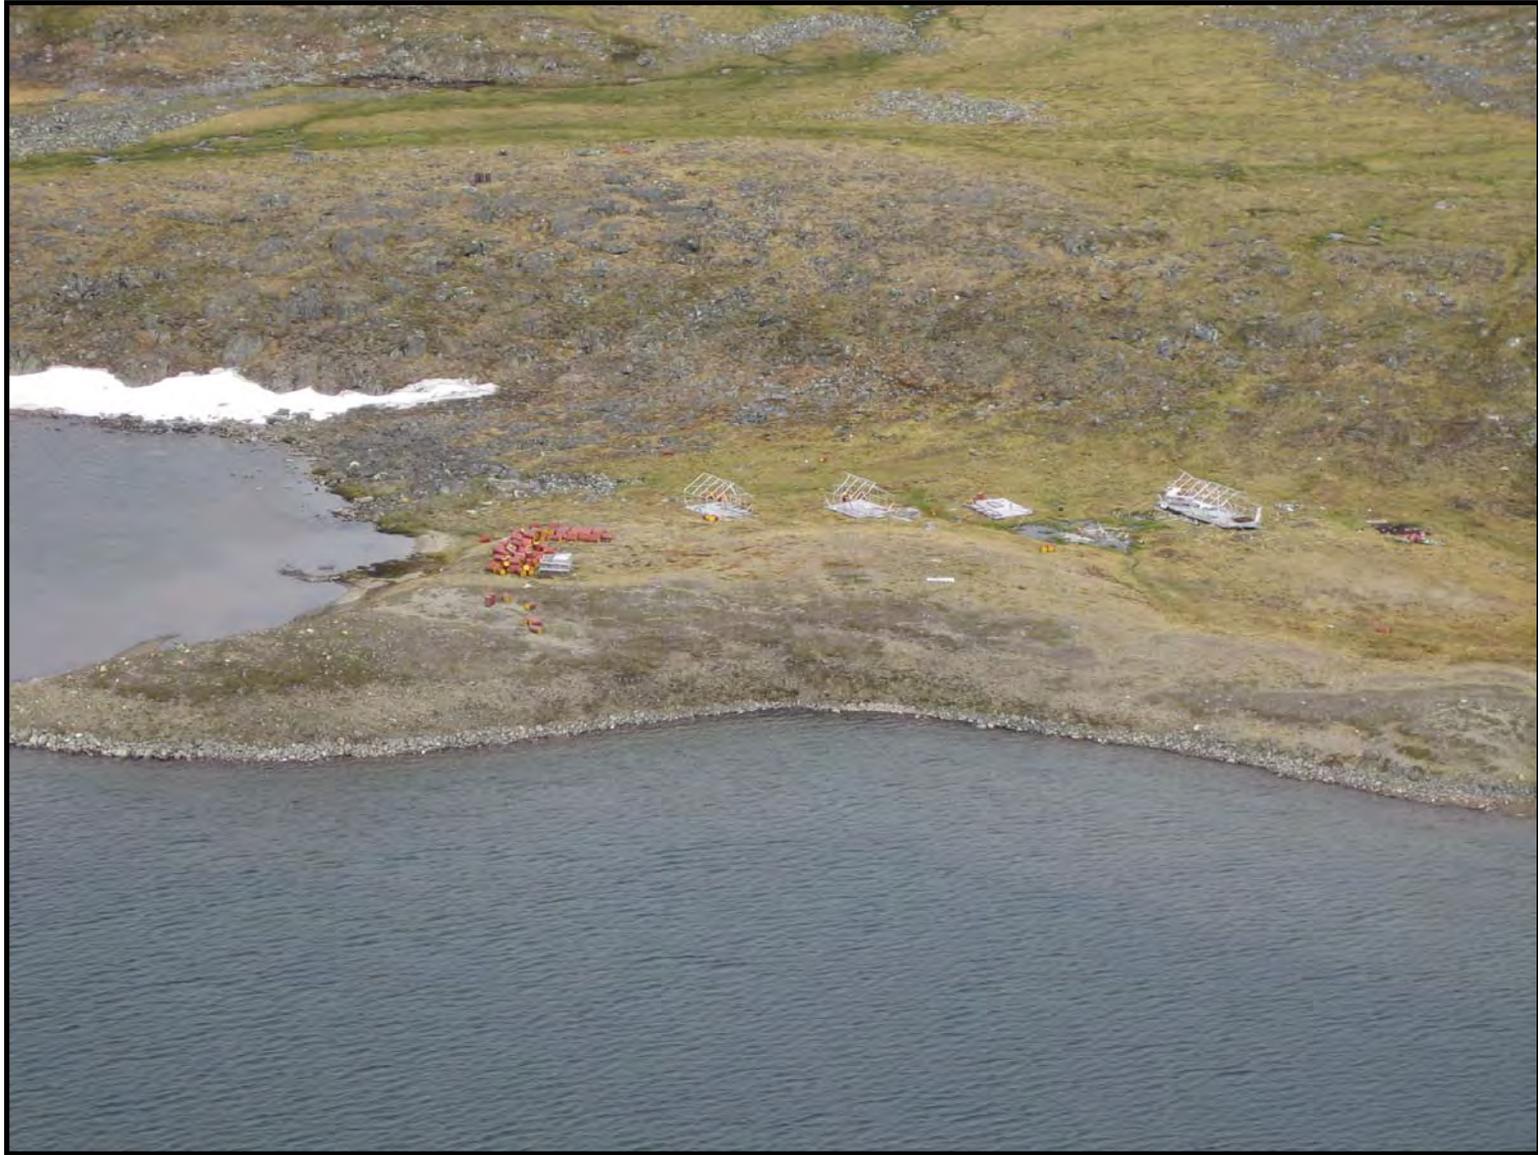
Photo 1. Aerial photo of historical abandoned camp near Lac Dumas, Nunavik, before commencement of clean-up efforts. Note large cache of fuel drums at left, tent floors and tent frames in center of photo. View looking north, July 7th, 2005.

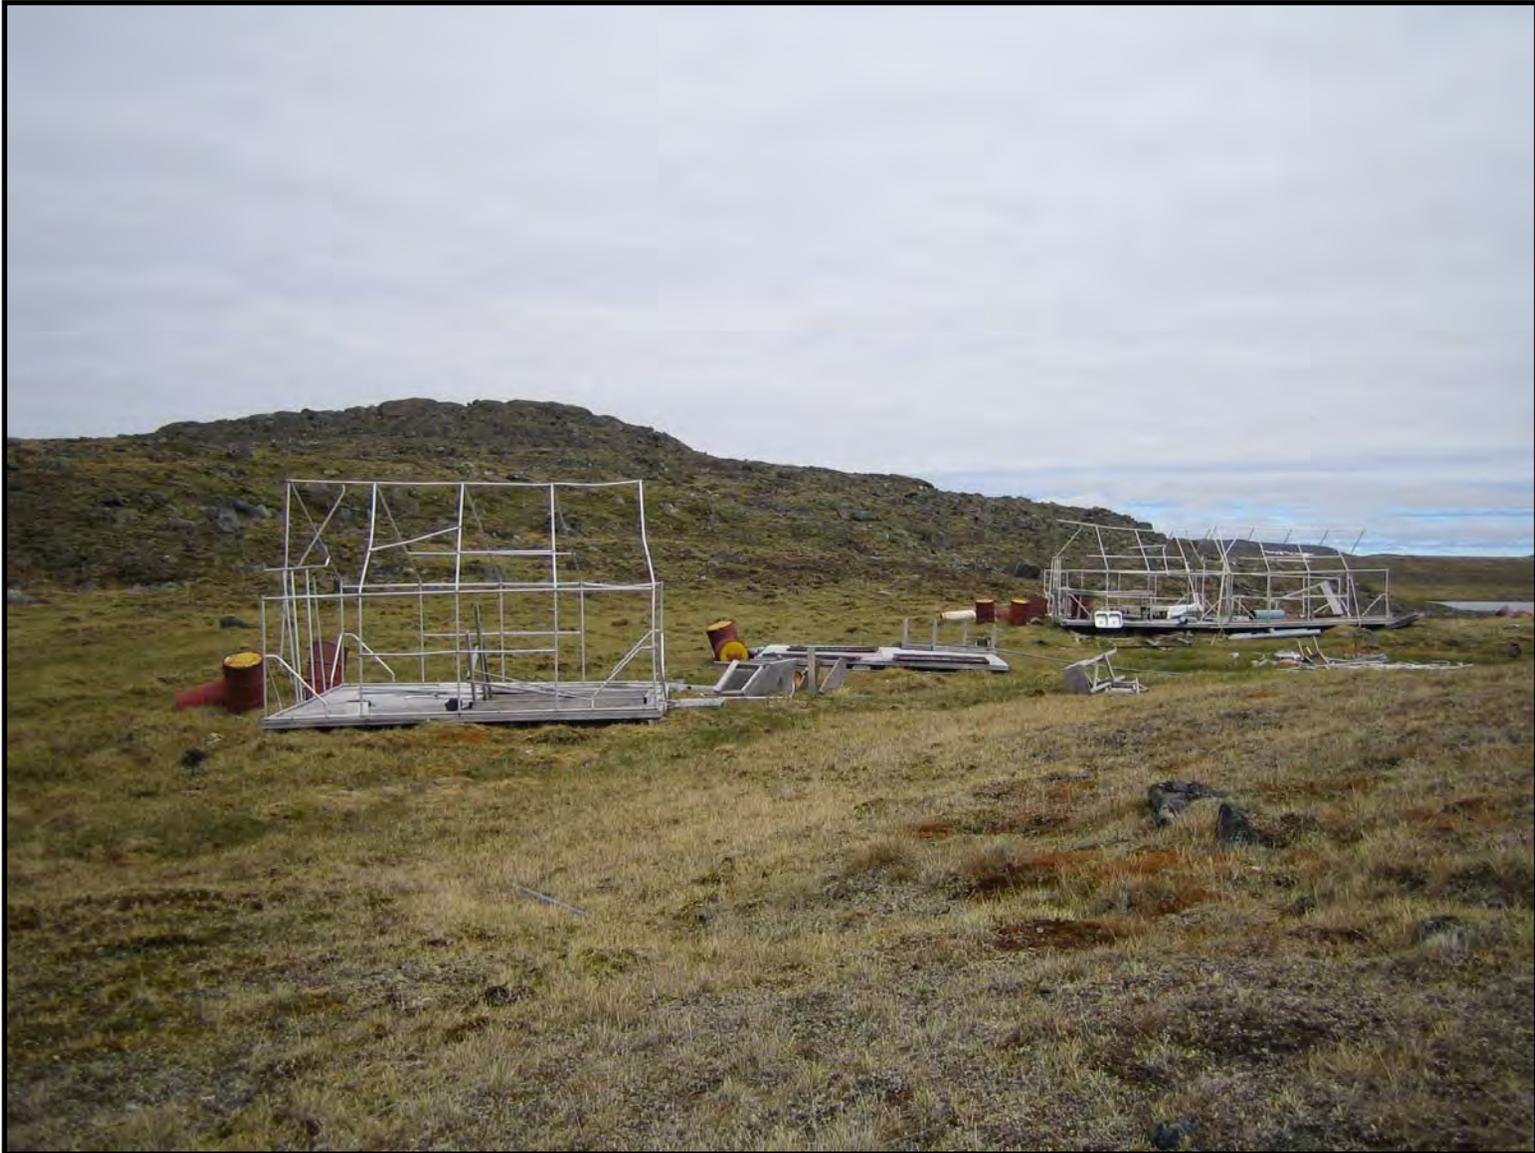
Photo 2. Aluminum tent frames and old fuel drums at the abandoned camp near Lac Dumas, Nunavik, before commencement of clean-up efforts. View looking east, July 7th, 2005.

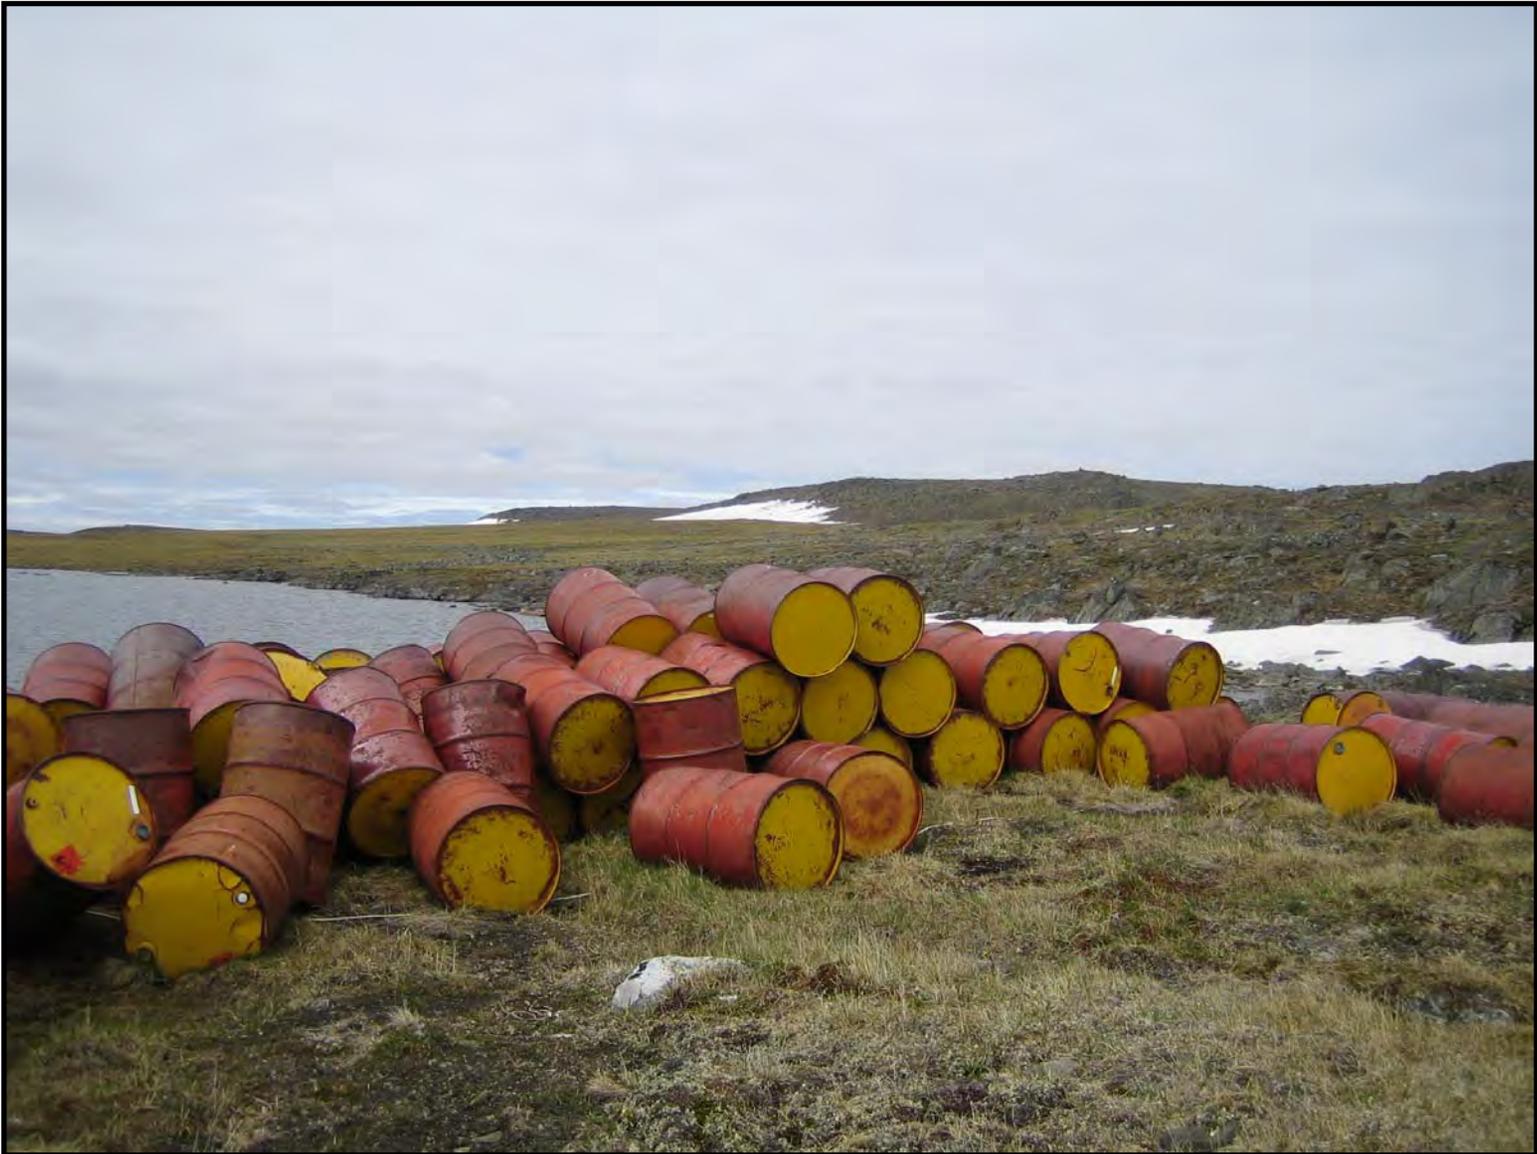
Photo 3. Pile of old fuel drums at the abandoned camp near Lac Dumas, Nunavik, before commencement of AAEC's clean-up effort. A total of 30 drums of fuel were transferred to new drums (6 gas, 24 diesel) and 75 empty drums were brought to Belanger camp in 2005. View looking west, July 7th, 2005.

Over the course of the 2005 summer, from approximately early August to mid September, personnel from AAEC’s Belanger exploration camp transferred the contents of 30 old fuel drums (6 gas, 24 diesel) into new drums and brought the

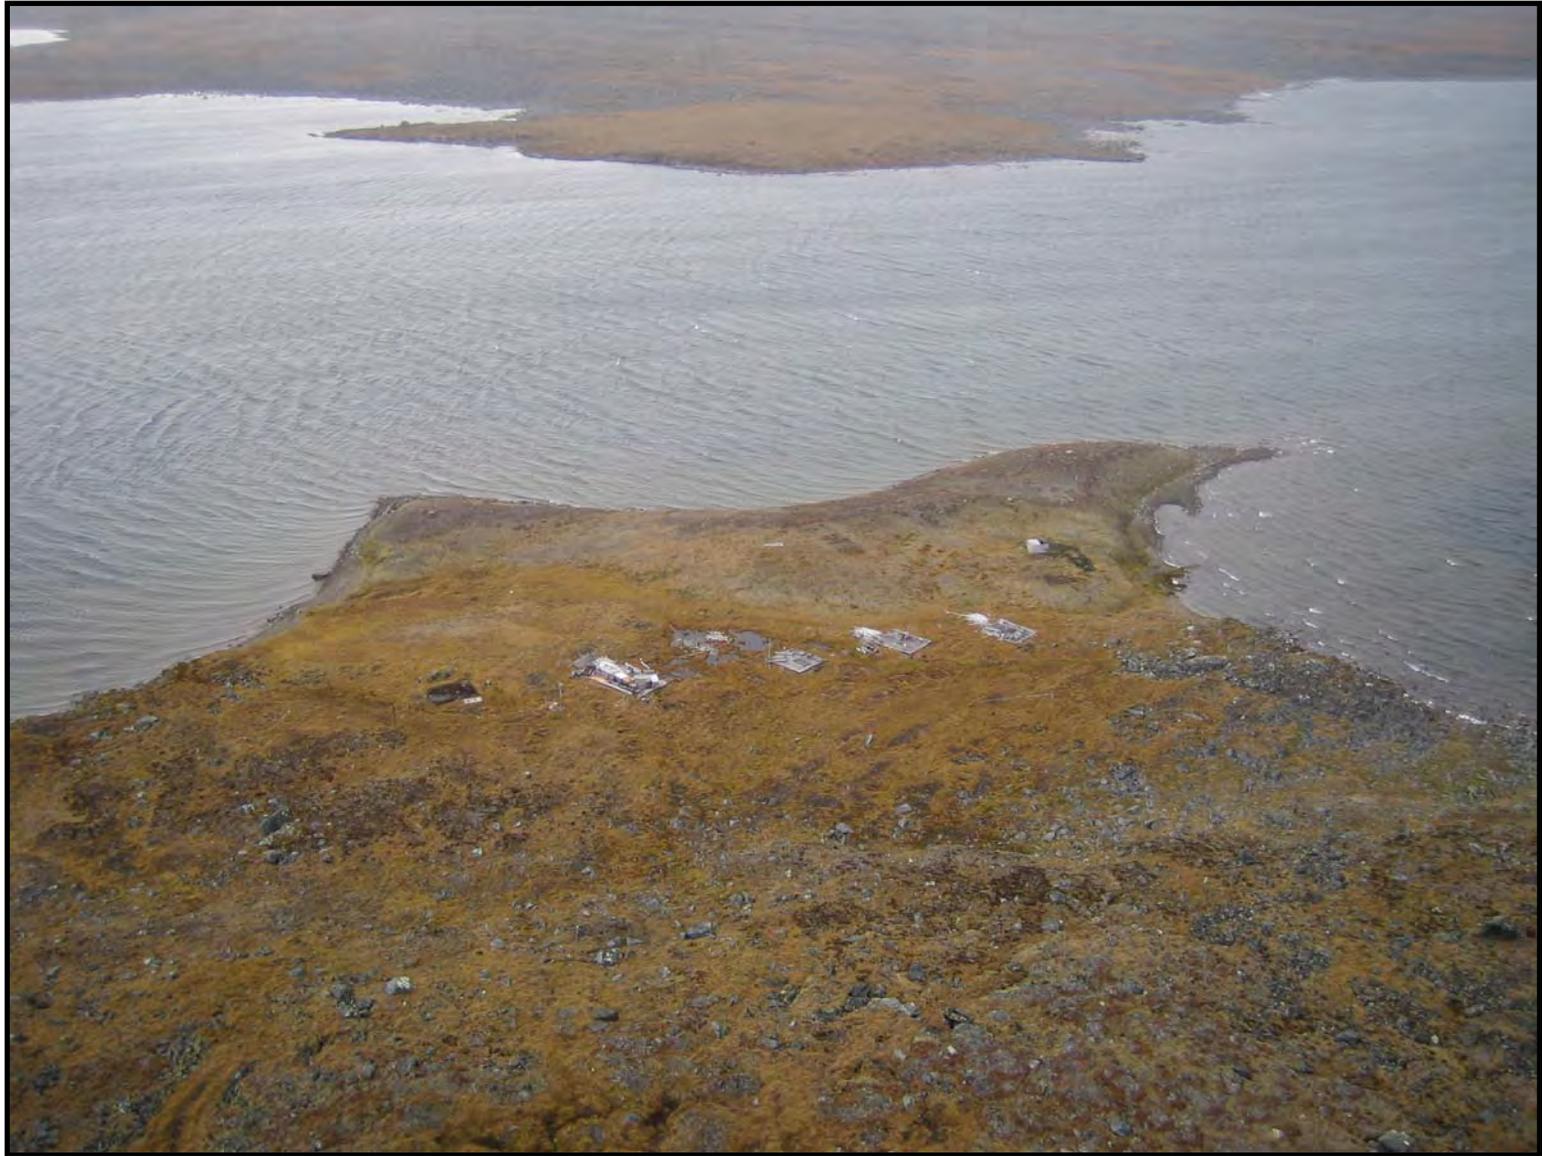
Photo 7. Aerial photo of abandoned camp near Lac Dumas, Nunavik, after AAEC's clean-up effort. Note all old fuel drums have been removed from site, and all tent frames have been taken down. A total of 30 drums of fuel were transferred to new drums (6 gas, 24 diesel) and 75 empty drums were brought to Belanger camp in 2005. View looking south, September 5th, 2005.
