**SUMMARY REPORT ON THE REHABILITATION WORK AT THE 18 "MAJOR"
ABANDONED MINERAL EXPLORATION SITES IN NUNAVIK CARRIED OUT
DURING THE SUMMER OF 2009**

UPDATE ON THE GENERAL RESPONSE PLAN

Kativik Regional Government

**Renewable Resources, Environment
and Land Use Planning Department**

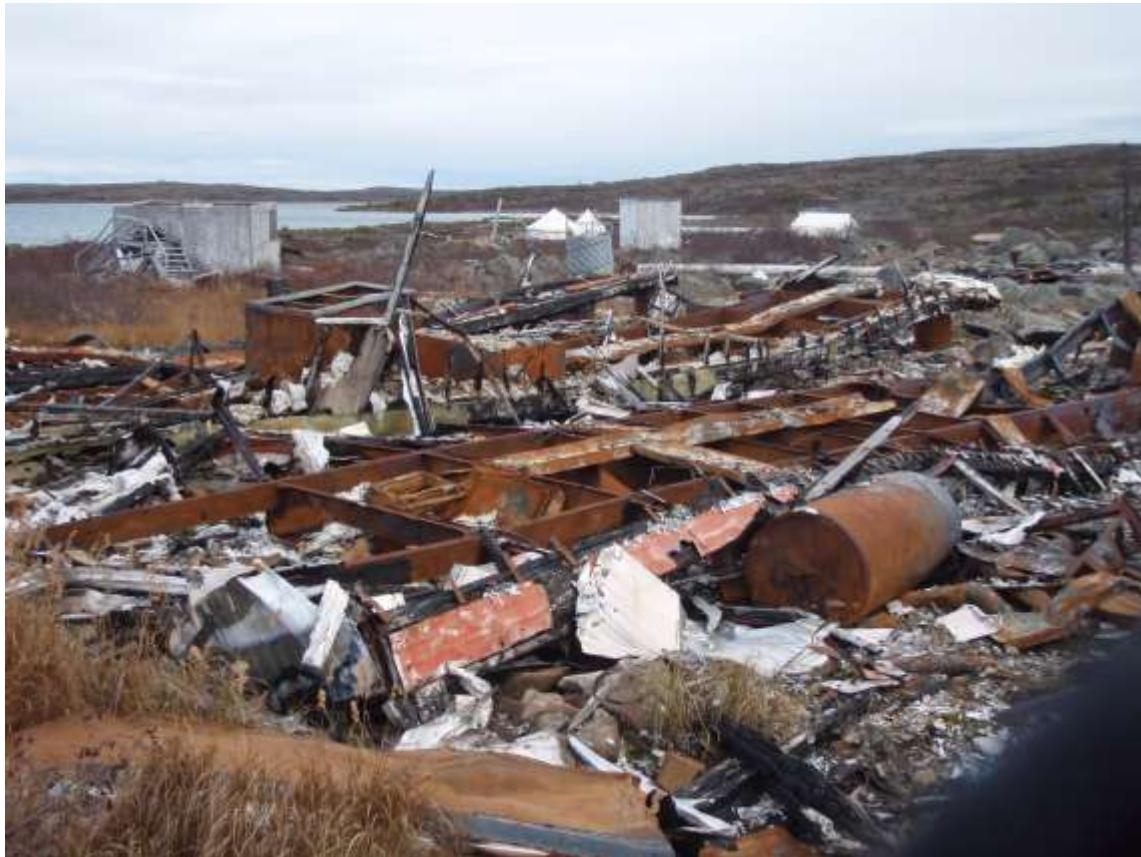
Figure 1: Trailer frames remaining on site KAW-35 from 2008 fieldwork.

All of the metal frames of eight buildings (trailers), which had been burned in 2008, were cut into smaller pieces and piled nearby for transportation. Figure 1 and 2 show before and after views of the site where the trailers were located. Tin sheets that had been removed from these trailers in 2008 were also cut into smaller pieces and piled. Approximately nine thousand pounds (9,000 lbs) of metal from the trailers were later transported by helicopter to Kawawachickamach, loaded into a trailer and transported to Schefferville where it was then transported via train by Services Naskapi Adoschaouna to Sept-Iles to a metal recycling facility. A helicopter was used this year because the floatplane service was unavailable, accounting for a greater transportation cost than estimated.

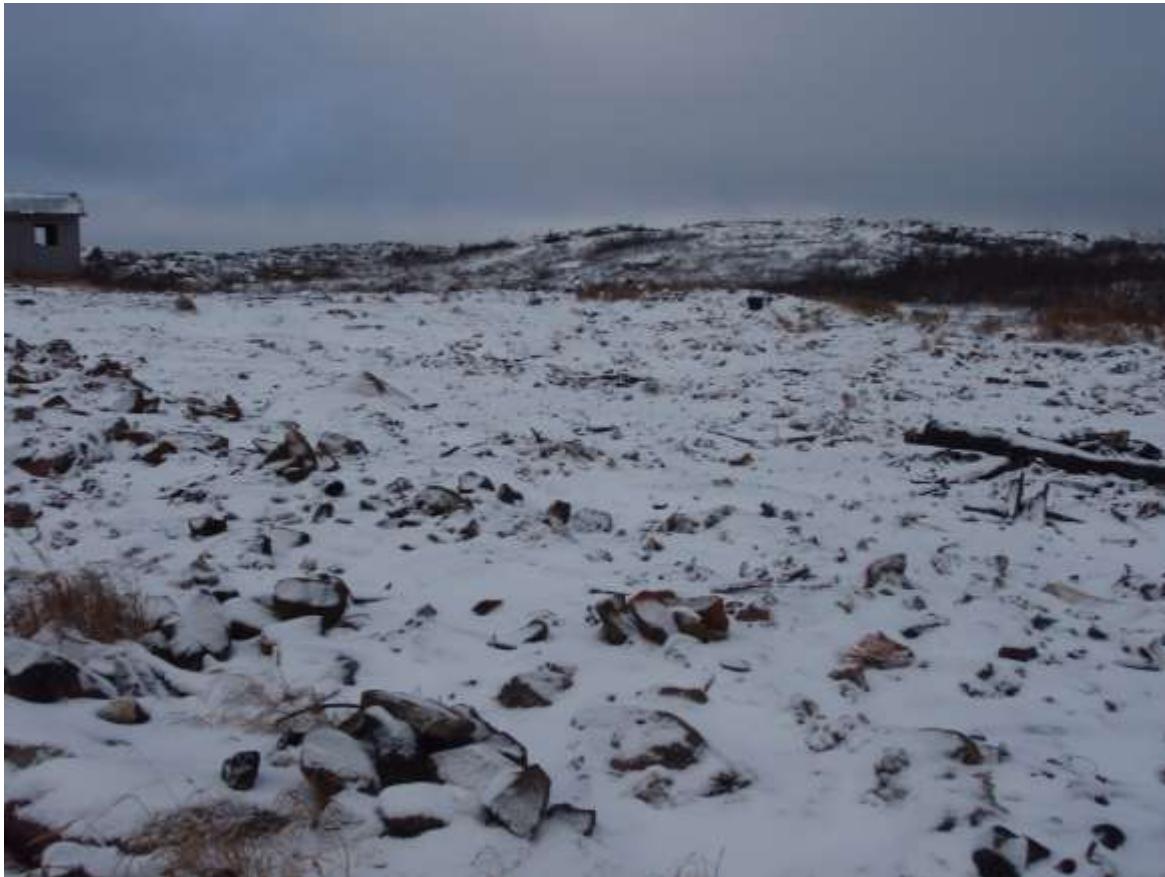
Figure 2: A photo of the area after trailer frames have been removed from KAW-35 (October 2009)

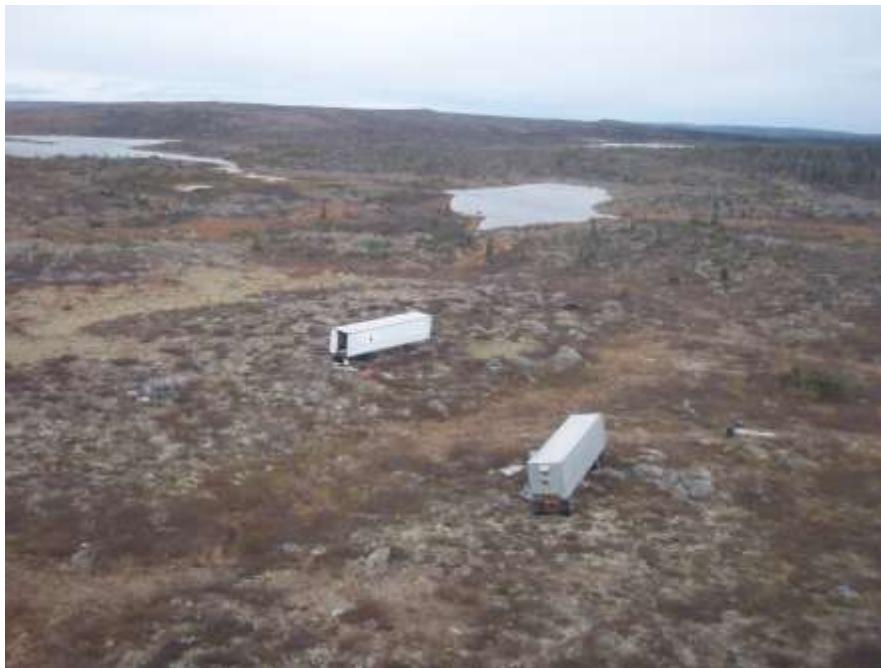
Figure 3: The 2 transport trailers that are located 1 km north of the main site of KAW-35.

The work crew were also able to inspect the contents of two transport trailers that are located north of the site (Figure 3). They are said to contain mostly small metal pieces. A pile of metal rods are located next to the trailers.

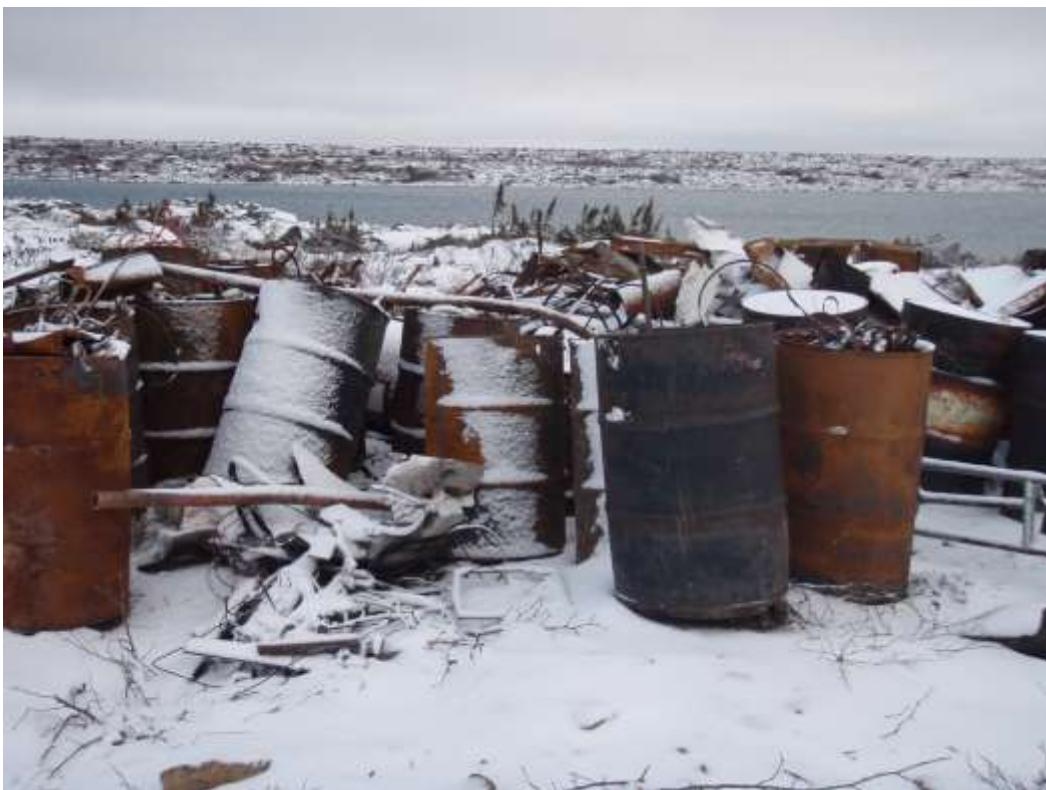
Figure 4: A pile of metal ready for transportation by floatplane in 2010 on site KAW-35.

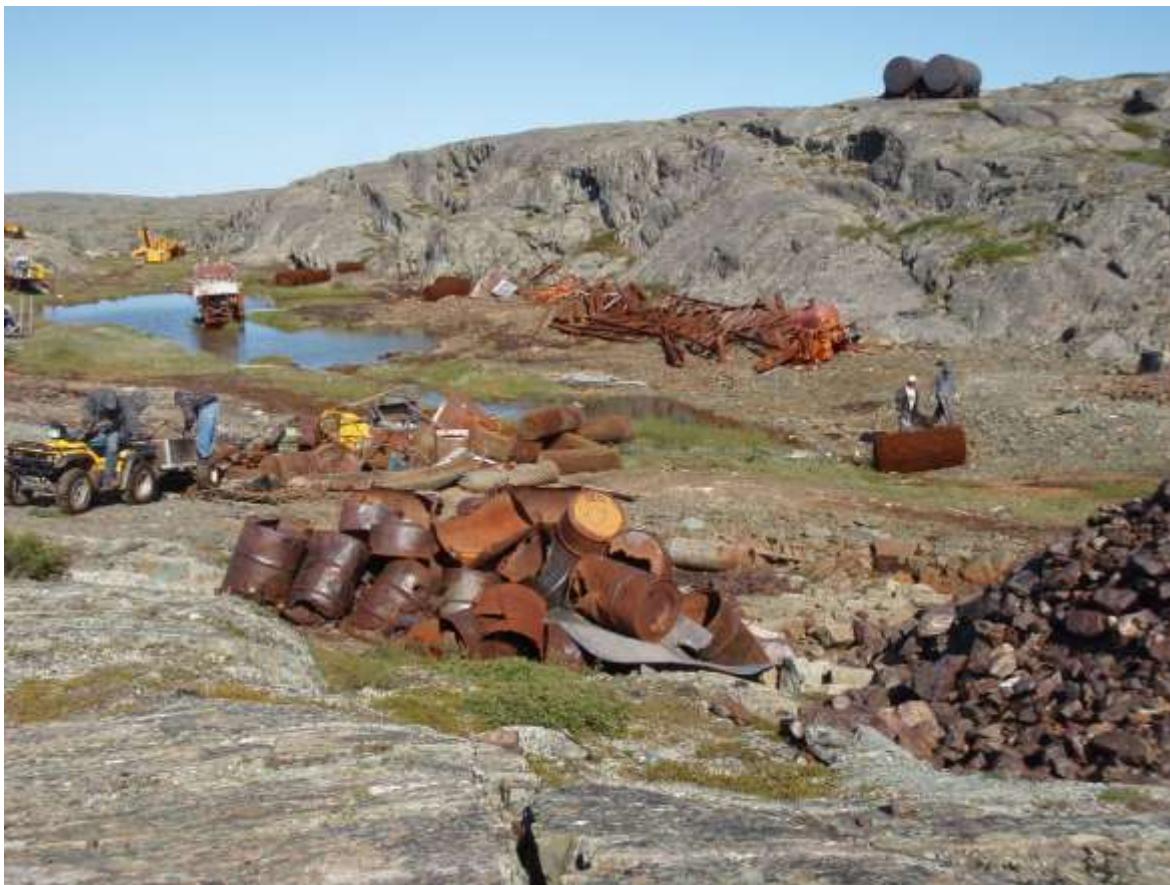
Figure 5: Sector 4 of PJ-1, July 2009

Sector 4 is the largest sector at this site. In July 2009, most of the work was concentrated in this area. Again, piles of similar items such as barrels, scrap metals, tires, and hoses were assembled together to easier transportation by helicopter. A number of wooden crates were opened and their contents (mostly thick rubber hoses and engine parts) inventoried and piled together. The crates and all combustible material in this sector were burned in compliance with MDDEP regulations. Figure 5 shows an overview of Sector 4 during clean-up work in July 2009.

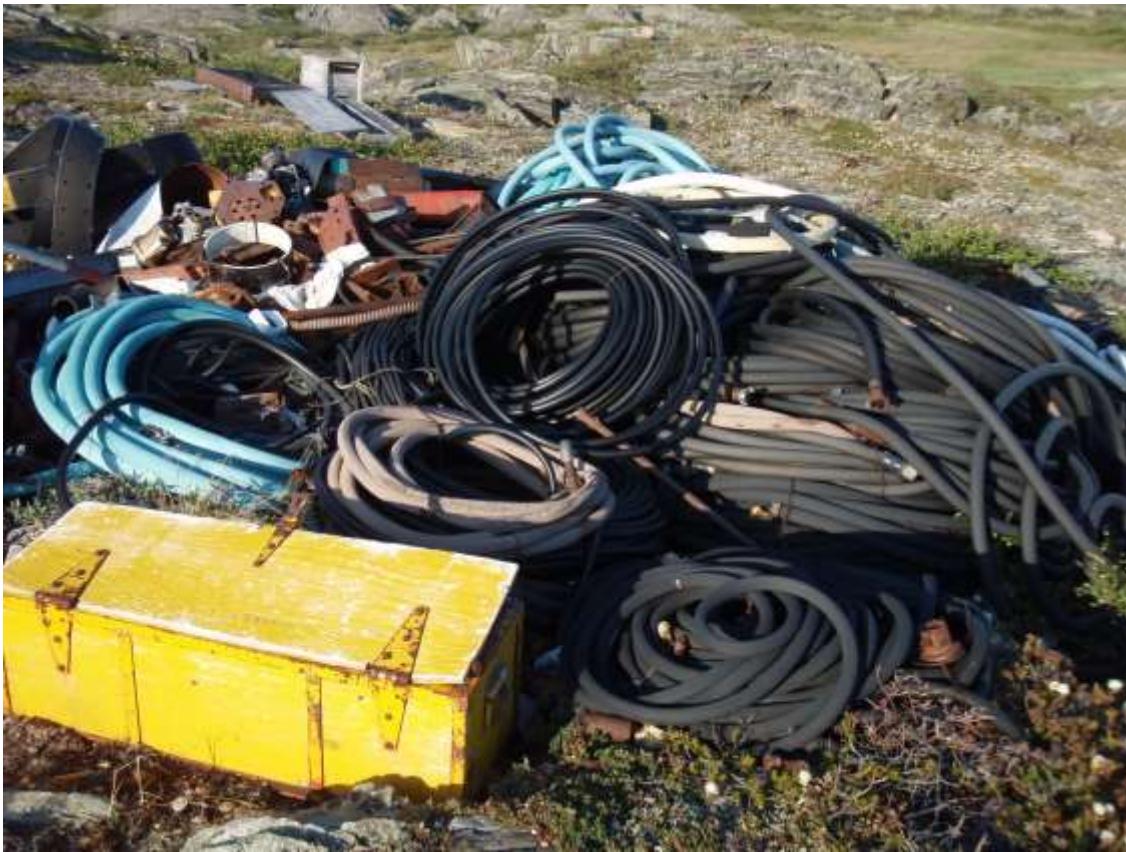
Figure 6: Debris found in Sector 6 of PJ-1 (removed in October 2009).

In the summer of 2009, Sector 7 was inspected and deemed complete. Sector 6 has one pile of debris, containing mostly rubber hoses and small metal parts, remaining. Figure 6 shows the pile of debris found in Sector 6.

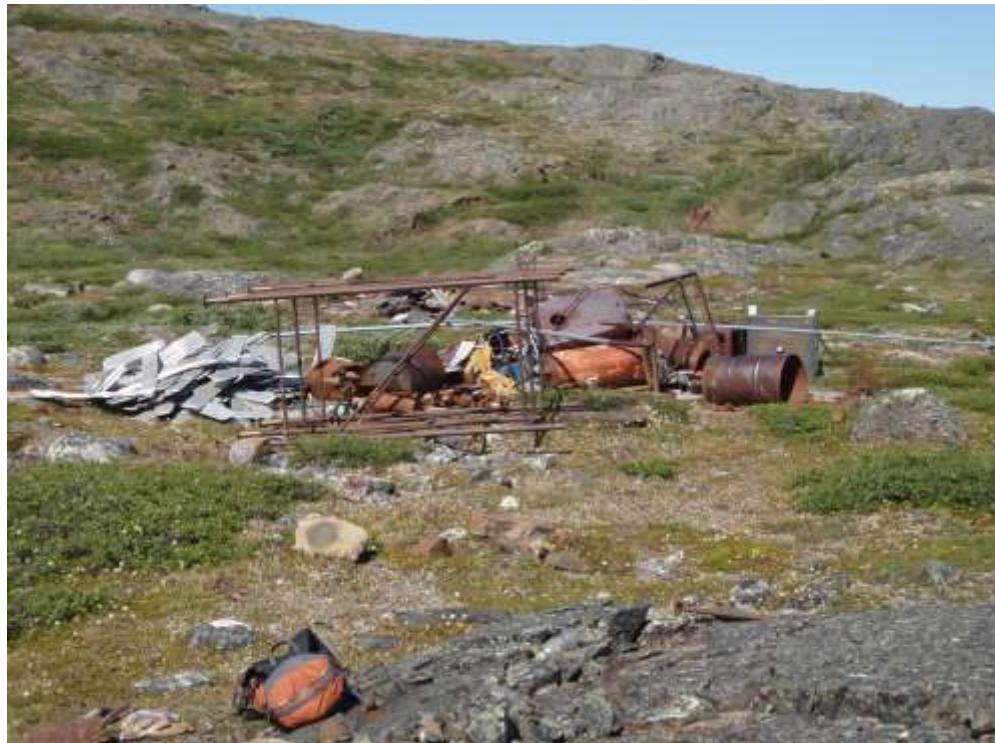
Figure 7: Pile of metal to be transported from Sector 8 of site PJ-1.

Clean-up work was also carried out in sector 8 during the July 2009 season. The sector contained scattered barrels and a large volume of metal debris. These were gathered and assembled into one main pile for transportation during next season (Figure 7). Finally, the wood debris found in sector 8 was burned on site in compliance with MDDEP regulations.

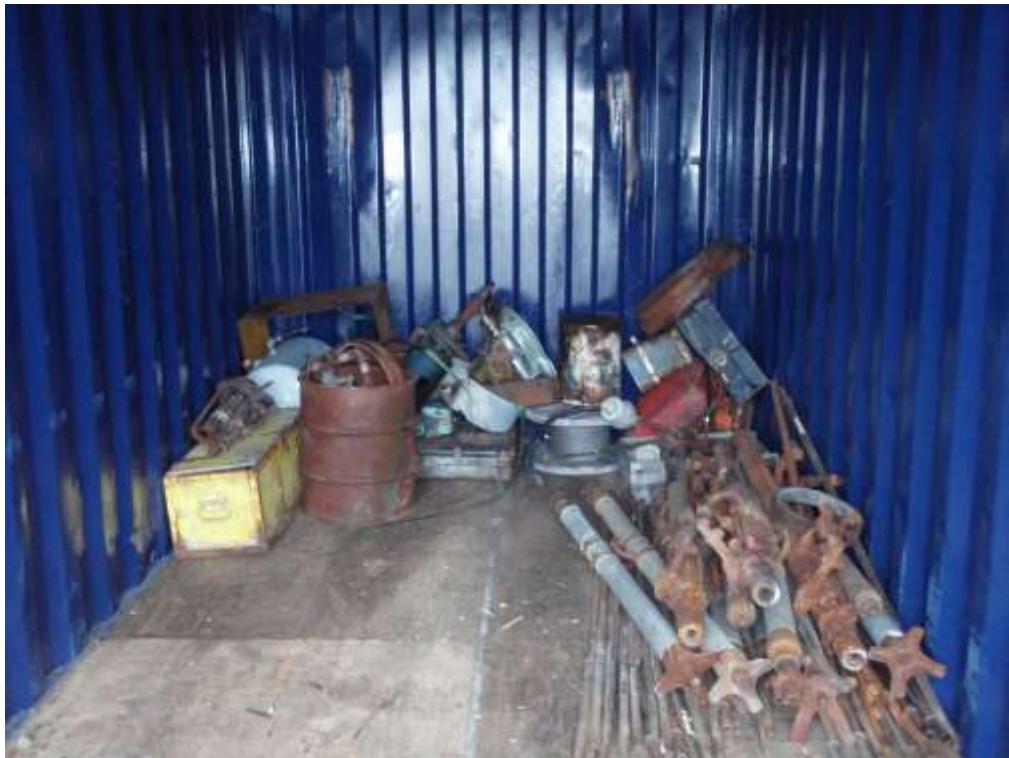
Figure 8: Some debris from PJ-1 that was transported by marine container in November 2009.

Another team of 6 workers (the project coordinator, an environmental technician and 4 Inuit) carried out a second phase of cleaning on October 15 and 16, 2009. This work consisted mostly of transporting material that had been piled in Sectors 6, 5 and 4 by helicopter to the community of Aupaluk. Here the debris was placed into marine containers according to category of waste (Figure 8). These containers were shipped south in November 2009. Approximately twenty thousand pounds (20,000 lbs) of debris was removed from the site during the two days of work. Table 2 lists the items shipped by container.

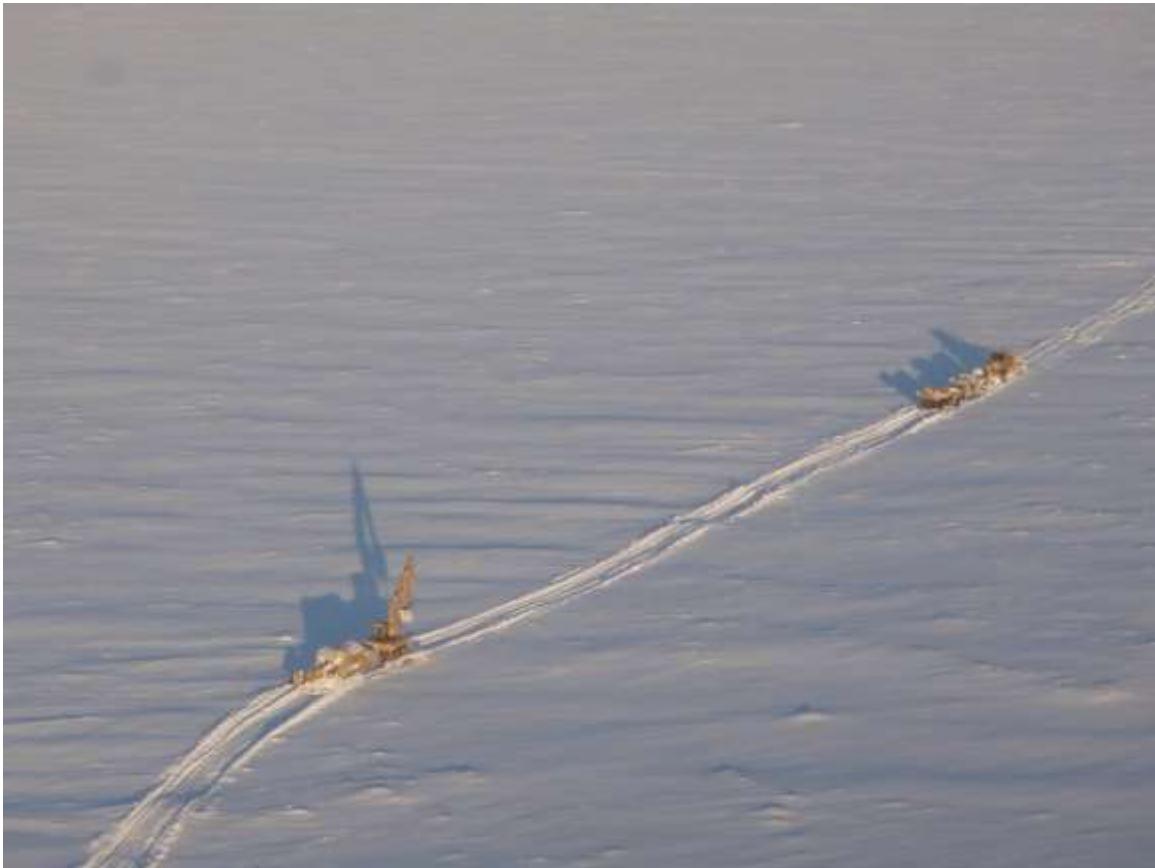
Figure 9: Heavy pieces of equipment from PJ-1 being transported across the tundra

A second assessment of the heavy equipment found in sector 4 was carried out in the summer of 2009 by Georges Gagnon of the Makivik Corporation's construction division. Repair and transportation work was carried out by a crew of professionally contracted welders, mechanics and operators in November and December 2009. 4 Inuit workers assisted them. During the nearly 3 weeks of work, this team was able to remove all but one piece of heavy equipment, including a truck, bulldozer, crusher and conveyor, from the site by excavator and tractor. They were transported across the tundra using a winter road and are now in temporary storage in Aupaluk (Figure 9). They will be shipped south of the province in the summer of 2010. One trailer was burned and all of its metal frame and tin were also transported to Aupaluk. The reservoirs that were on the site were used as trailers to haul debris. Some of these remain on site. There are still several large pieces of metal, mostly from a tower structure and rolls of metal mesh remaining on site (Figure 10). They will be removed during the winter of 2010 in a similar fashion.

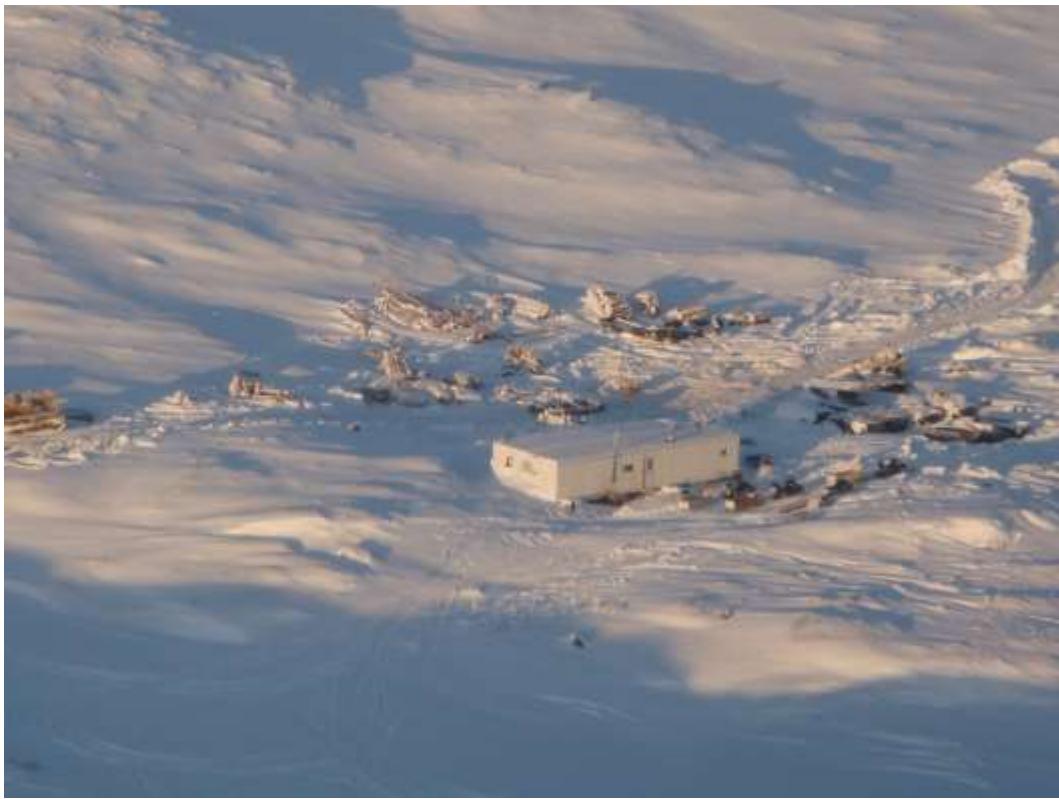
Figure 10: Items remaining on site PJ-1, sector 5

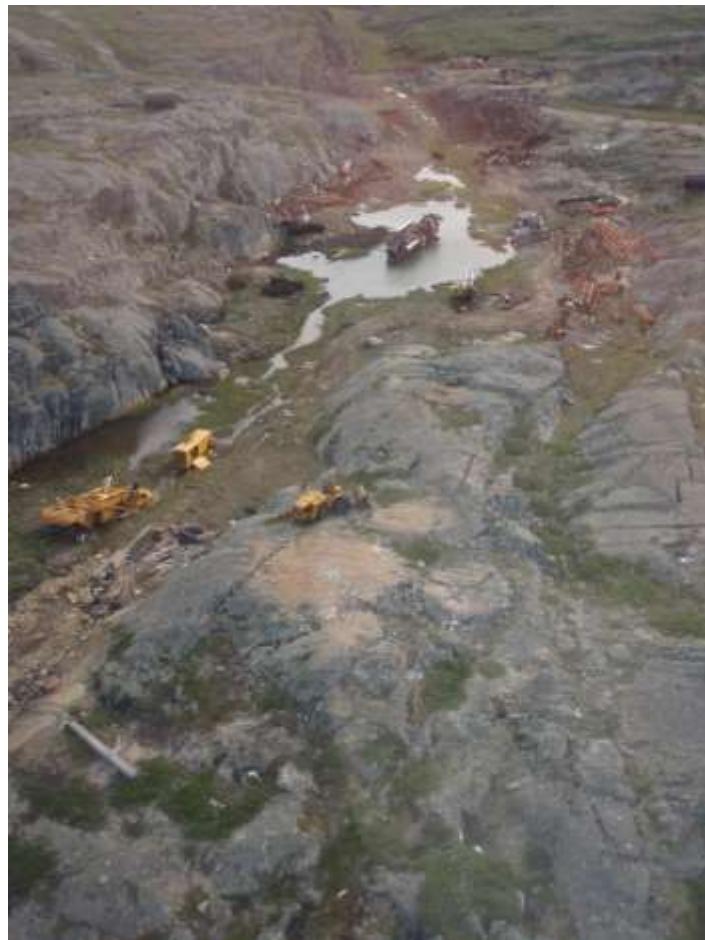
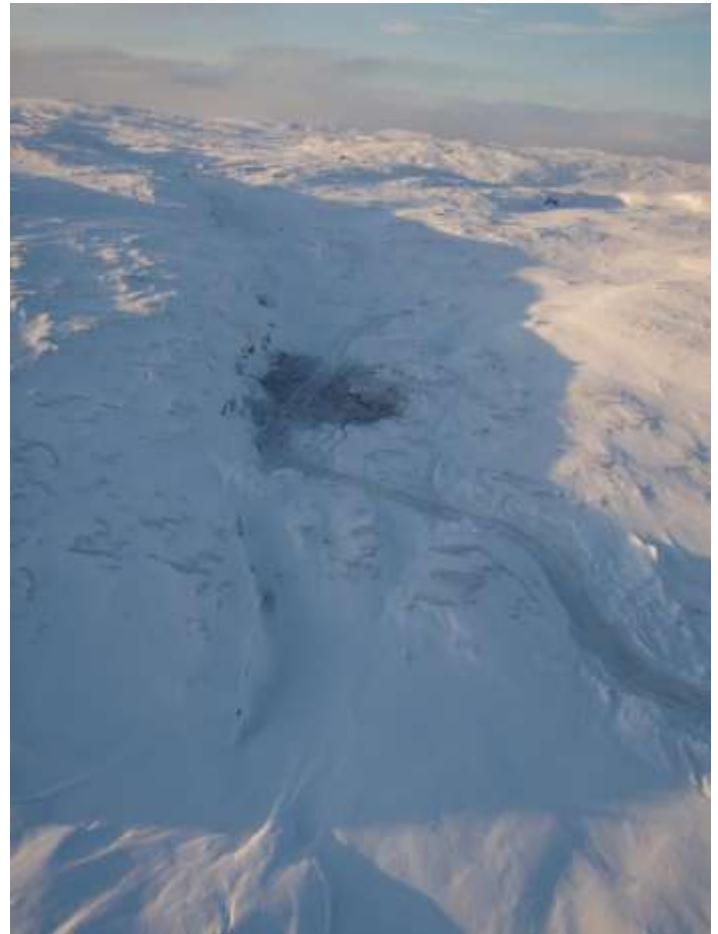
Figure 11: A photo of PJ-1 Sector 4 in July 2009 and December 2009

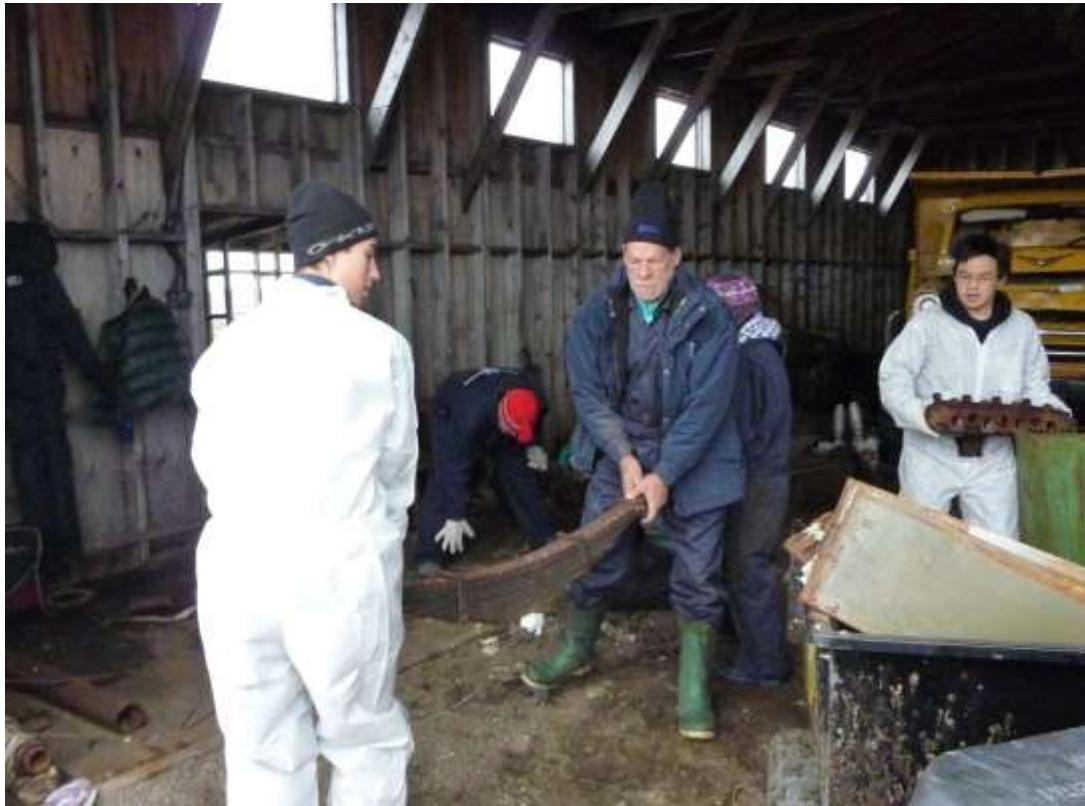
Figure 13: Volunteers removing metal and debris from garage on site PJ-17.

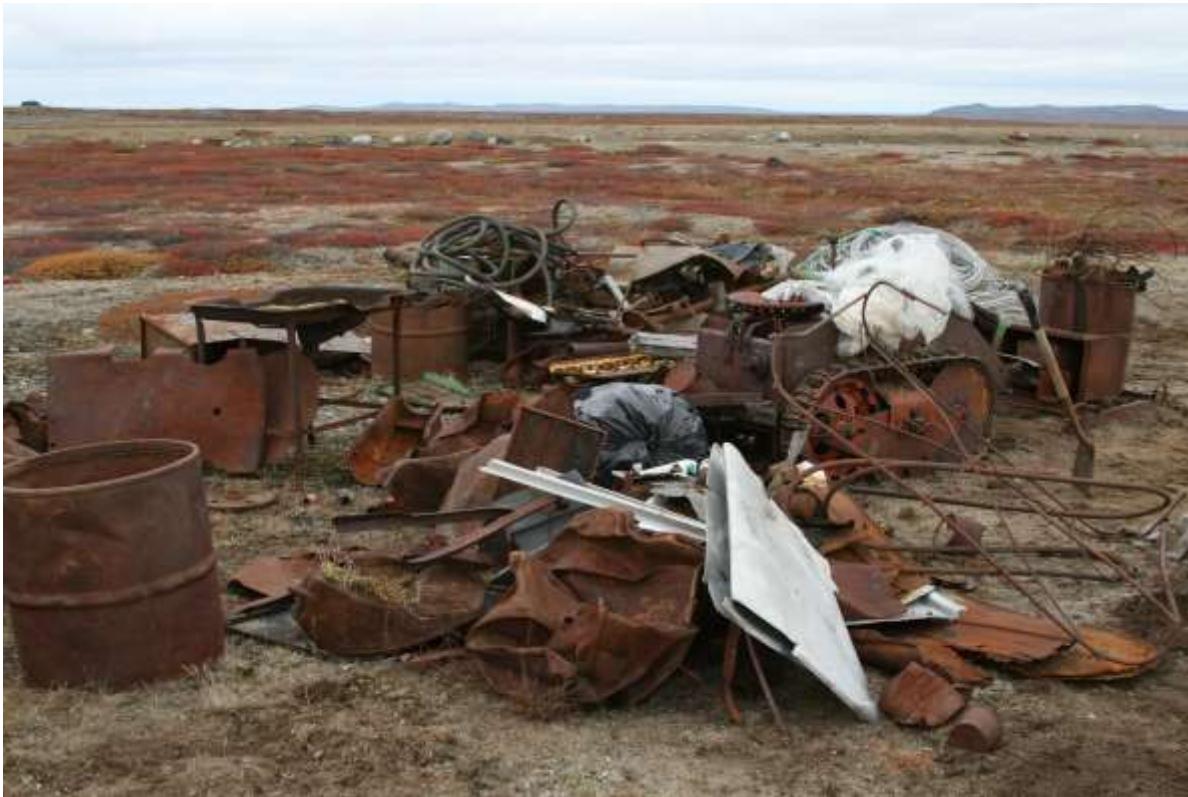
Figure 14: BEFORE: Some of the debris transported to the ship by helicopter on site PJ-17.

During the 2005, 2006, 2007 and 2009 fieldwork, approximately 325 barrels, 60 propane tanks, thousands of pounds of metal and other debris including metal rods and piping and a considerable quantity of small- and medium-sized debris have been removed from the site. Figures 14 and 15 depict a before and after view of site PJ-17.

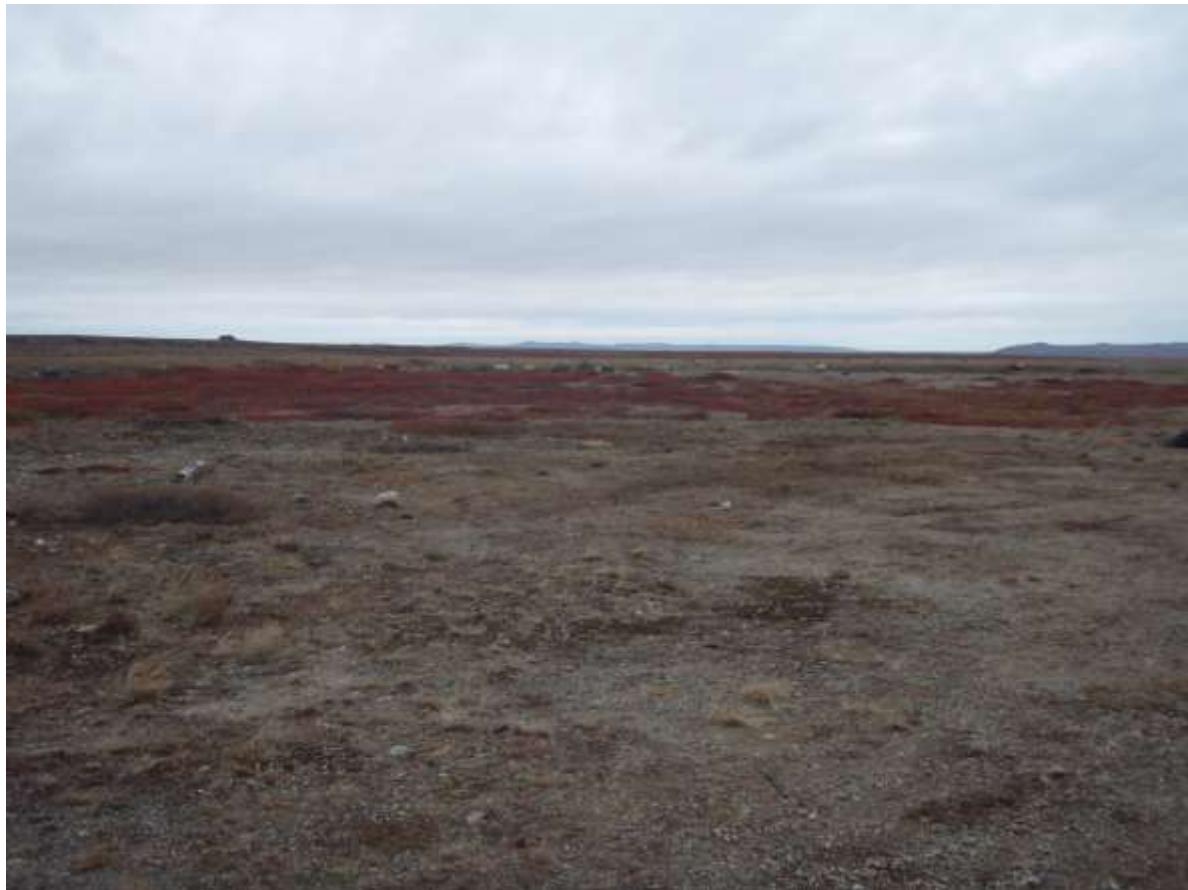
Figure 15: AFTER: The site is now clear of debris.

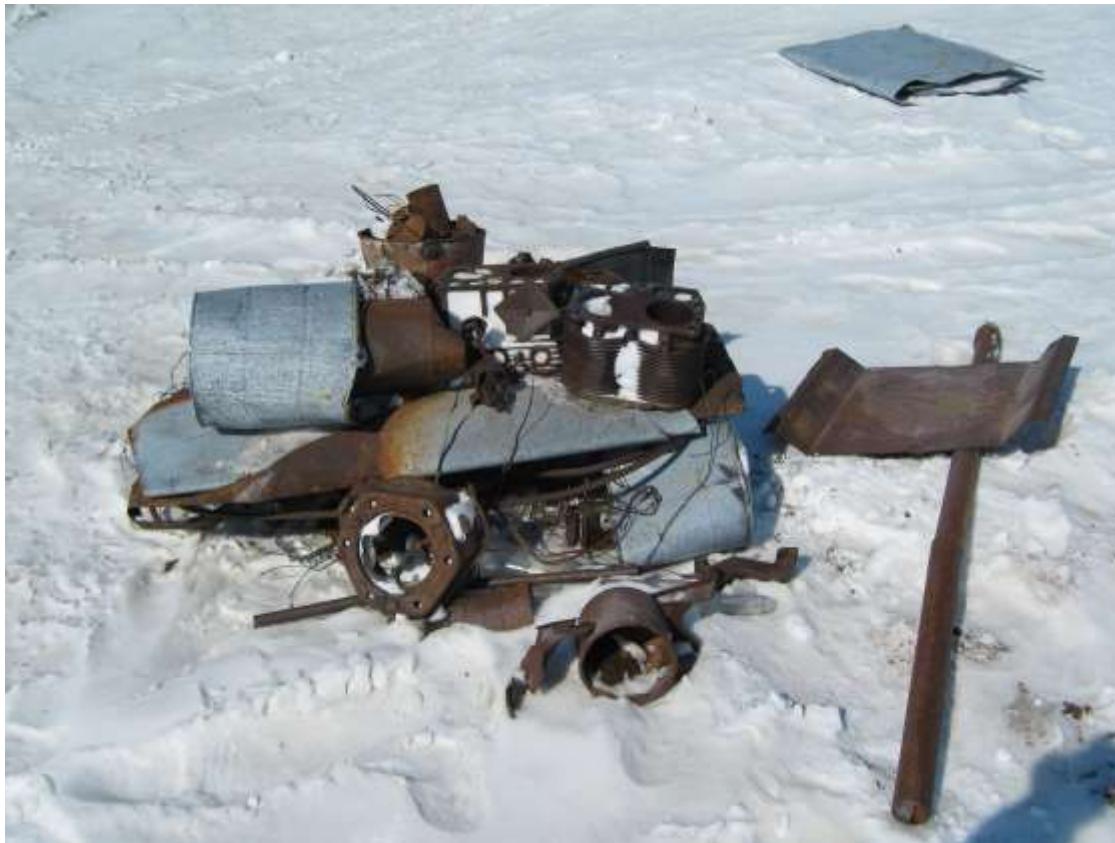
Figure 16: An example of material that was removed from site TW during spring 2009.

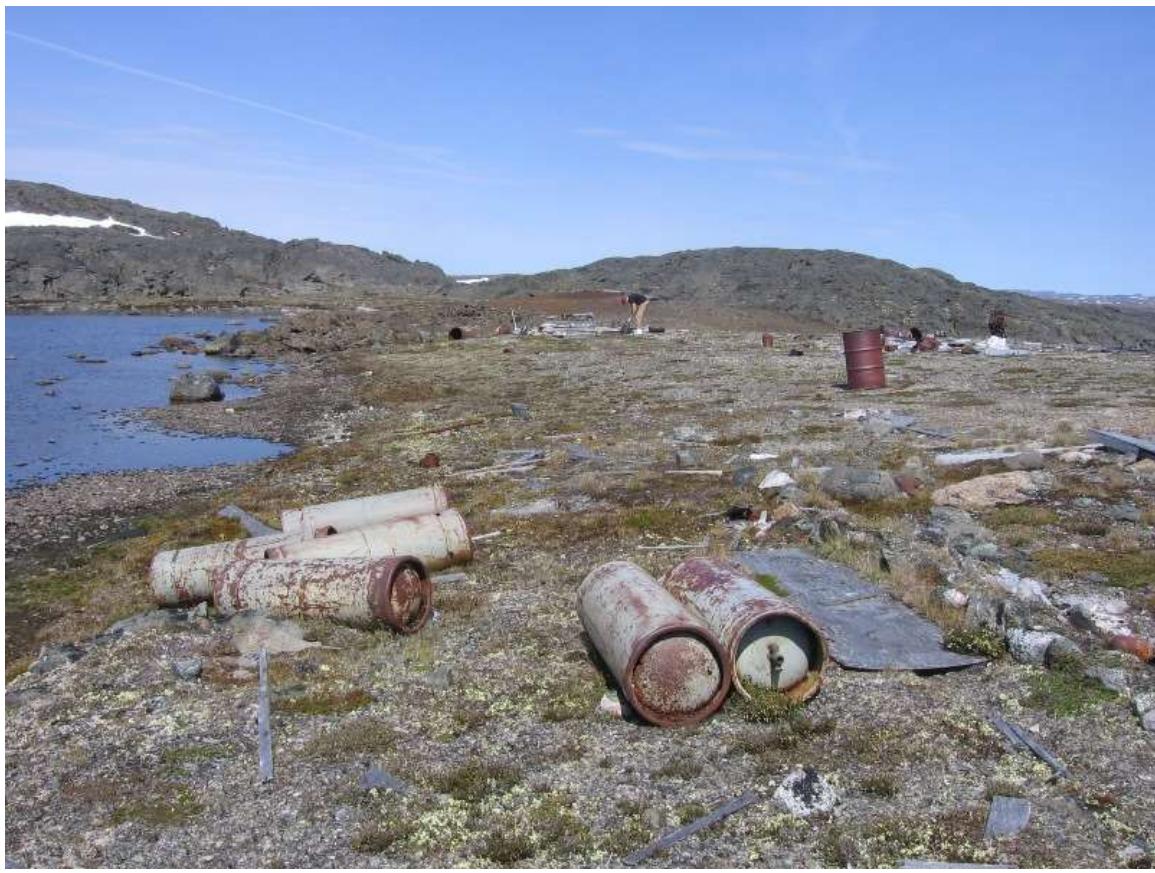
Figure 17: BEFORE: fieldwork conducted in 2007 on site TW.

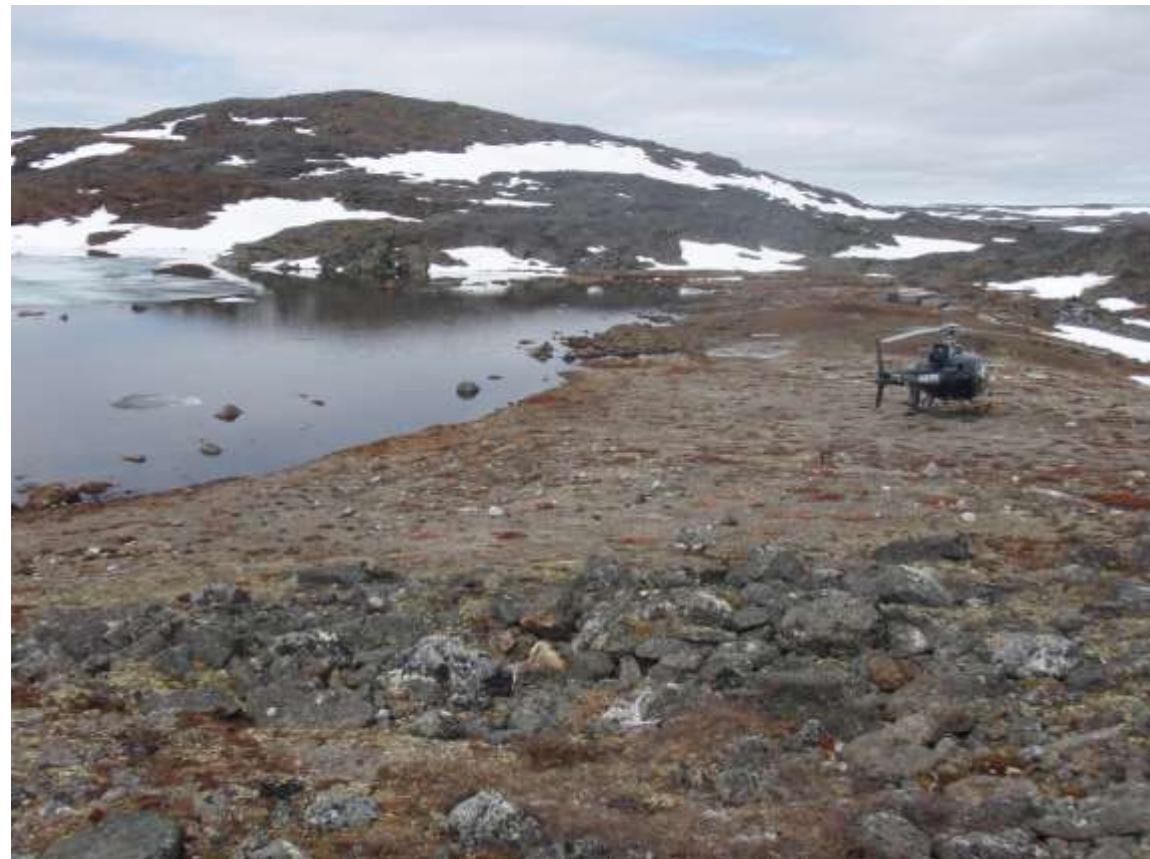
Figure 18: AFTER: the TW site is now complete (June 2009).

Only exploratory drilling samples, which are located on stands, and a wooden platform remain on the site. The site is now complete.

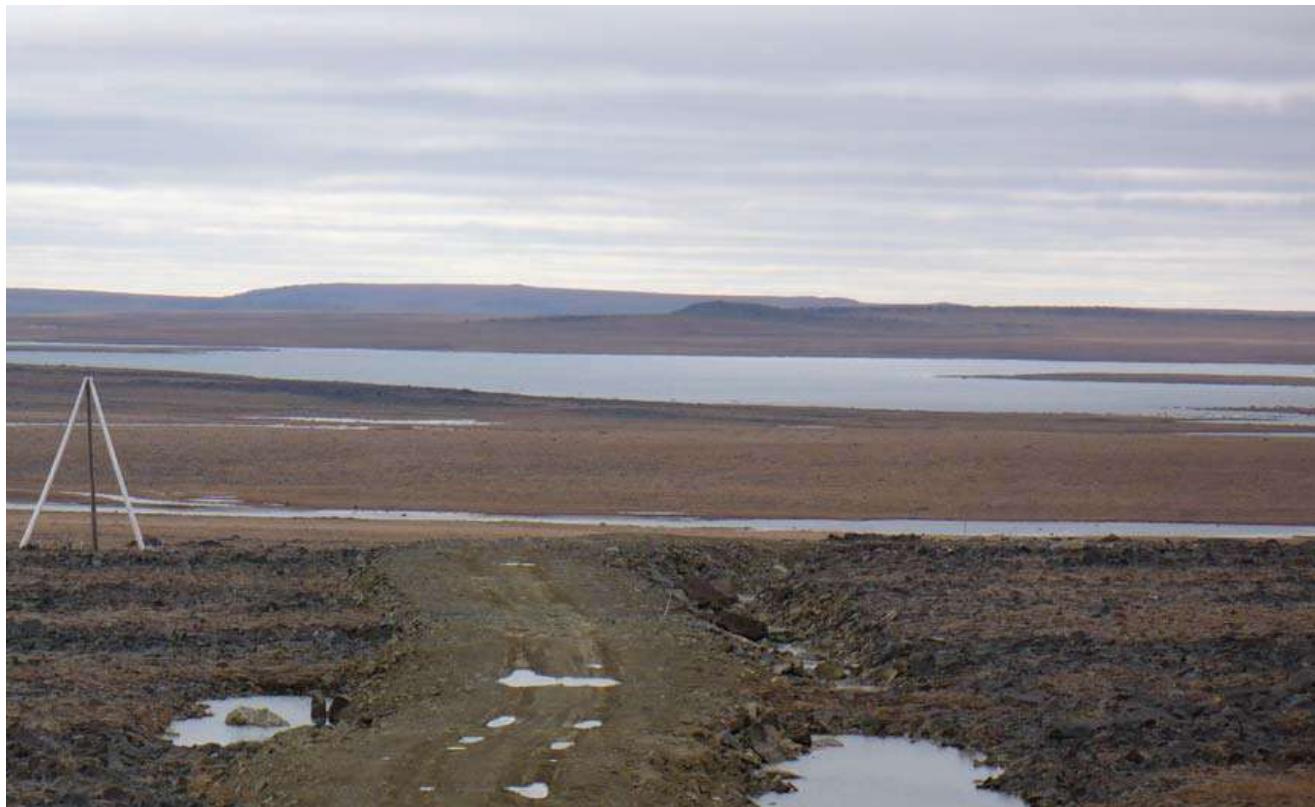
Figure 19: The final clean-up work by Canadian Royalties on site K-28 (August 2009)

In 2005 and 2006, Canadian Royalties (CR) transmitted to the KRG an updated list of its active camps. Among these camps, the site K-28 (also known as Mesamax Camp) is a drilling site currently operated by CR. A photograph taken during the site inspection on July 3, 2007, shows the location of the site K-28 described in the 2001–2002 inventory, and the location of the new camp. At the time of the inspection, a survey team was present at the site but no mineral exploration work was underway. In 2006, Canadian Royalties (CR) carried out a partial clean-up of the site. According to the information received, wood was burned, the barrels scattered around the site were stacked together, and barrels of diesel and bags of calcium chlorite were removed from the site. In sector 3, except for the tripod and a pile of metal debris at the base of the tripod, all the drilling equipment observed in 2001 has been removed from the site. In 2009 CR continued its clean-up work and removed all the remaining barrels and other debris. The petroleum-hydrocarbon contaminated soil ($5 m^2$) was also removed from sector 1. The site is now complete (Figure 19).

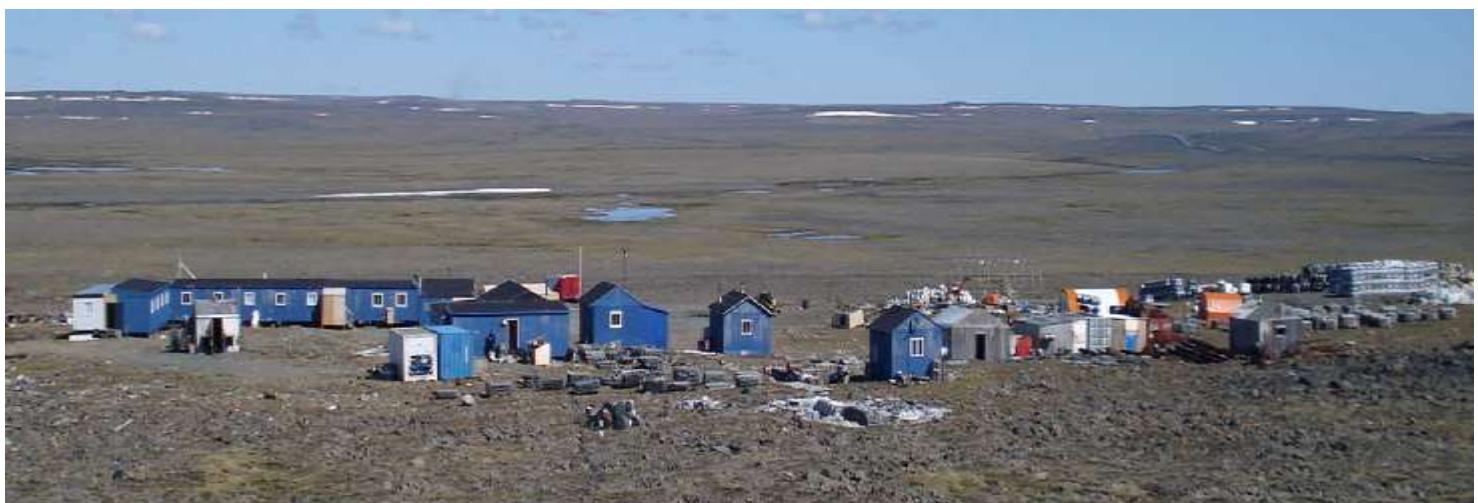
Figure 20: Expo camp, July 2008

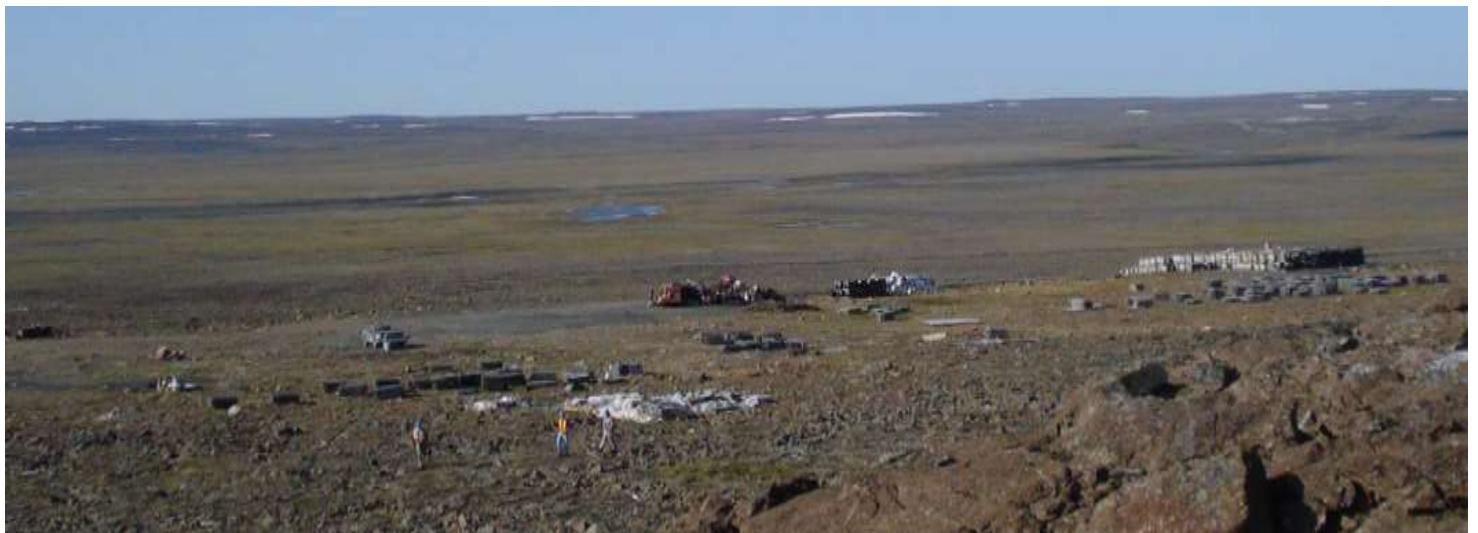
Figure 21: Expo camp, during clean up of July 2009

The site is currently operated by Canadian Royalties (CR) under the name Expo Camp. Since the 2001–2002 inventory, the original buildings have been demolished or renovated. In 2006, Canadian Royalties began clean-up work on the site which included removing a number of barrels, metal and non-hazardous waste and a muskeg. In 2009 CR continued its clean-up work and removed the remaining barrels and debris as well as petroleum-hydrocarbon contaminated soil ($75 m^2$) from the site.

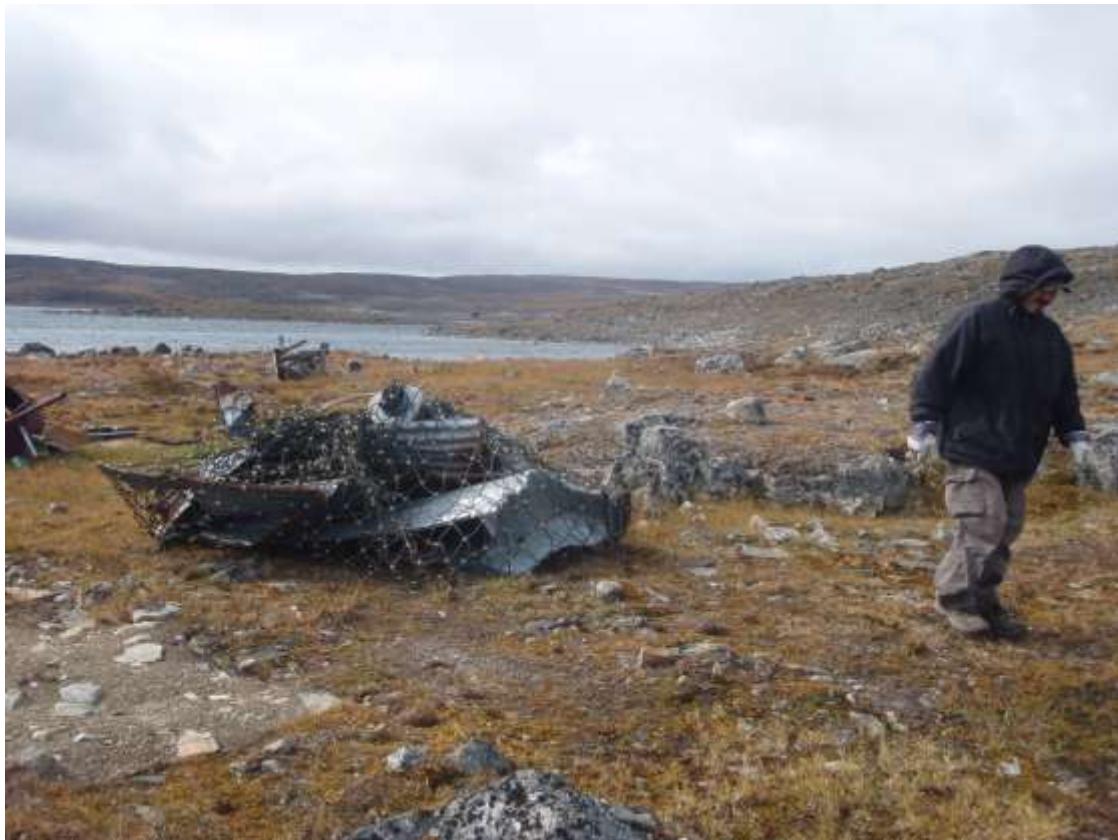
Figure 22: Debris collected and placed in nets for the helicopter to transport from site WB-3

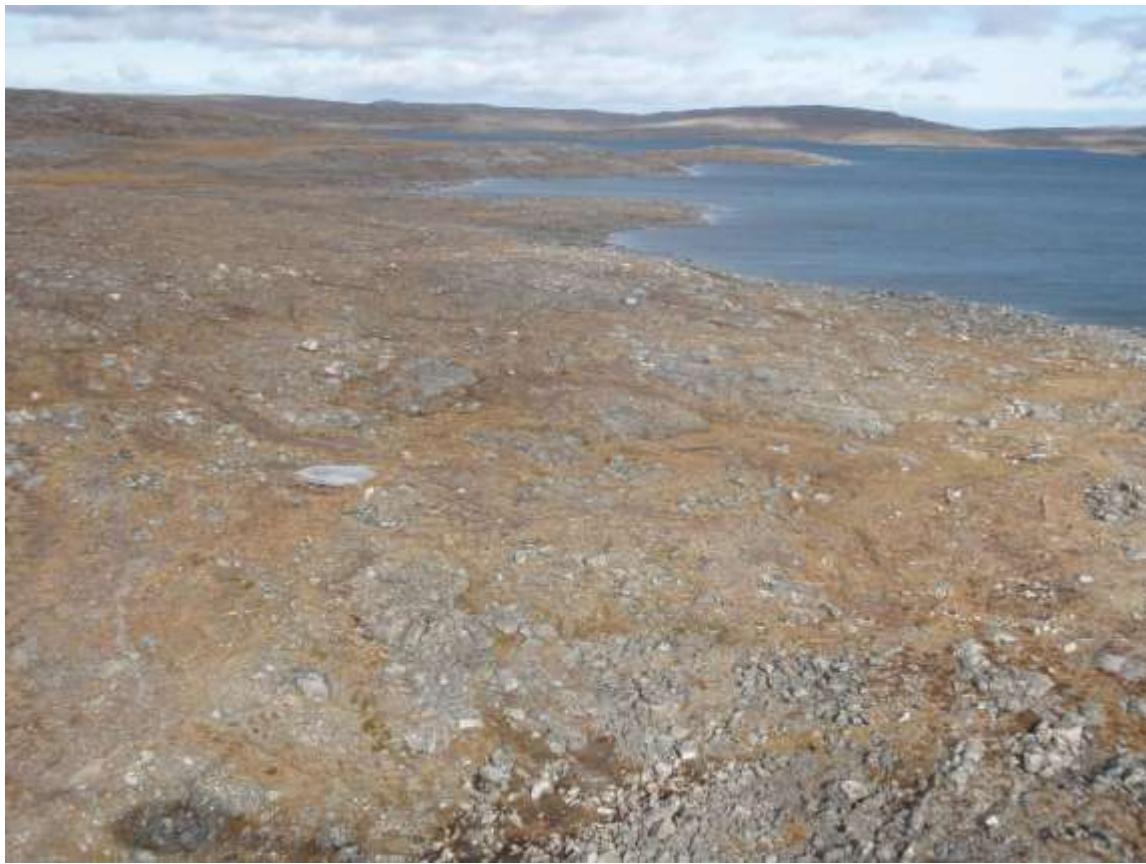
Figure 23: The site WB-3 is now complete.
