**SUMMARY REPORT ON THE REHABILITATION WORK AT THE 18 "MAJOR"
ABANDONED MINERAL EXPLORATION SITES IN NUNAVIK CARRIED OUT
DURING THE SUMMER OF 2009**

UPDATE ON THE GENERAL RESPONSE PLAN

Kativik Regional Government

**Renewable Resources, Environment
and Land Use Planning Department**

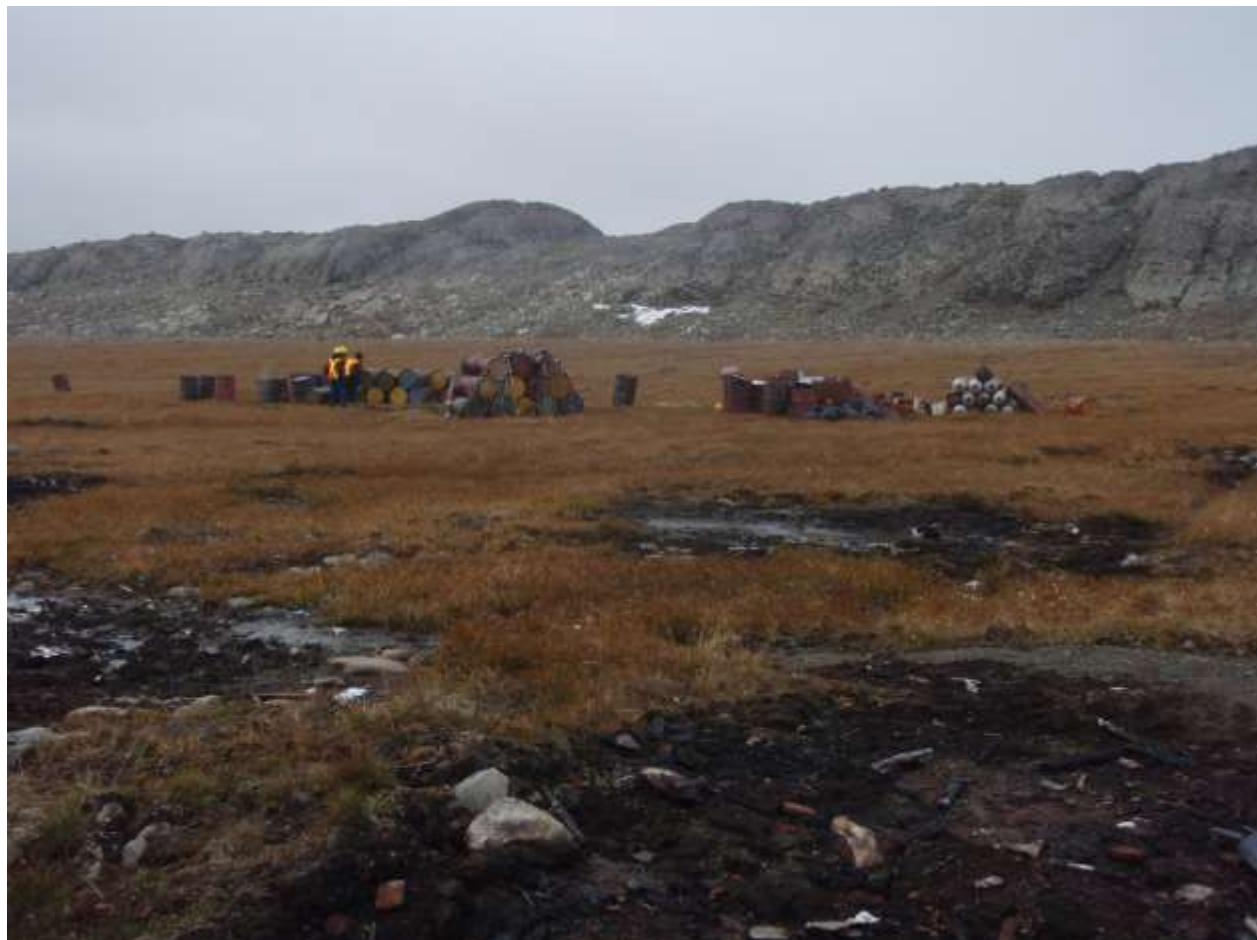
Figure 24: Fieldwork conducted on Site SAL-1 (September 2009)

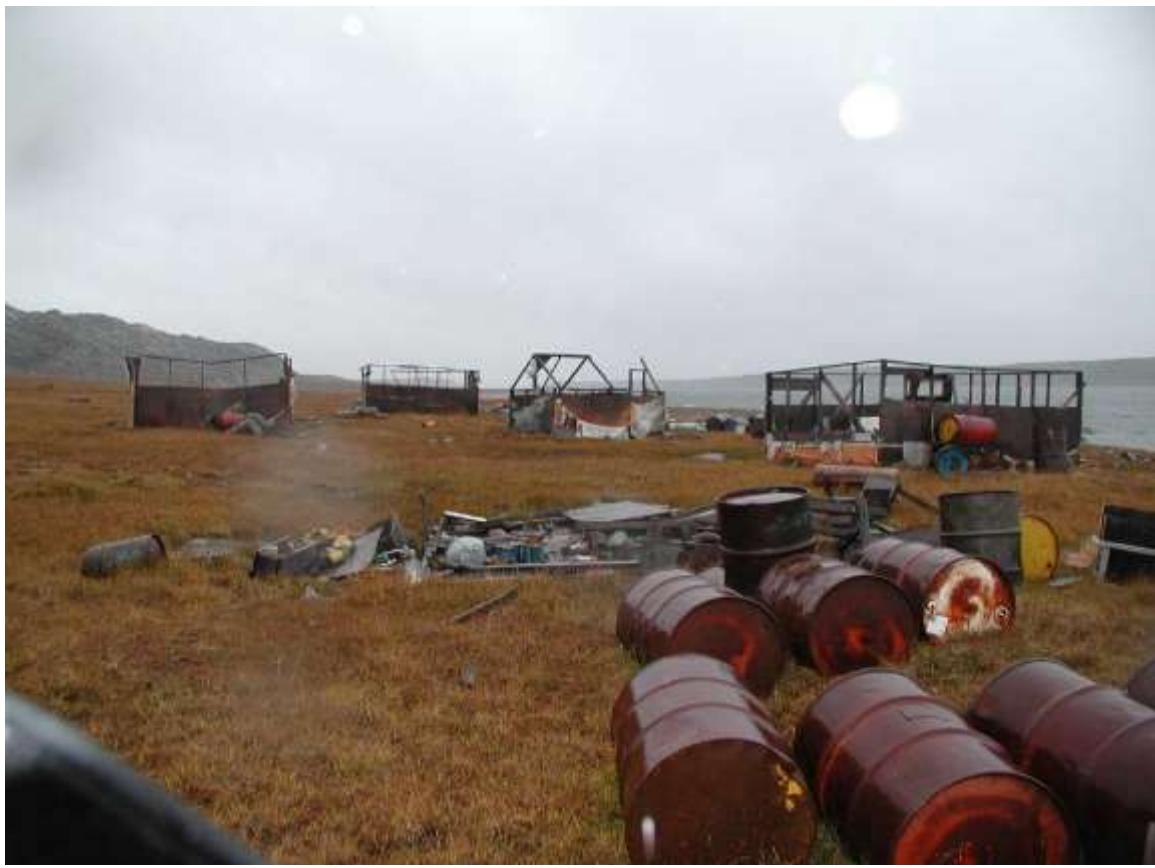
Figure 25: A picture of SAL-1 taken during the 2001-2002 inventory (September 2001)

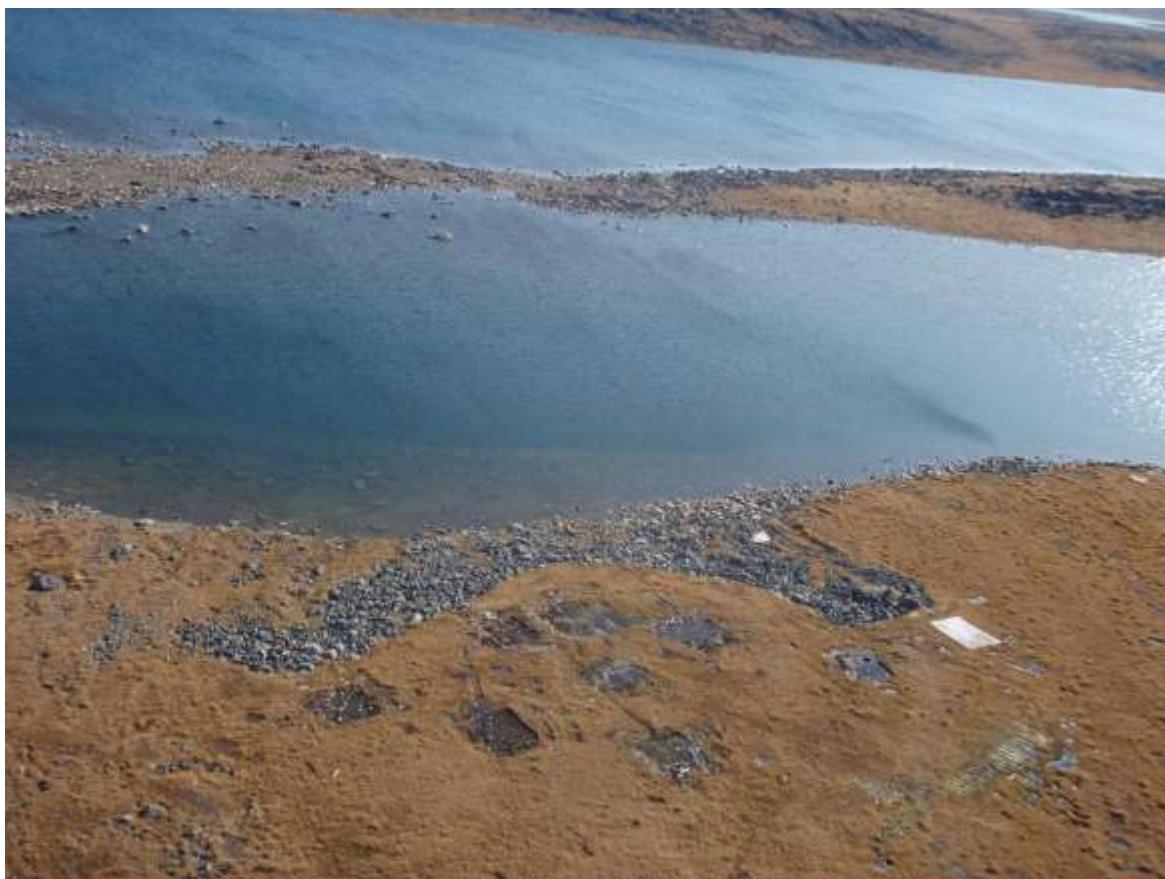
Figure 26: A picture if the site SAL-1 taken after September 2009 field work.

The Northern Villages of Kangiqsuuaq and Salluit contributed to the rehabilitation work at site SAL-1 by providing the necessary workers. Goldbrook Venture, in particular the team at Camp Bélanger, contributed to the clean-up work by providing food and lodging for the workers and by allowing the use of 2 of their helicopters for transporting the waste to the camp and their chartered Twin Otter to transport the waste to Salluit. This site is now complete.

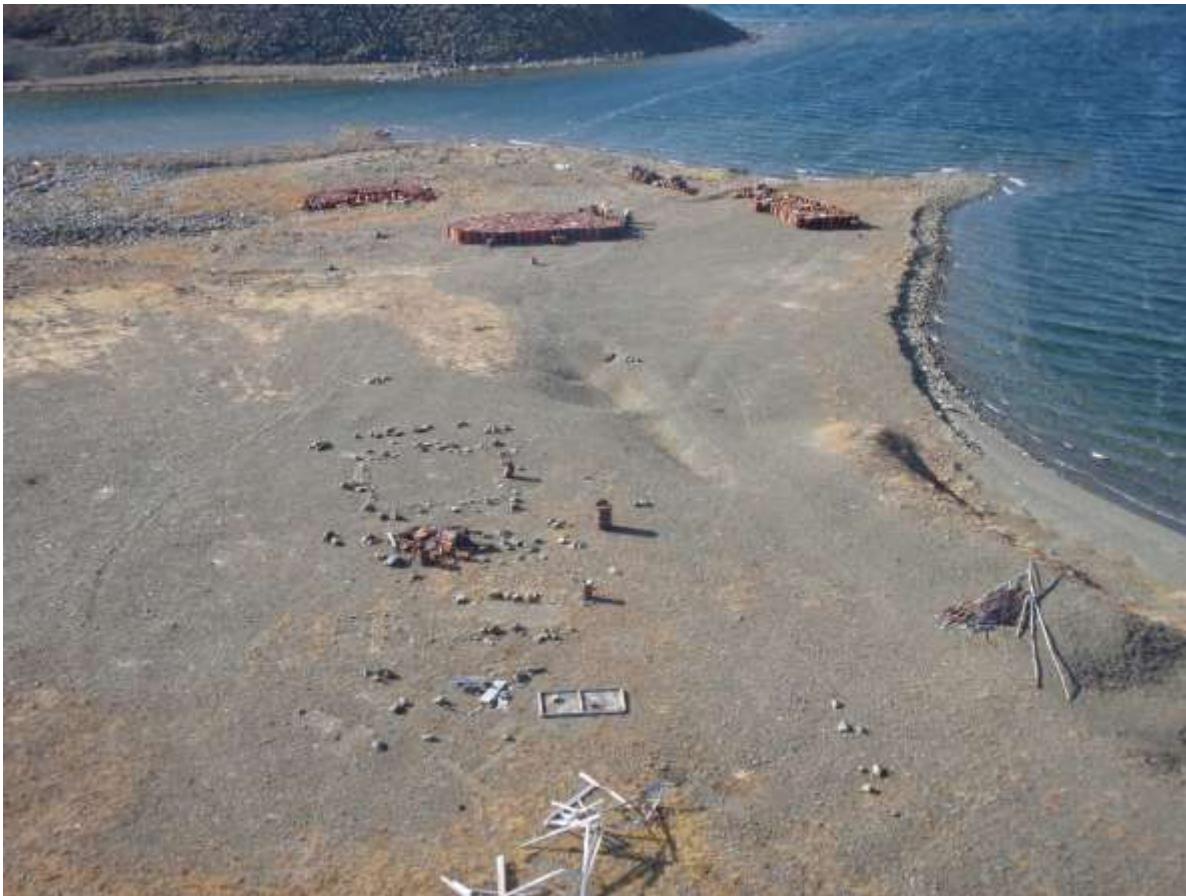
The site was inspected by the project coordinator and Goldbrook's Camp manager on September 8, 2009. They found approximately 400 crushed barrels, 20 empty propane tanks, 300 empty uncrushed barrels and 20 full barrels gathered in one location near the shore of a lake (Figure 27). About 10 piles of various metal debris are scattered among the site. A second grouping of barrels is located along the shore of the same lake about one kilometre east of the main site and contains nearly 100 empty very rusty barrels and 19 full new barrels (Figure 28).

Figure 27: Site SW-34, Sector containing crushed barrels and propane tanks (September 2009)

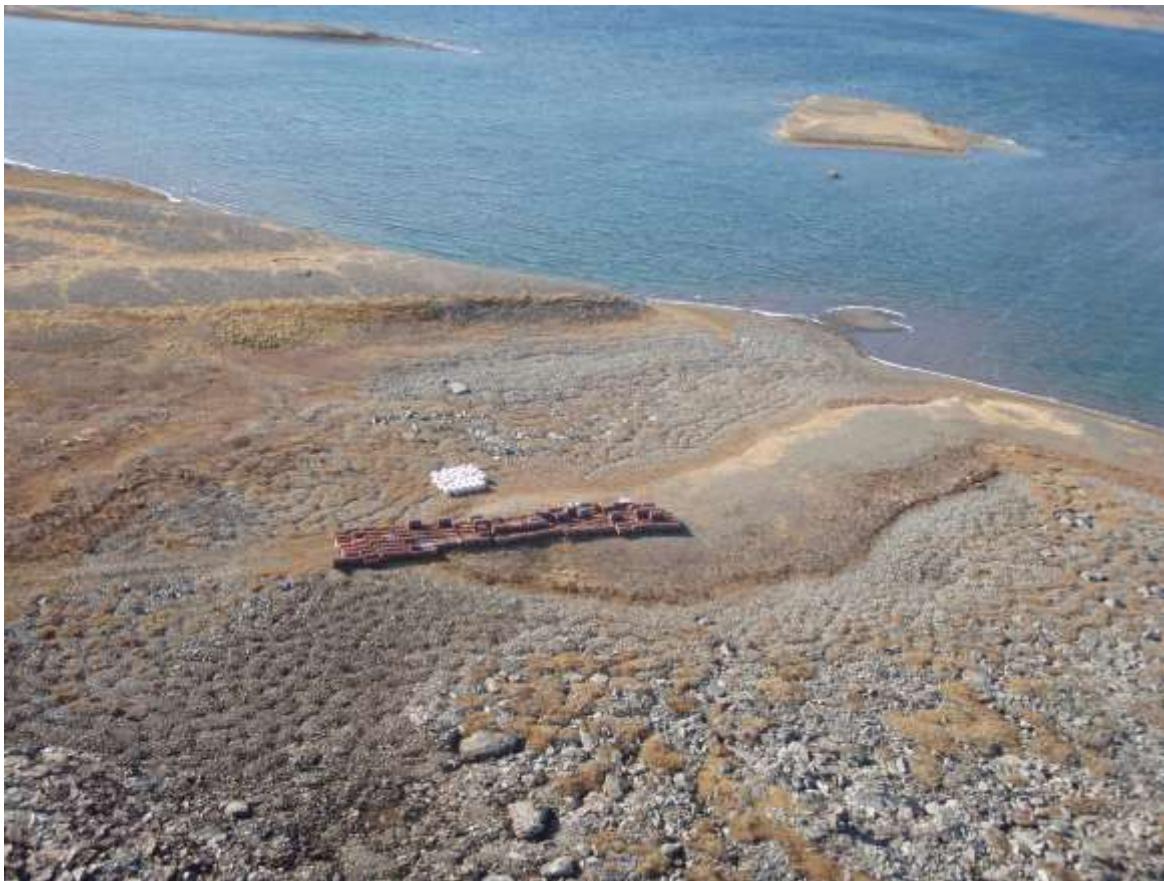
Figure 28: A second grouping of uncrushed barrels on site SW-34.

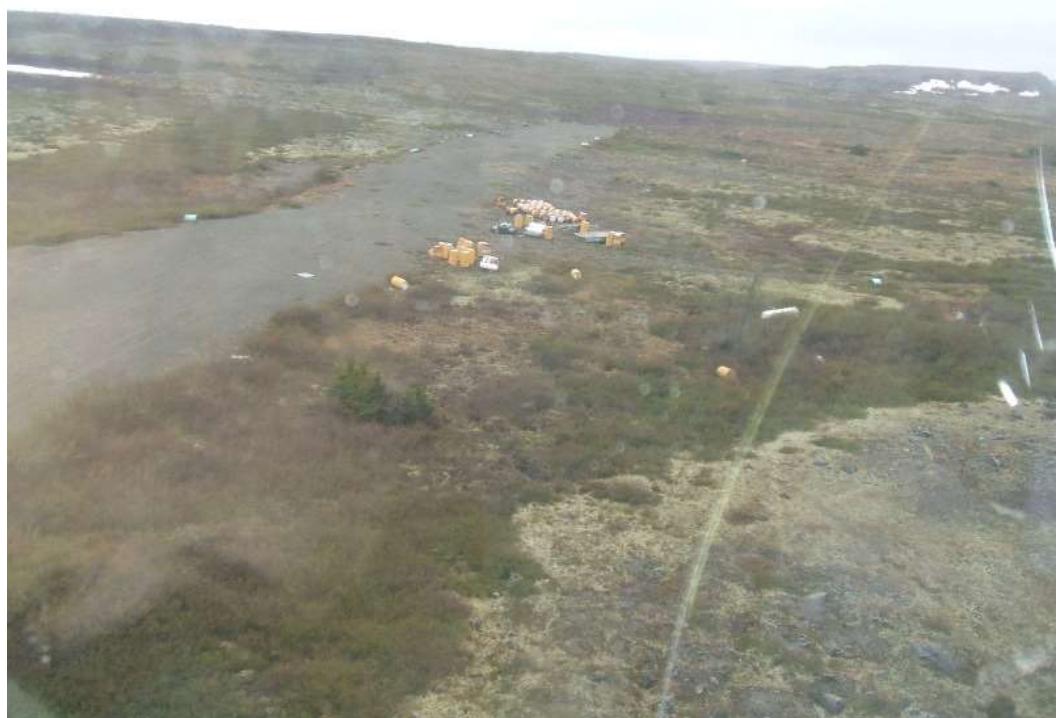
Figure 29: Near the site TQ-1. Barrels containing diesel next to the landing strip taken during the 2001-2002 inventory.

This site might be easier accessed by floatplane, which can also accommodate the transportation of waste to Kuujuaq for shipment south by sealift in 2010 or 2011.

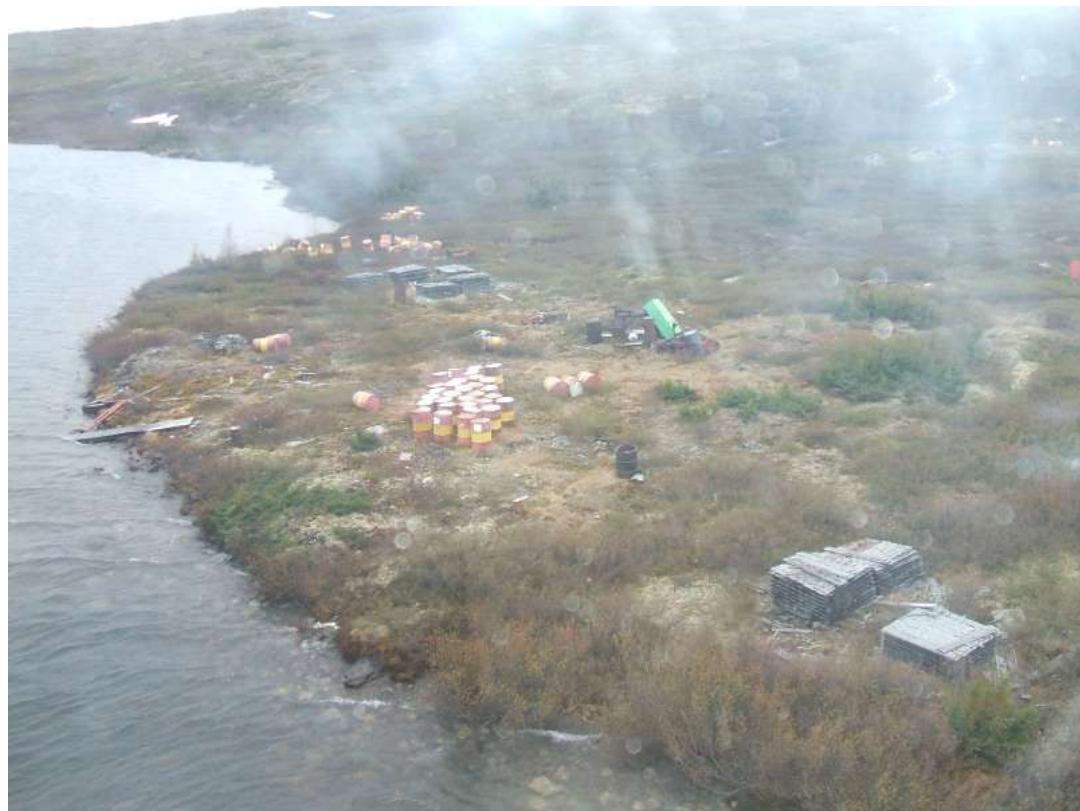
Figure 30: Intermediate site P-24F13-5. Barrels next to Lake Gerido, near the site TQ-1 taken during the 2001-2002 inventory.

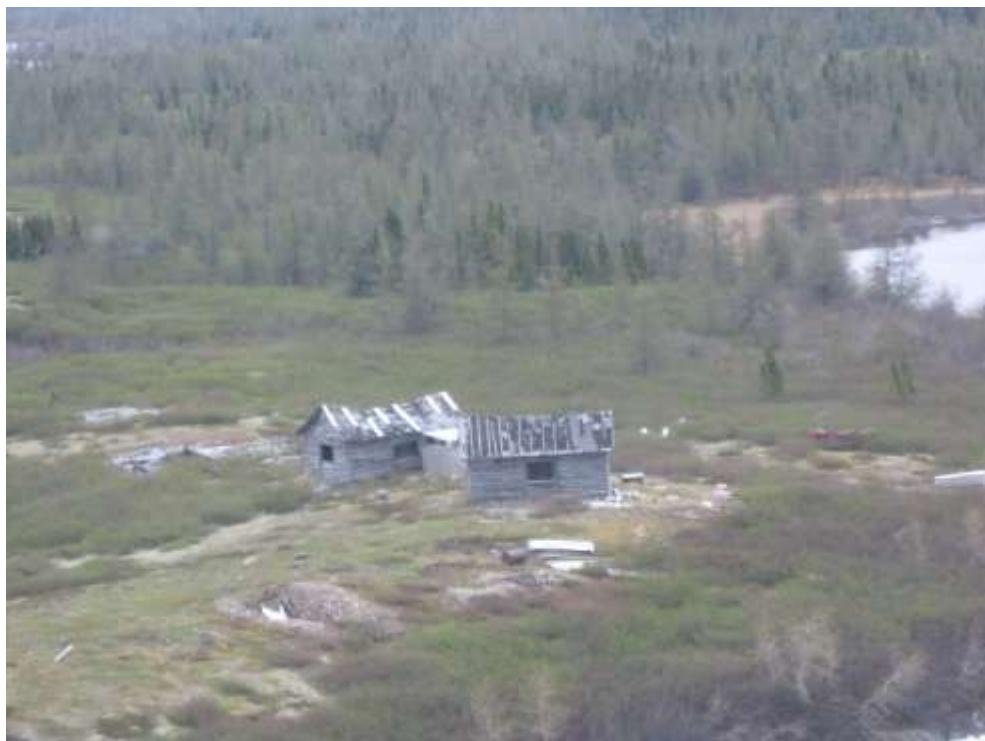
No soil contamination was noted during the 2001–2002 inventory. Notwithstanding, the contents of one barrel in sector 1 appear to have since leaked, causing soil contamination.

Figure 31: Site TQ-4, sector 1 taken during the 2001-2002 inventory.

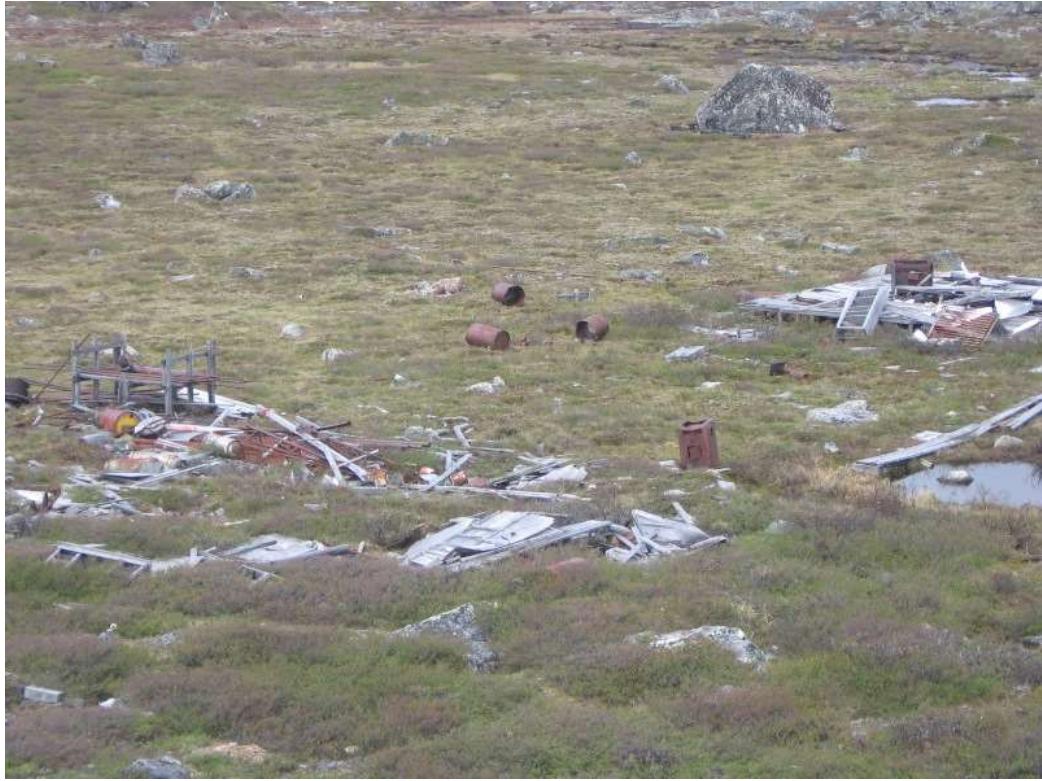
The site was inspected in 2007 and revealed that the site matched the description prepared during the 2001–2002 inventory. Figures 32 and 33, take n in 2007 show the site.

Figure 32: Site PJ-10, sector 1 taken during the 2001-2002 inventory.

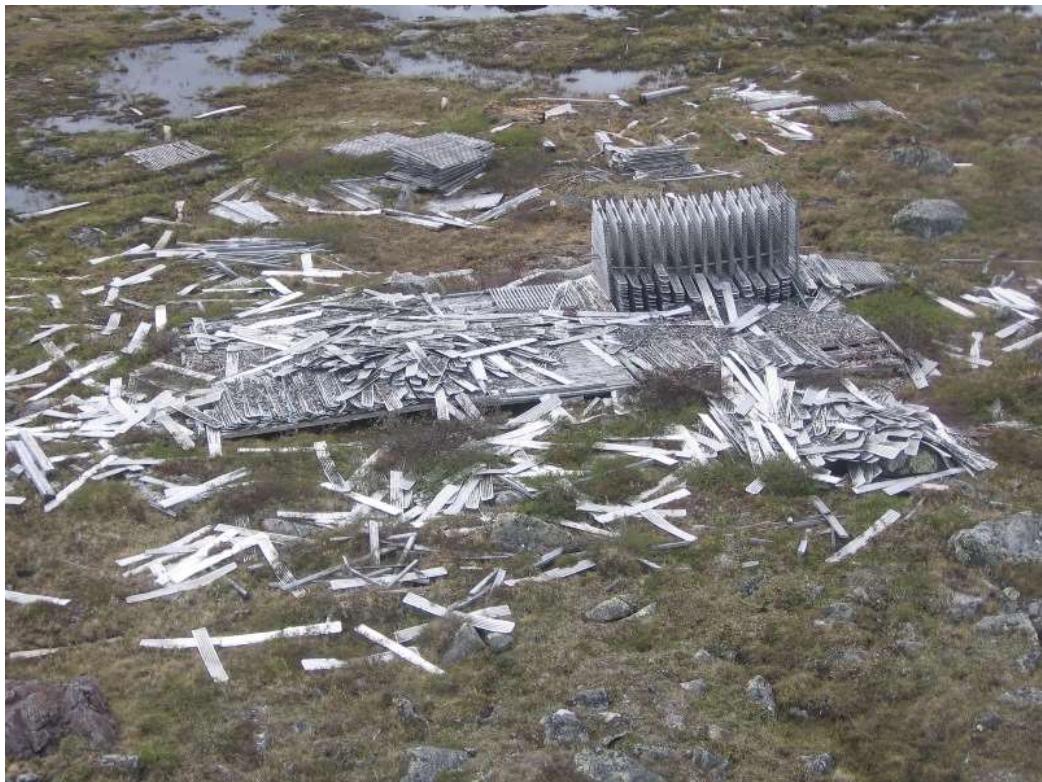
Figure 33: Site PJ-10, sector 2 taken during the 2001-2002 inventory.

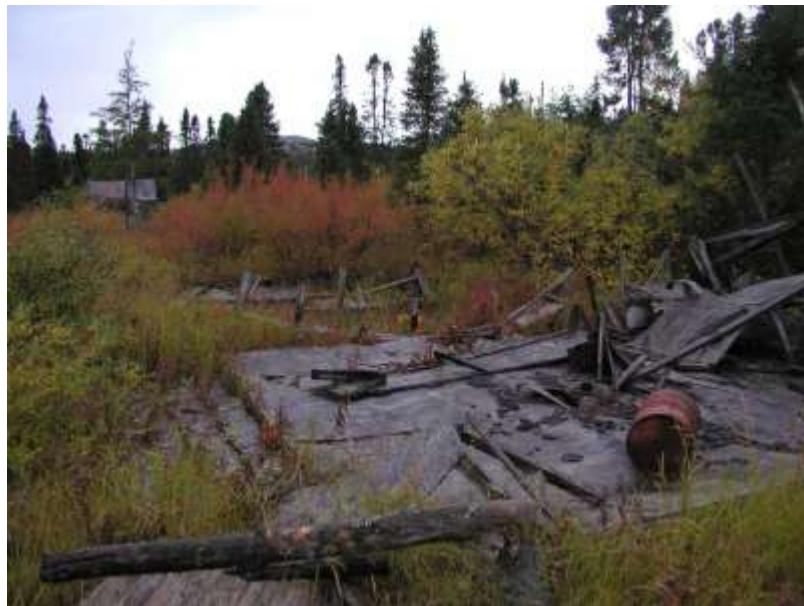
According to the 2001–2002 inventory, the site comprises a wooden building in poor condition, nine wooden bases, four 205-L barrels including one filled with diesel and the remaining three containing together roughly 30 L of diesel, 19 40-L barrels including four containing together 50 L of diesel residue, and less than 3 m³ of metal debris. A 6 m² area inside the building is contaminated with petroleum hydrocarbons. Figures 34 and 35 are photographs of the site taken during the 2001-2002 inventory.

Figure 34: Collapsed building at site WHA-1.

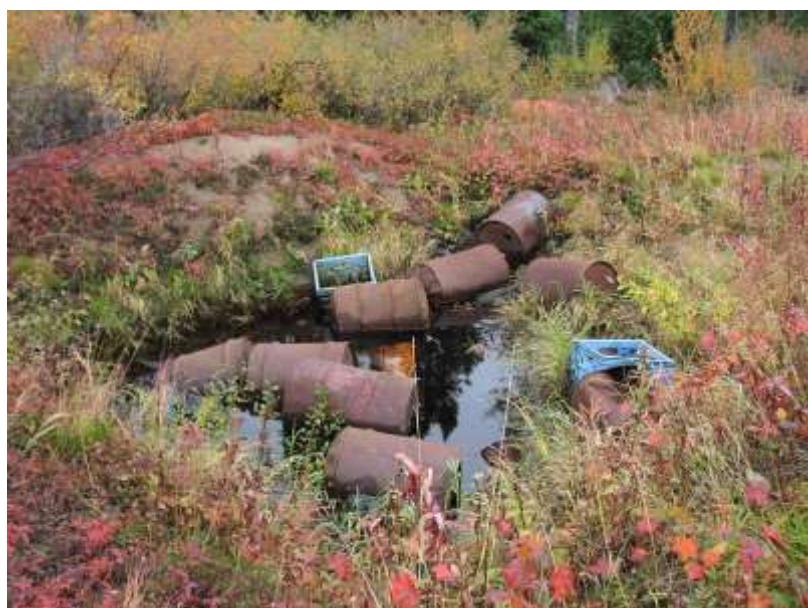
Figure 35: Barrels at site WHA-1.

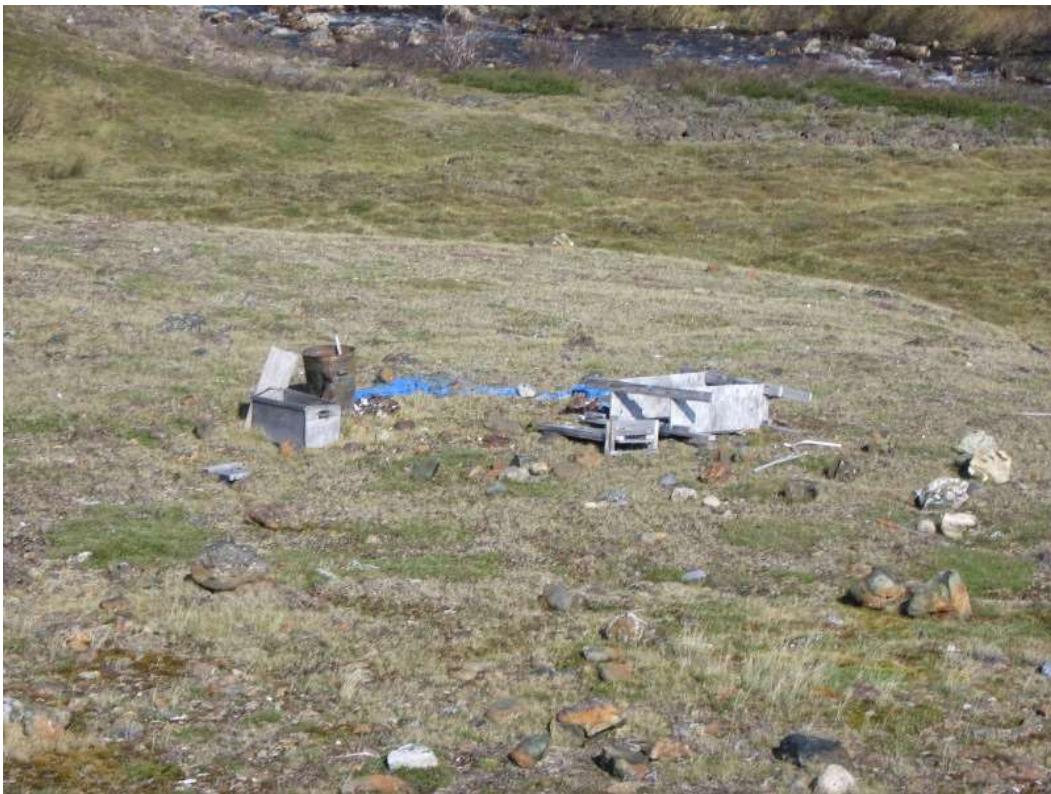
Figure 36: A photograph of KV-1 taken during the 2001-2002 inventory.

The site is located near site SW-27 and should be cleaned-up in conjunction to make the best of a work team and helicopter use. Work will most likely consist of gathering barrels and other debris for transportation, burning combustible materials on site and inspecting the waste disposal site.

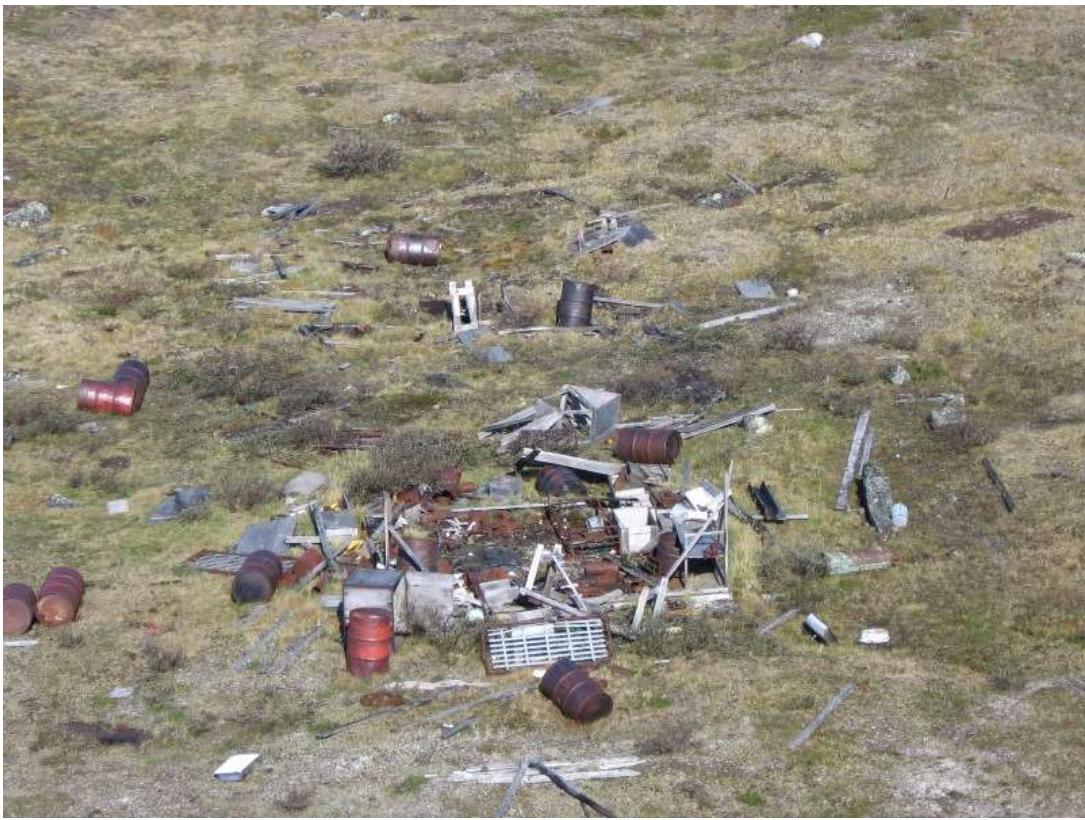
Figure 37: A photograph taken of site SW-27 during the 2001-2002 inventory.

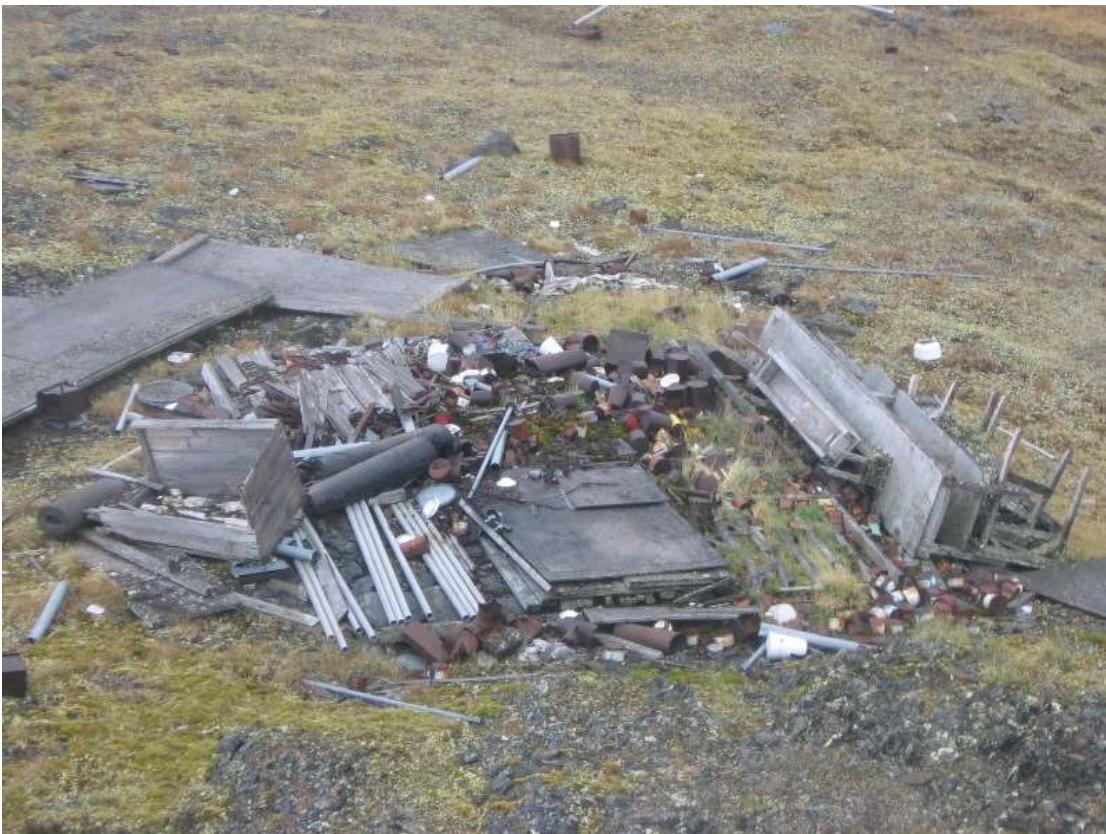
Figure 38: A photograph taken of site SW-42 during the 2001-2002 inventory.

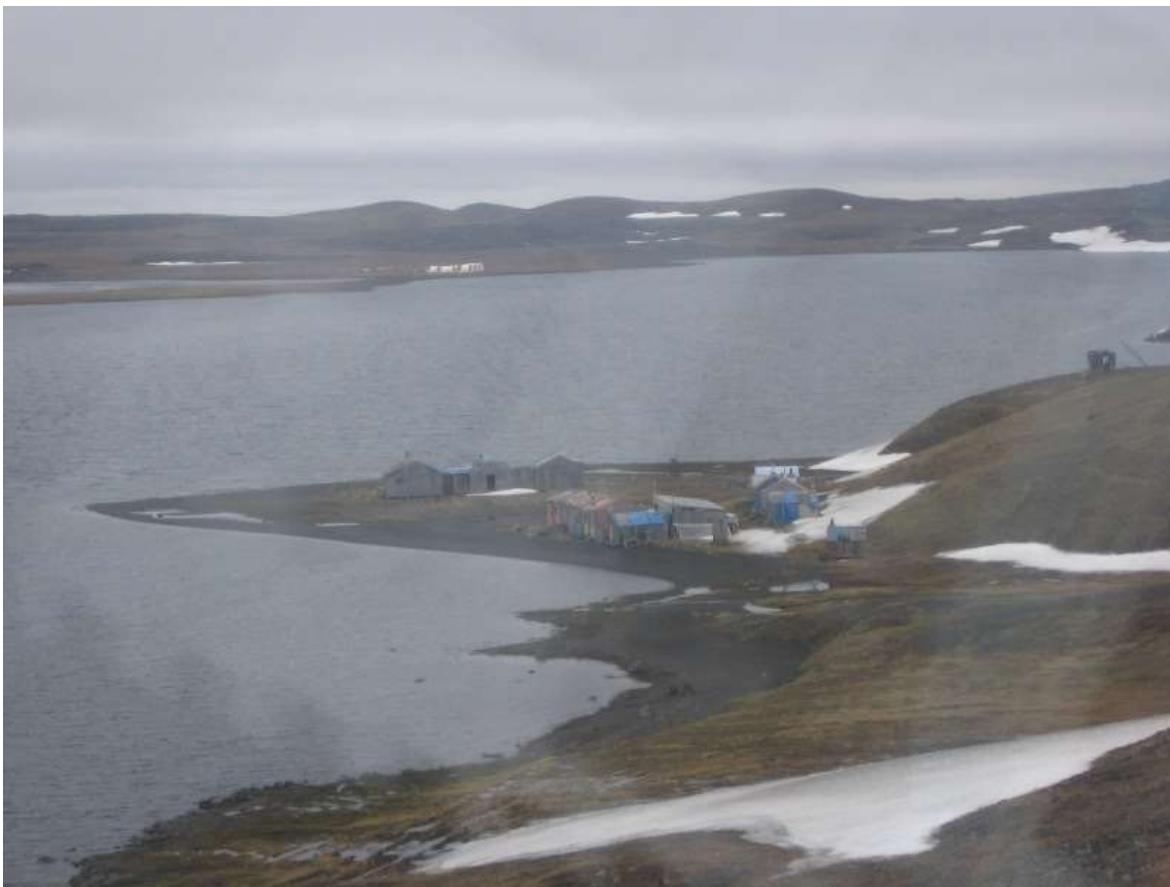
Figure 39: A photograph taken on site WB-9 during the 2001-2002 inventory.

This site is located between the properties of Golden Valley Mines Inc and Goldbrook Ventures and collaboration will be helpful when cleaning this site. All of the wooden structures will need to be emptied, striped of metal and non-hazardous waste and burned on site. The barrels and other debris will have to be transported by helicopter to a temporary storage facility.

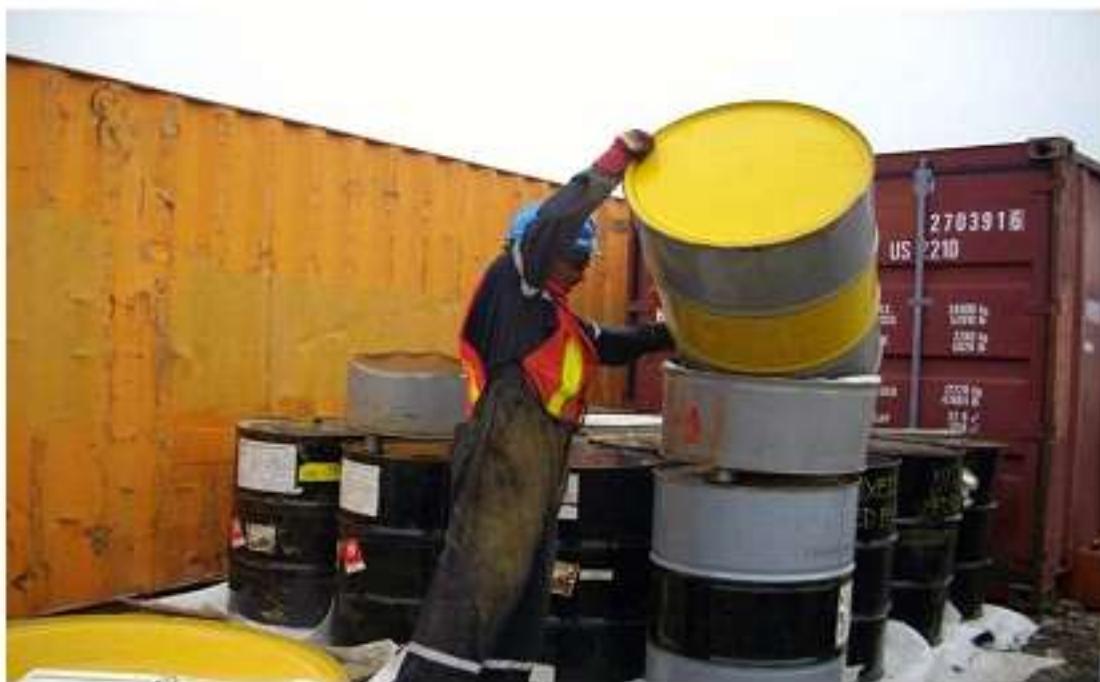
Picture 1 - Recovery of residual fluids

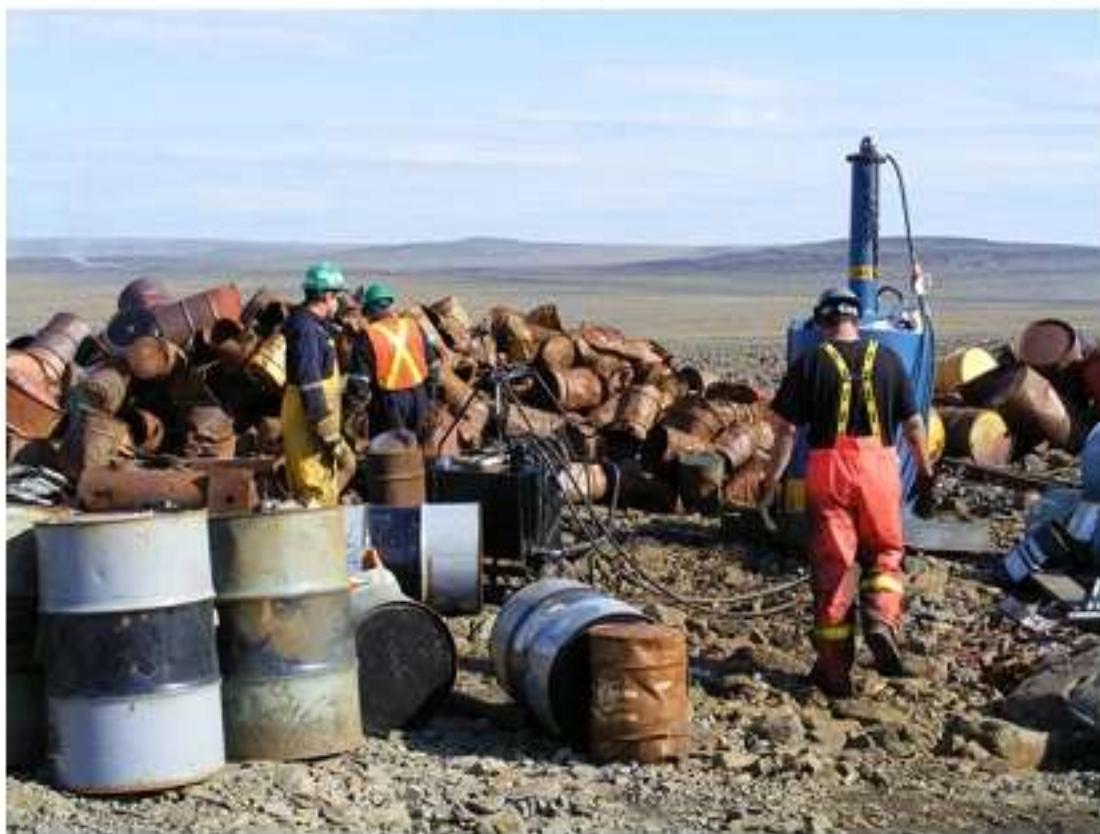
Picture 2 - Crushing of barrels for transportation - K-61

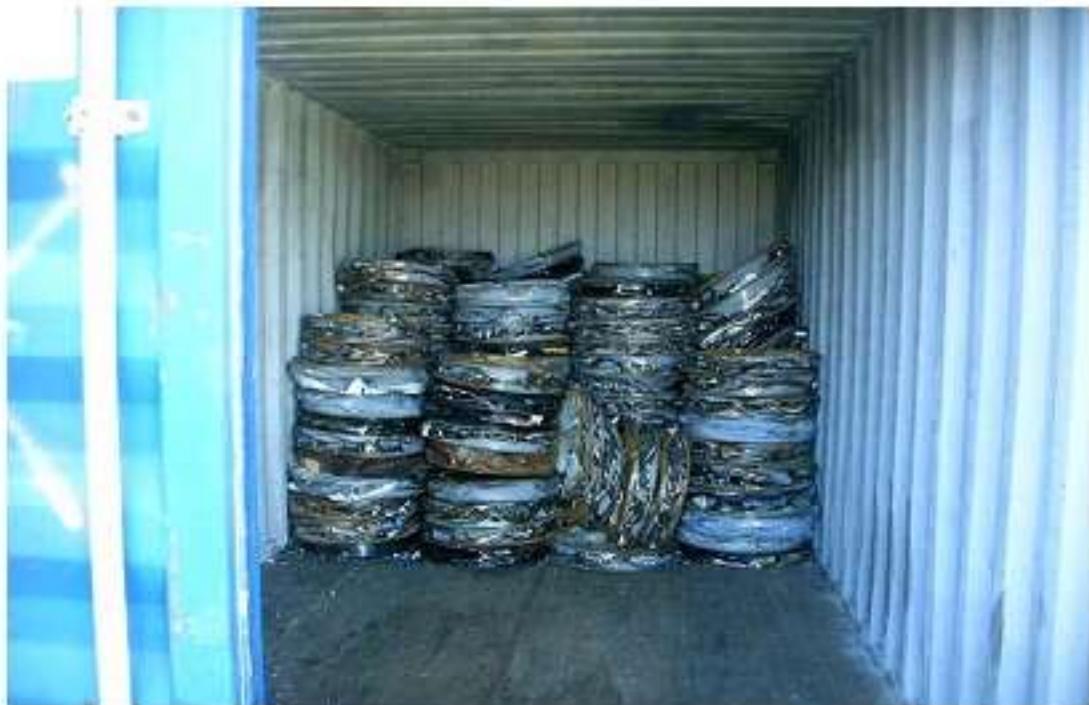
Picture 3 - Loading of barrels inside containers before shipping to the south & recycling

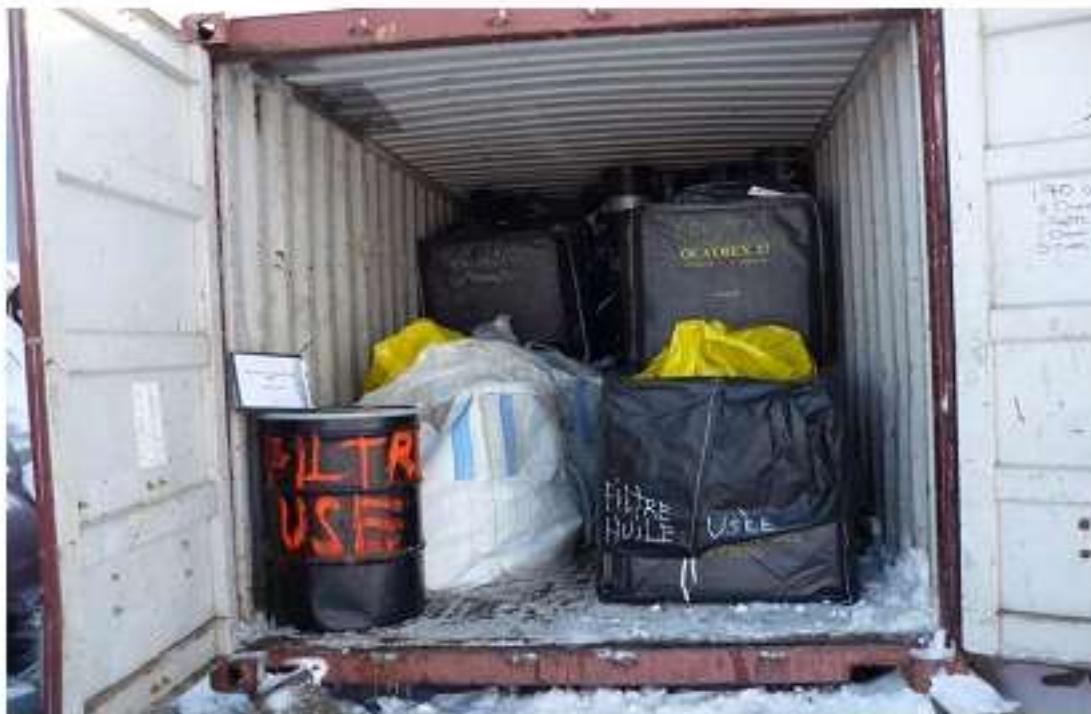
Picture 4 - Loading of residual materials before shipping south

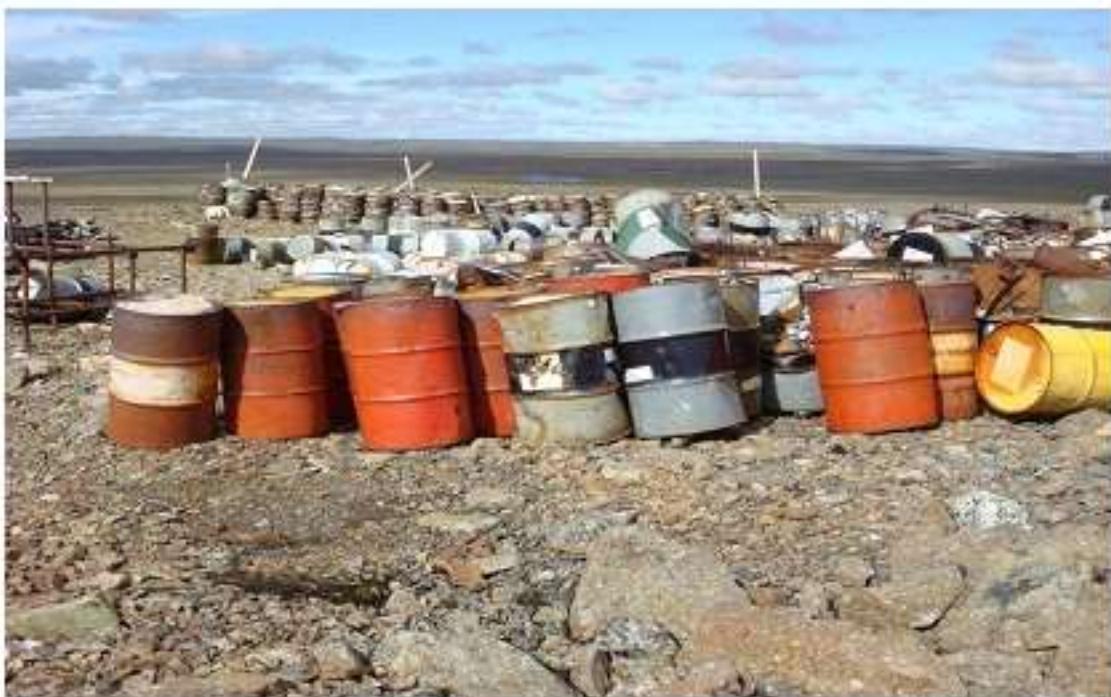
Picture 7 - Old Dump at K-61 - Storage of scrap and debris - 2007

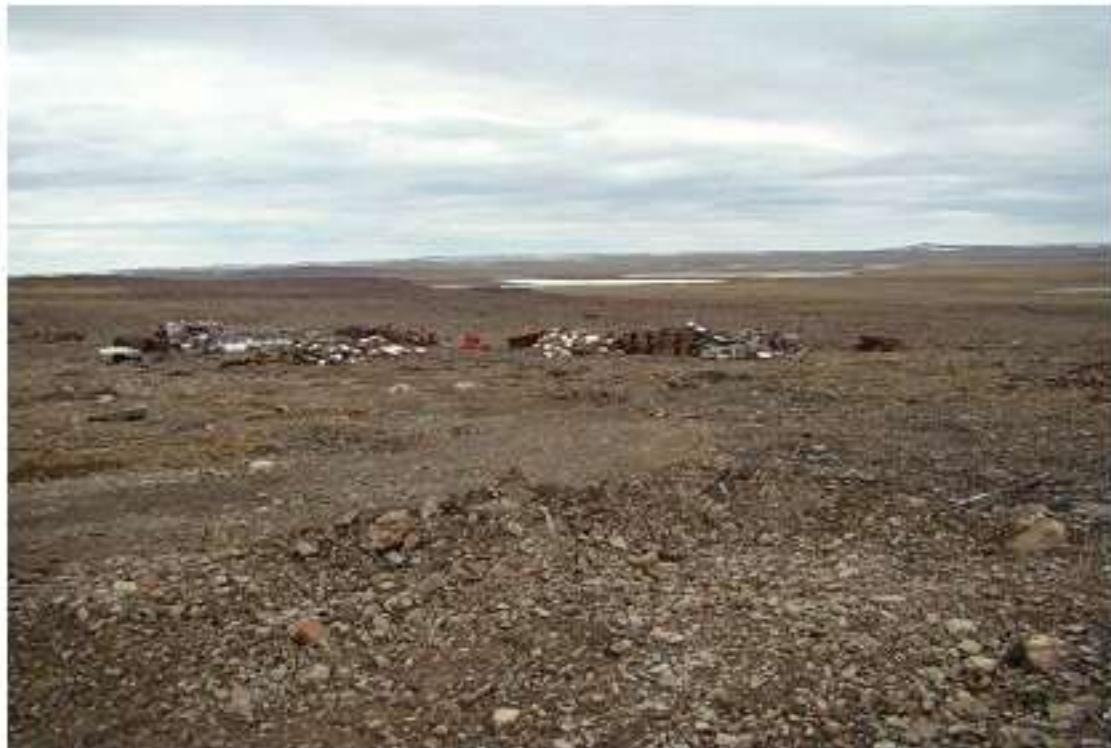
Picture 8 - Old Dump at K-61 - Cleaning Operations September 2008

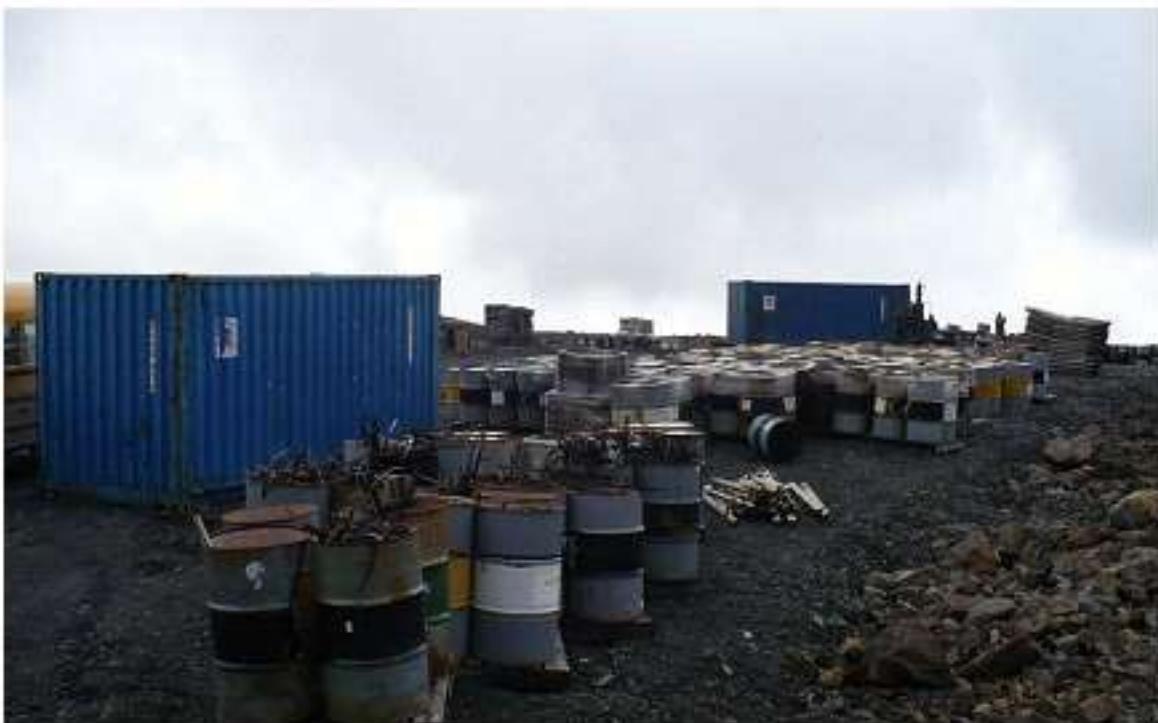
Picture 9 - Recovery of steel & barrel crushing station

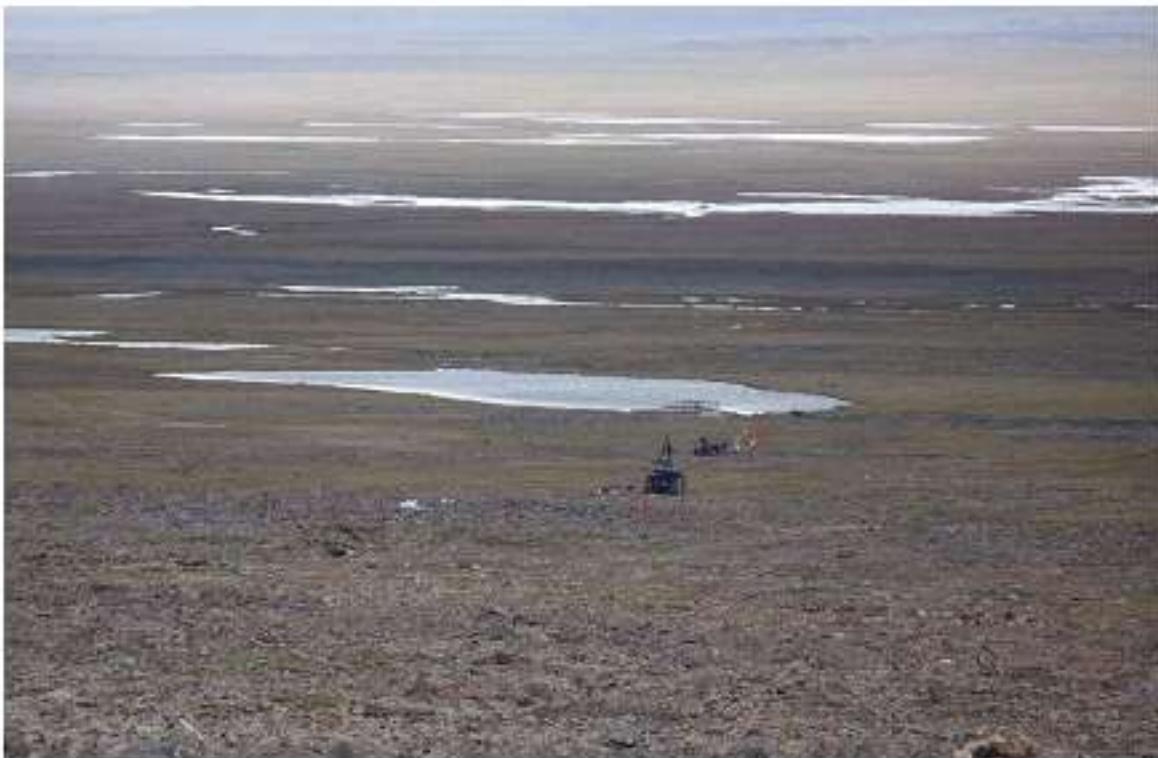
Picture 10 - Recovery of old water supply pipes

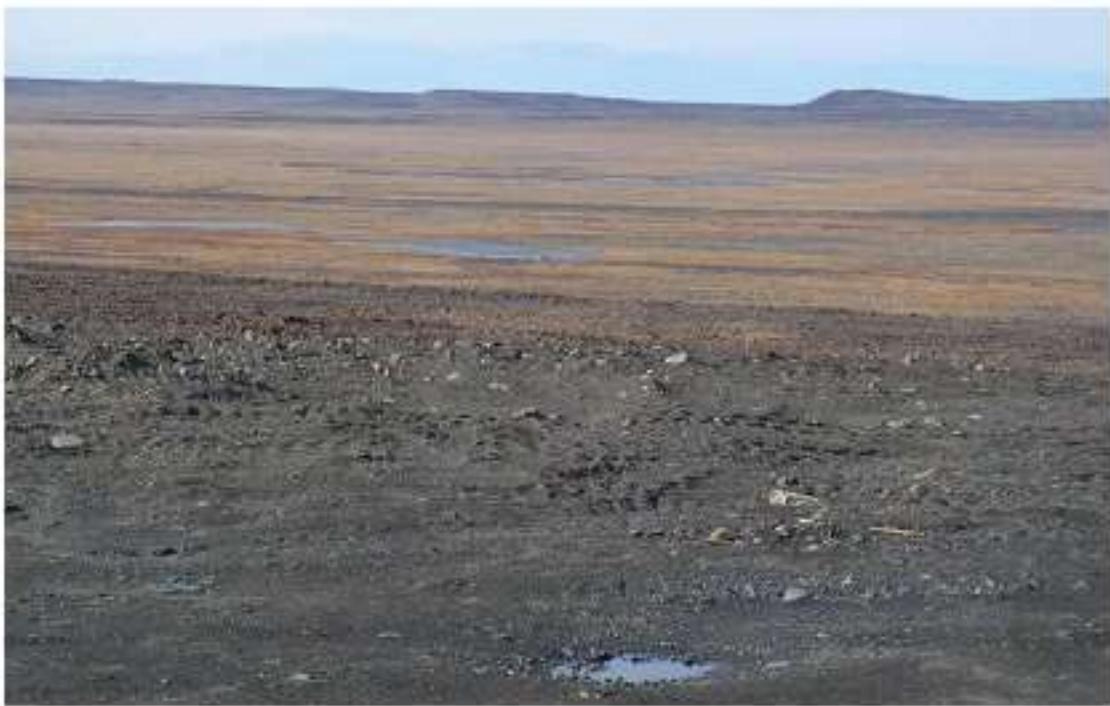
Picture 11- Old Dump at K-61 - Clean-up completed- September 2009
