**SUMMARY REPORT ON THE REHABILITATION WORK AT THE 18 "MAJOR"
ABANDONED MINERAL EXPLORATION SITES IN NUNAVIK CARRIED OUT
DURING THE SUMMER OF 2009**

UPDATE ON THE GENERAL RESPONSE PLAN

Kativik Regional Government

**Renewable Resources, Environment
and Land Use Planning Department**

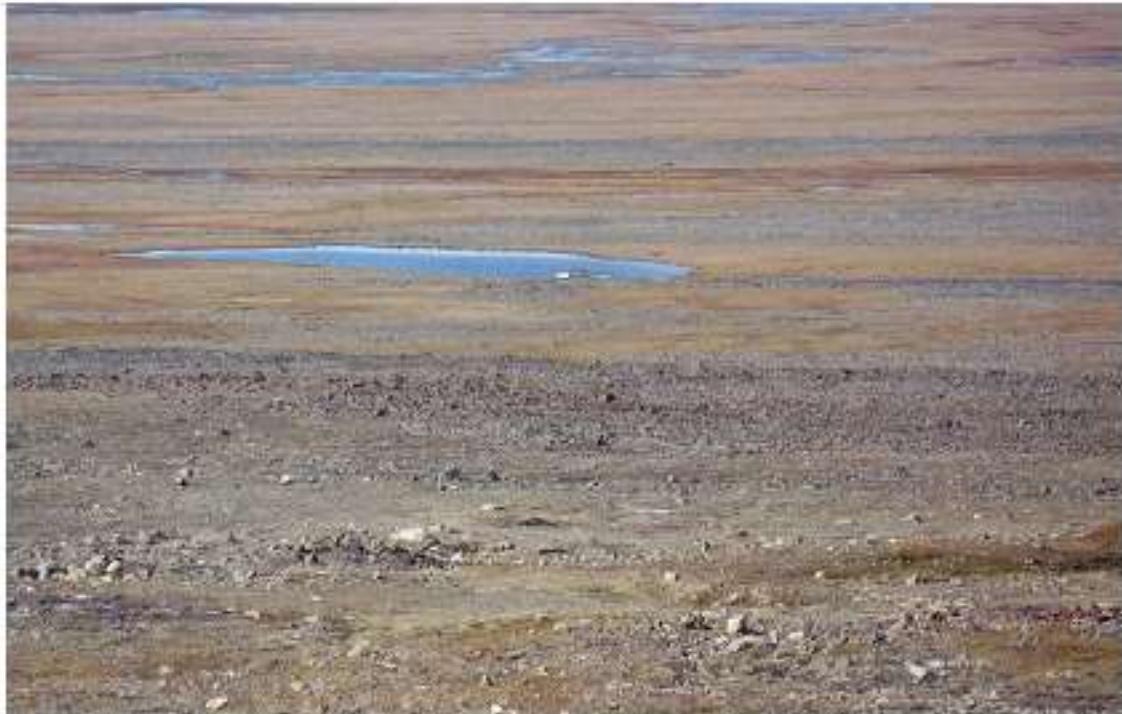
Picture 12 - Old Dump at K-61 - Clean-up completed - September 2009

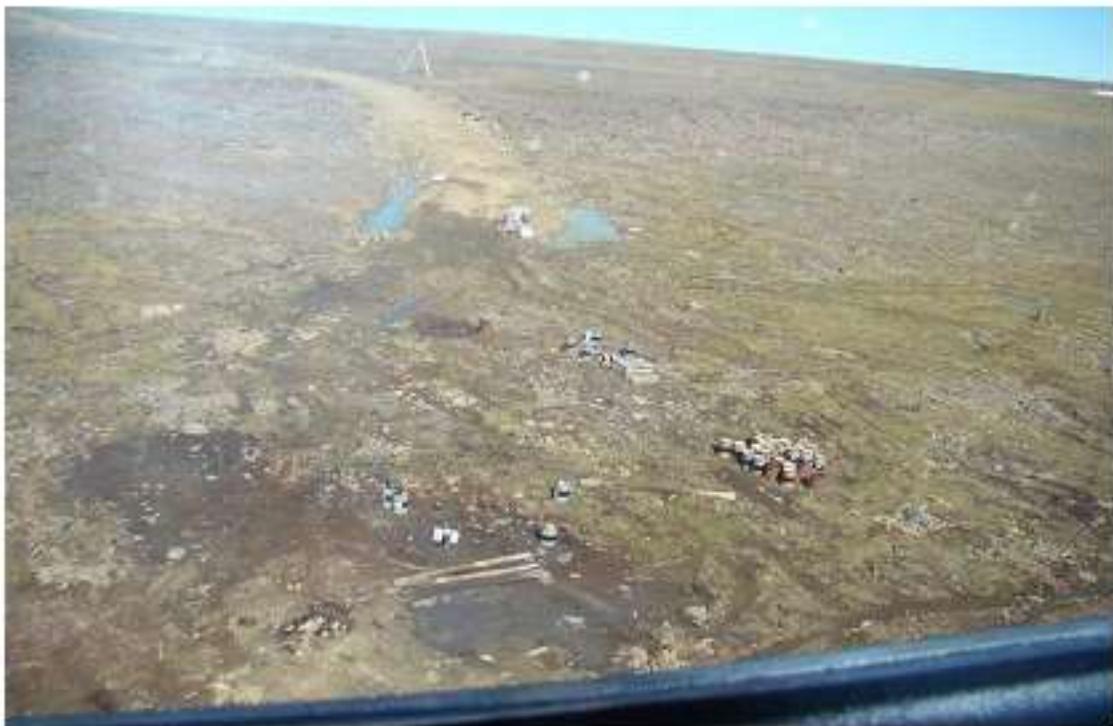
Picture 13 - Mesamax K-28 - During clean-up operations - July 2009

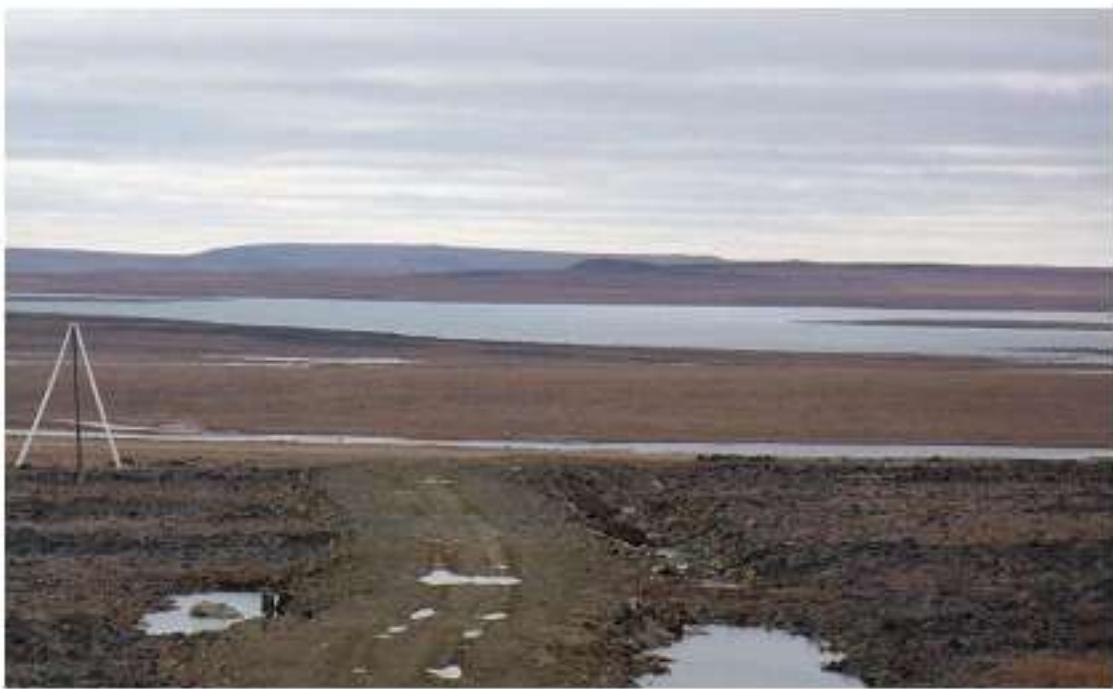
Picture 14 - Mesamax K-28 - After clean-up - August 2009

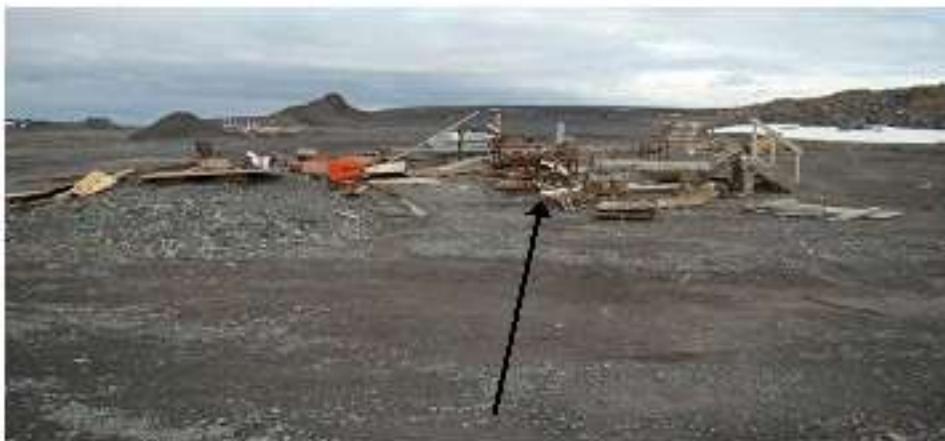
Picture 21 - Crushing Site - Expo July 9, 2009

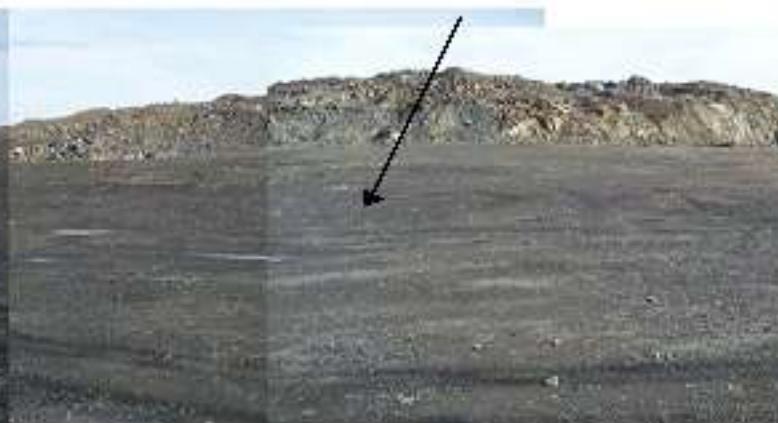
Picture 22 - Crushing Site- Expo, September 9, 2009 after site cleaning
