**SUMMARY REPORT ON THE REHABILITATION WORK AT THE 18 “MAJOR”  
ABANDONED MINERAL EXPLORATION SITES IN NUNAVIK CARRIED OUT  
DURING THE SUMMER OF 2010**

**UPDATE ON THE GENERAL RESPONSE PLAN**

**Kativik Regional Government**

**APRIL 2011**

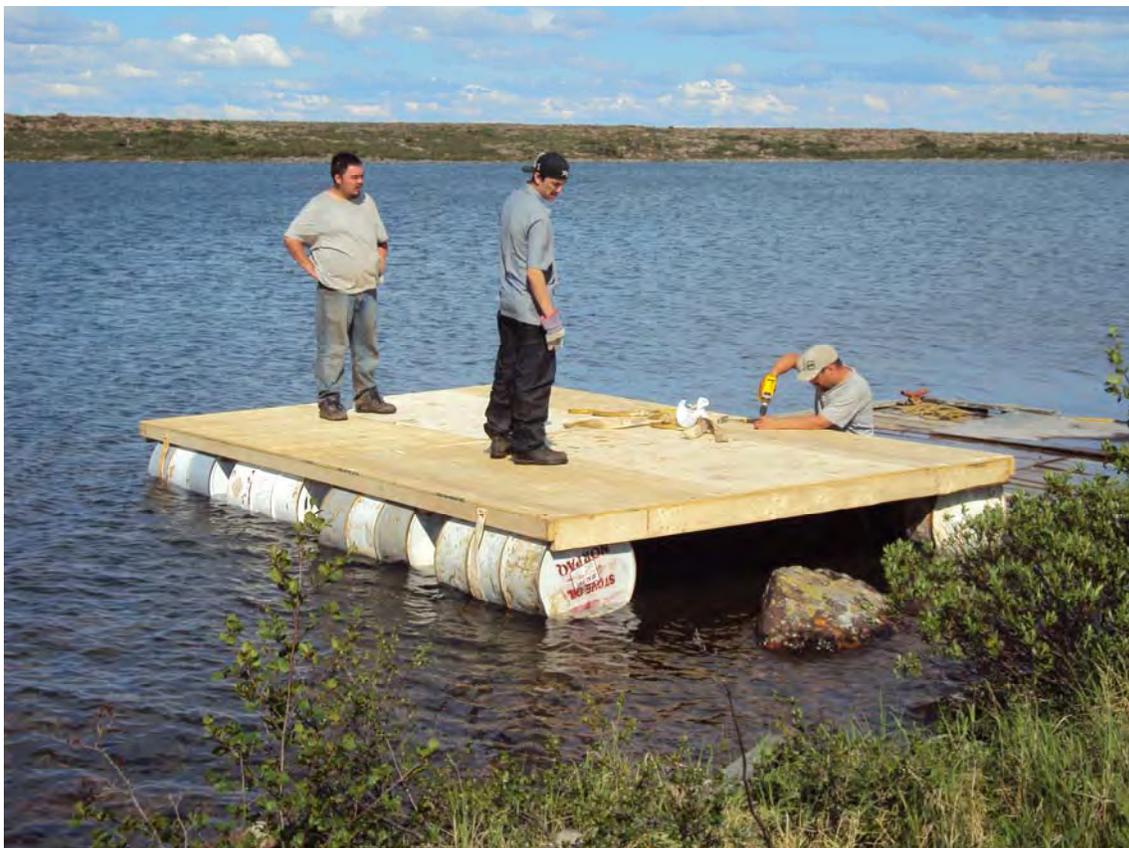
Figure 1: Workers building the new dock at KAW-35.

The first day on site was used to build a new dock, which allowed the workers to more easily and safely load the floatplane with debris from the site (Figure 1). This dock can now be used for future access to the area. Figure 1 show a photo of the new dock being built on site.

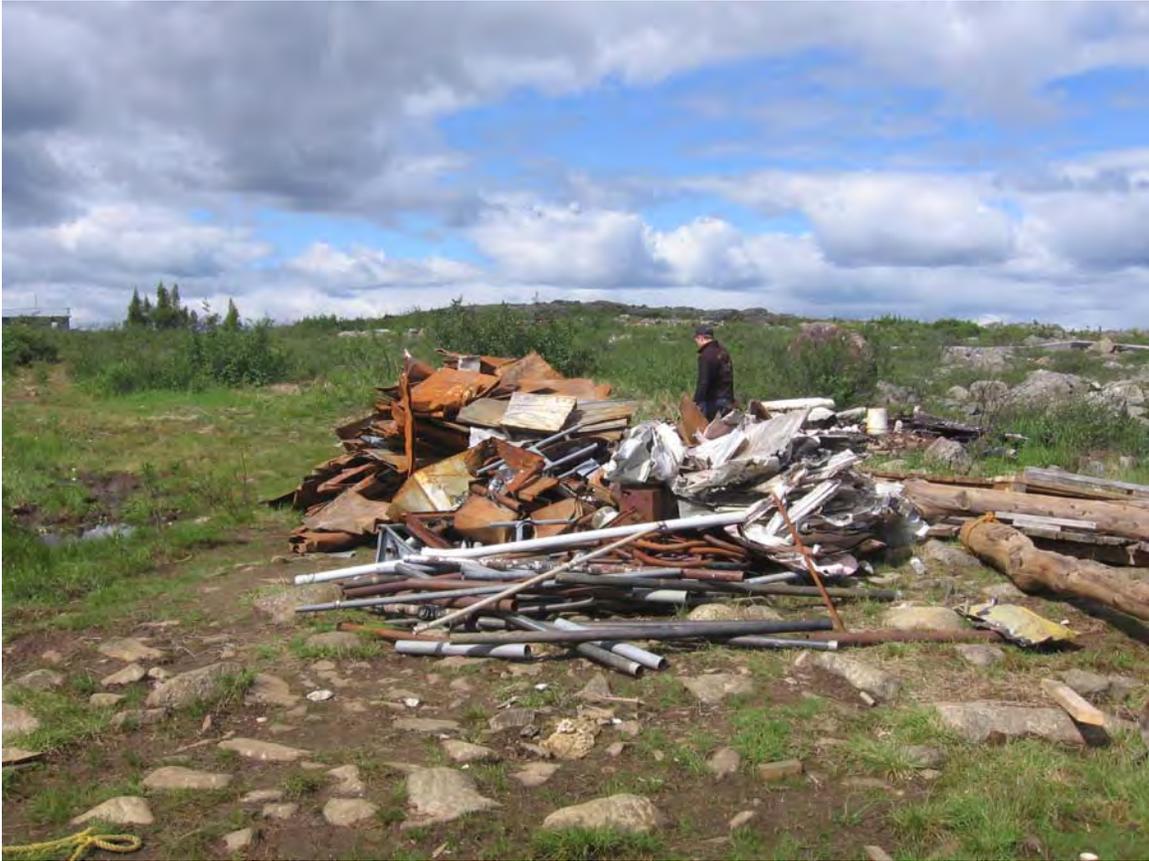
Figure 2: A photo of a pile of debris on site KAW-35.

Metal frames and tin from eight buildings, which had previously been cut into smaller pieces and piled on site were transported by floatplane to the train yards in Schefferville. This debris, along with two smaller piles of scrap metal, was then transported via train by Services Naskapi Adoschaouna to Sept-Iles to a metal recycling facility. Approximately nine thousand pounds (9,000 lbs) of metal was removed from the site. Figures 2 and 3 show the site before and after a pile of metal debris was removed.

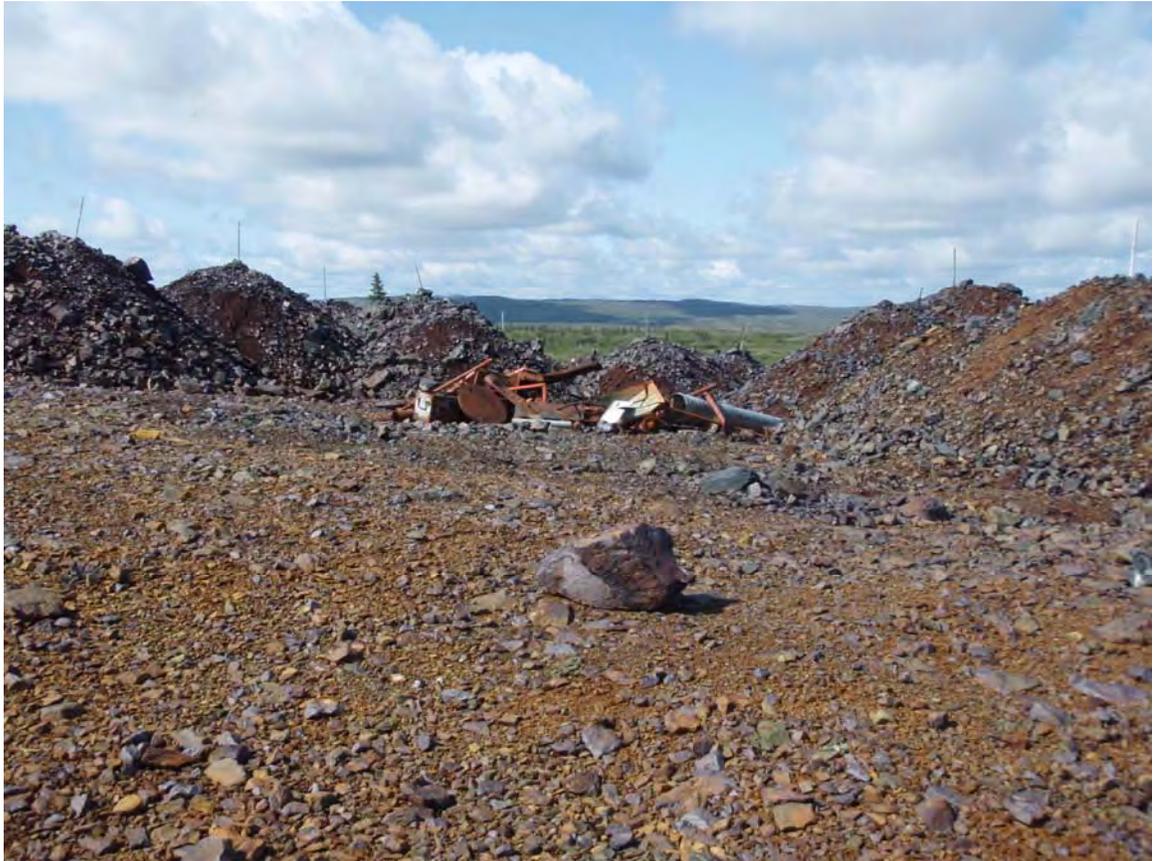
Figure 4: Mine tailings on site KAW-35.

Sector 2 contains a large quantity of mine tailings. A water sample taken from the now-flooded mine workings revealed an acid pH of 3.27 (21.7°C). This level of acid pH points to acid mine drainage. Due to the slope of the site, water drains towards the lake. Because an outfitting camp is located nearby, the site KAW-35 is visited often. Action is recommended to reduce the impact of acid mine drainage. Figure 4 shows a photo of this area.

To mitigate acid mine drainage, contact between the tailings and both oxygen and precipitation must be eliminated. At the site KAW-35, two solutions are possible: 1) place the tailings in the existing test well, or 2) cover the tailings with a moisture barrier to eliminate contact with precipitation. The first solution could prove more costly given the absence of information about the well (orientation, dimensions, etc.). Moreover, the placement of tailings in the test well could cause already highly acidic water in the well to leak into the environment.

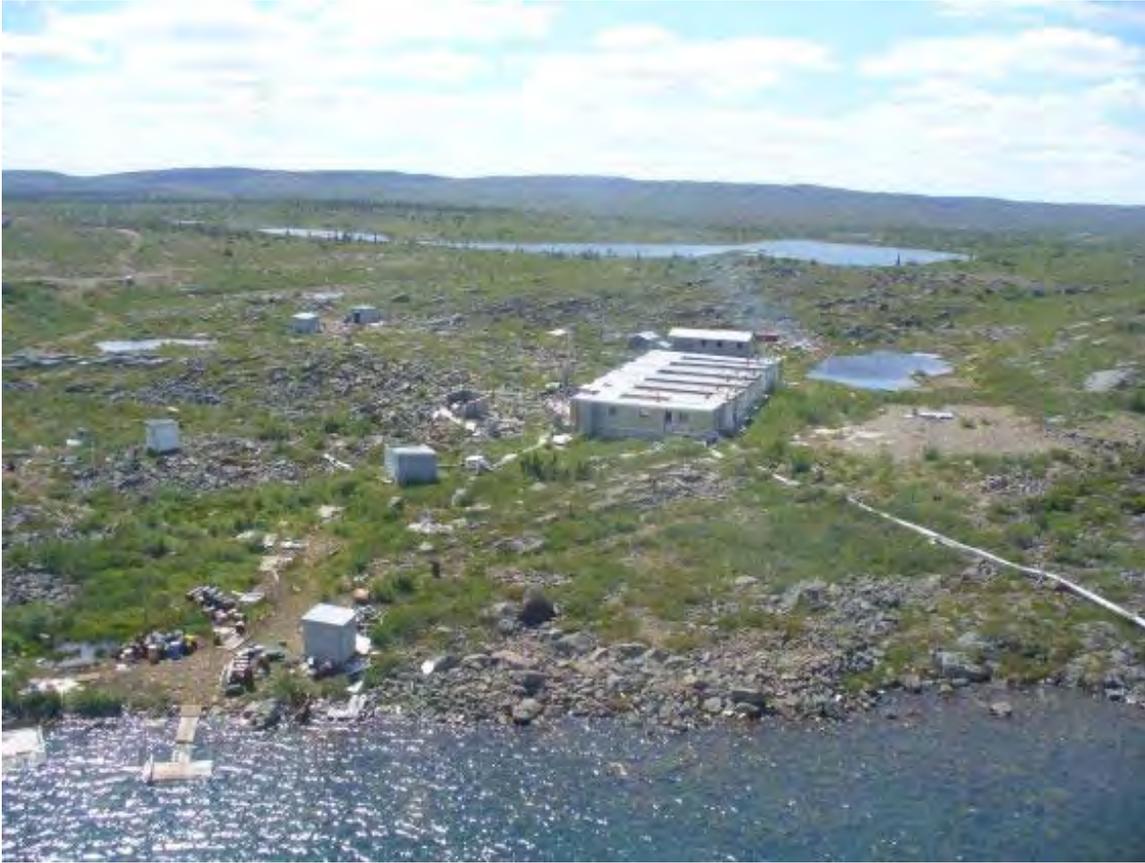
Figure 5: Photo of site KAW-35 taken in 2007.

Work on this site, subsequent to the removal of the reservoirs and trailers during the winter will then be complete. Figures 5 and 6 show an aerial view of the site before and during the clean-up efforts.

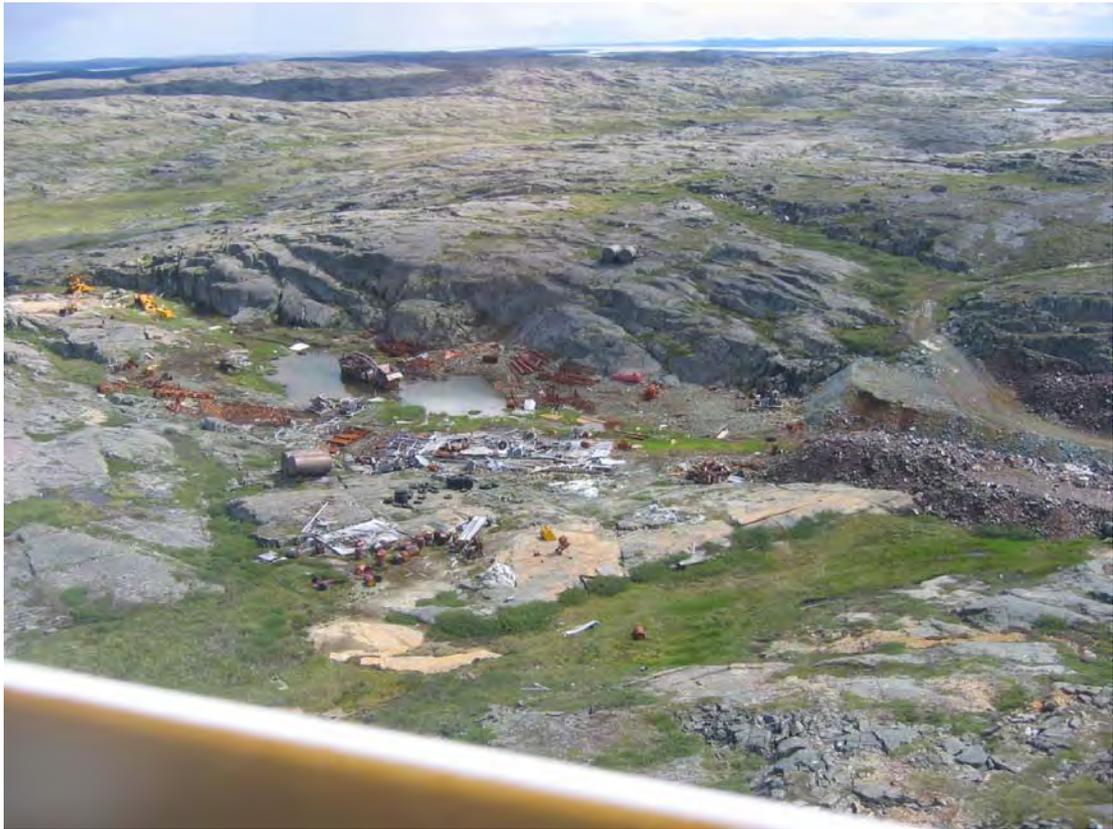
Figure 7: Sector 4 of site PJ-1, taken in 2006.

Figures 7 and 8 show this sector before and after the heavy equipment was removed.

Following a thorough evaluation of the equipment by the project coordinator a representative from a scrap metal recovery facility in July 2010, it was decided that reusable parts would be sold or redistributed within the region and any equipment no longer functional could be shipped to a recycling centre south of the province. In October 2010 several containers filled with propane tank, scrap metal and some crushed drums were transported by ship. However, due to the sheer size and weight of the heavy equipment, the ship's dock master decided the ship could not transport these larger pieces safely. A new strategy for removing this equipment from the community of Aupaluk is needed.

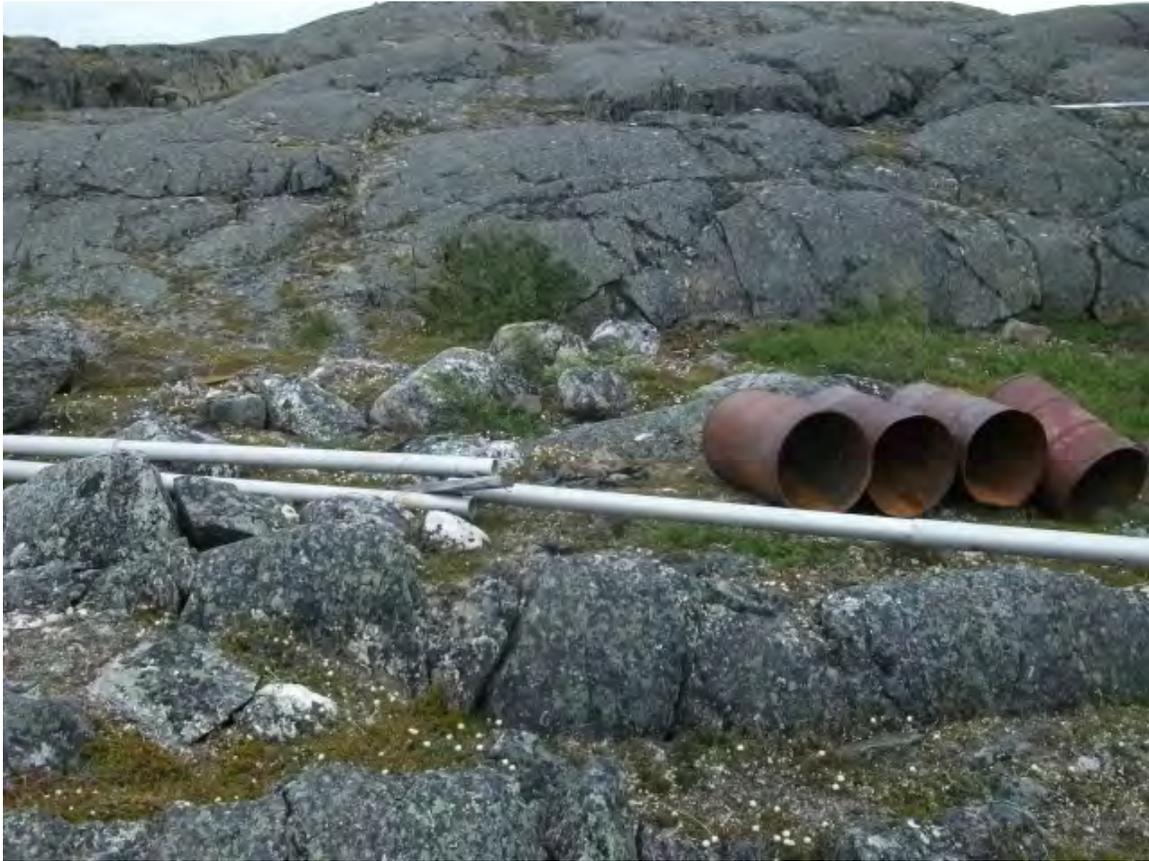
Figure 10: Waste removed from Sector 9 of site PJ-1 (July 2010).

In Sector 8, the work team transported a large pile of metal debris by helicopter to Sector 5 to be stored until the winter can permit easier transportation to Aupaluk. Sector 9 contained approximately 6 empty barrels and several very long metal rods that were also transported by helicopter to Sector 5 for storage. Figure 10 shows the waste found in Sector 9.

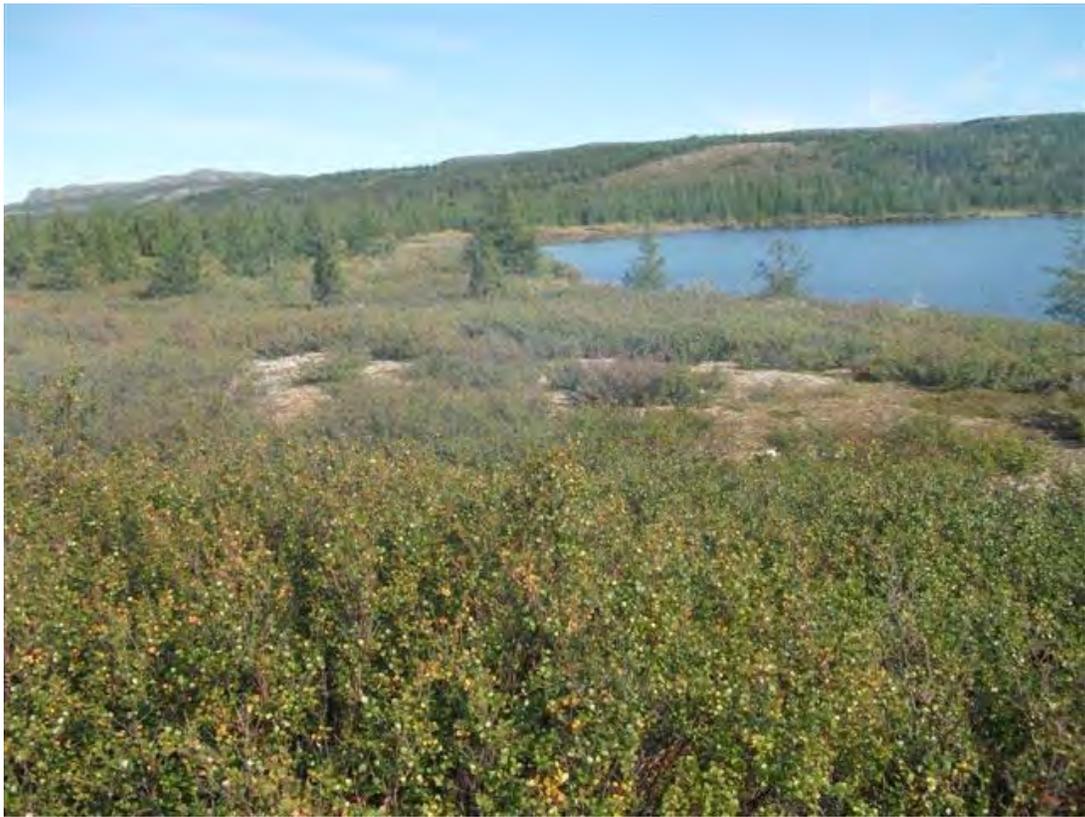
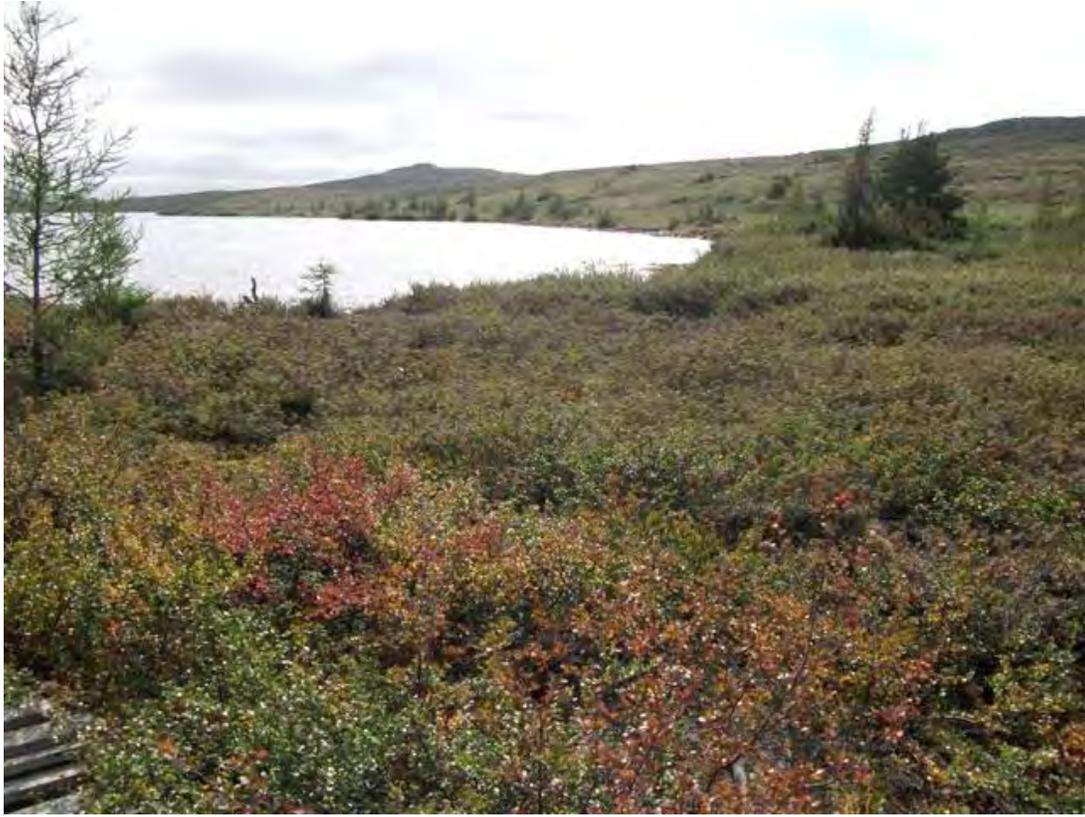
Figure 16: TQ-1 after 2010 clean-up activities

Figure 17: TQ-1 after 2010 clean-up activities

In September 2010 a team of 4 workers, including the field technician, gathered empty drums and scrap metal which were transported to Kuujjuaq by helicopter and stored in an empty container which will be shipped south to an appropriate recovery facility. In total, 15 loads of metal was removed from TQ-1. Furthermore, nearly 50 drums filled with diesel were also removed from the site by Twin Otter and brought to Kuujjuaq.

The Northern Villages of Tasiujaq and Kuujjuaq contributed to the rehabilitation of this site by providing workers needed for the clean-up. This site is now considered complete. Figures 14 and 15 show the site before work was undertaken while Figures 16 and 17 show the site once the work was completed.

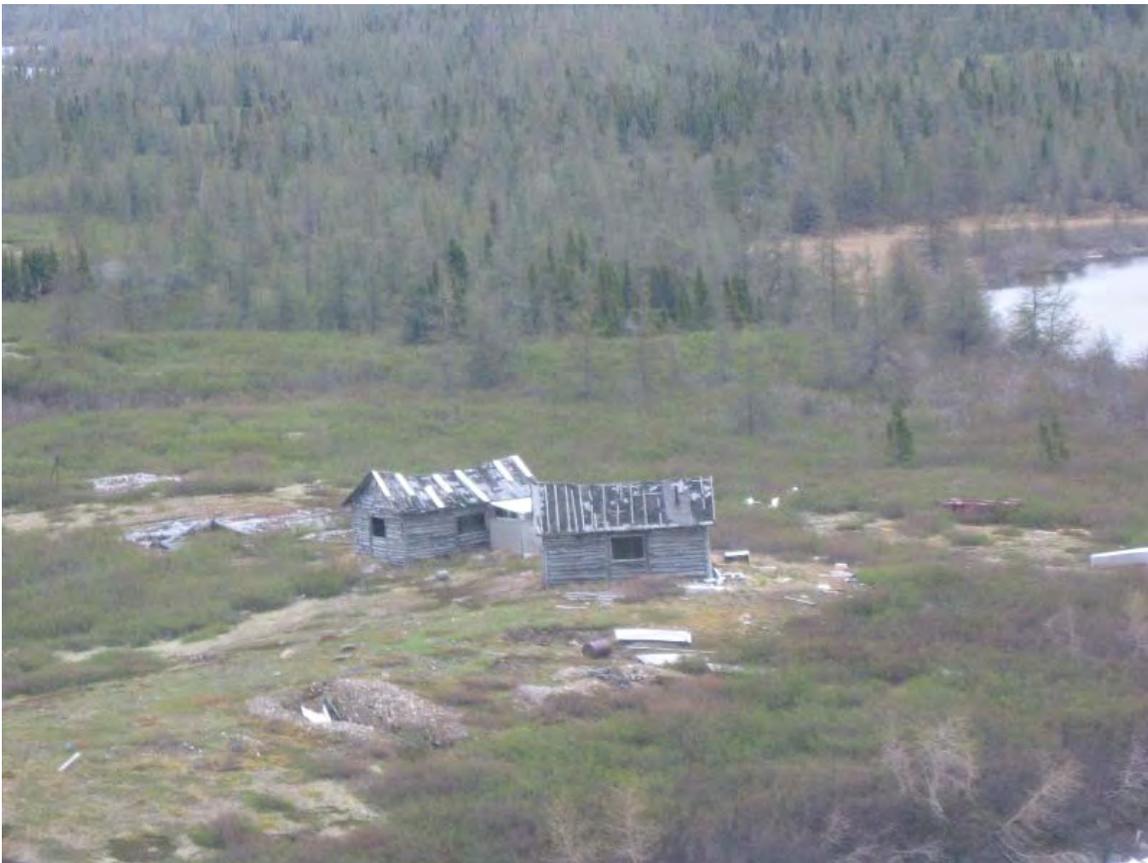
Figure 18: Site TQ-4, sector 1 taken during the 2001-2002 inventory.

Inspections in 2007 and 2010 revealed that the site closely matches the description prepared during the 2001–2002 inventory. A cabin suitable for use, a collapsed building, a wooden platform and a variety of debris (35 barrels, eight propane tanks, aluminium insulation sheets, etc.) near the two buildings were still present in Sector 1 while 115 barrels were still located next to the two depressions found in Sector 2.

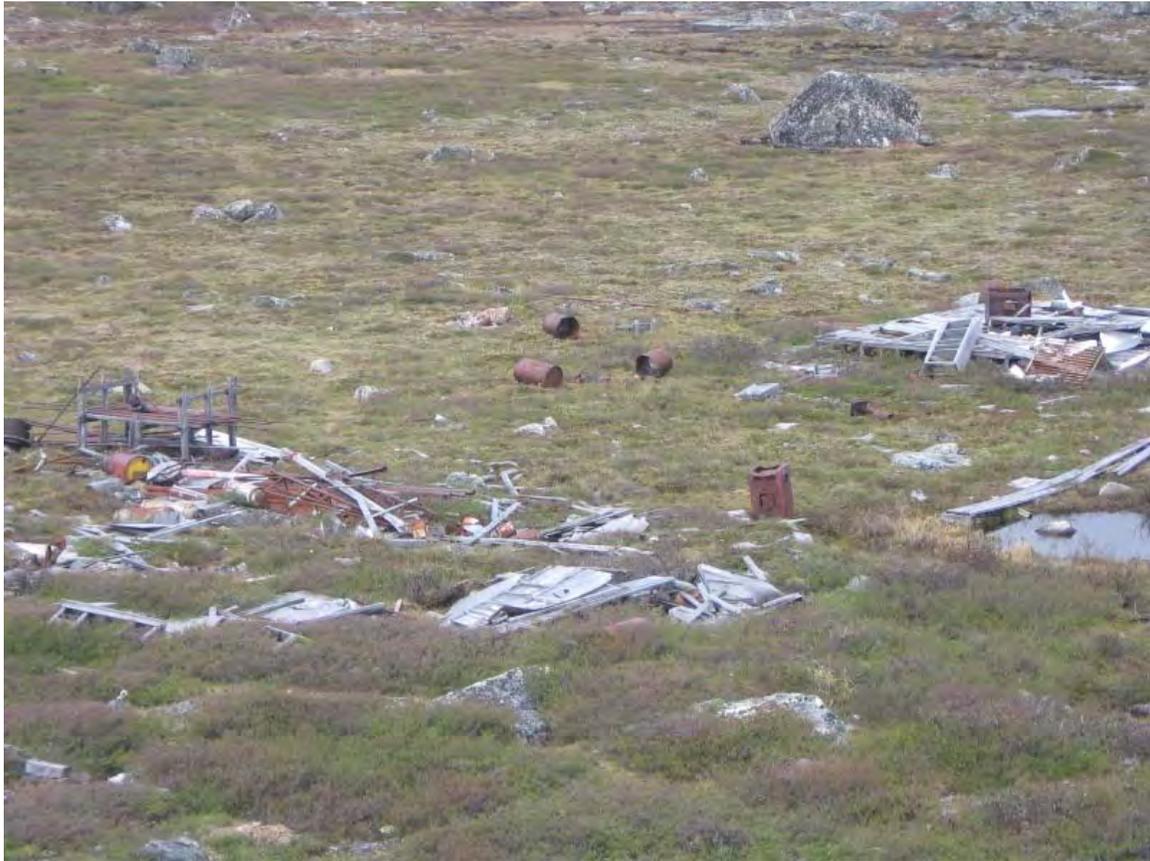
Figure 20: Site PJ-10, photo taken during the 2001-2002 inventory.

The site was inspected in 2007 and revealed that the site matched the description prepared during the 2001–2002 inventory. Figure 20 shows a photograph taken during the 2001-2002 inspection.

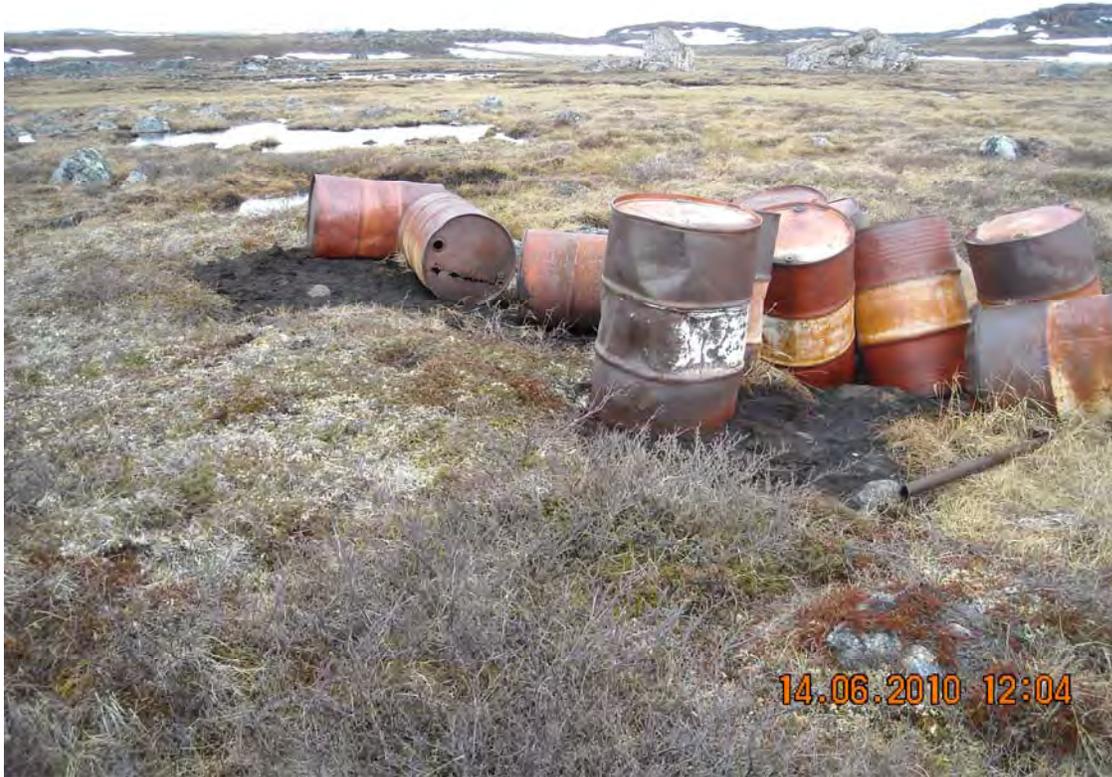
Figure 21: Group of leaking barrels at site PJ-10.

Furthermore, a group of 7 drums containing used oil was leaking on site. The contaminated soil was collected and placed in recovery bags and flown to Aupaluk by helicopter. These bags, along with the other hazardous waste material collected from the site have been stored in a marine container in Aupaluk. The remaining contents of these drums were transferred into non-leaking barrels and also flown to Aupaluk. Figure 21 shows the group of leaking drums and the contaminated soil. Figure 22 shows the site after the clean up work was completed during the summer 2010 after which several drums filled with small metal debris as well as several sheets of tin that were too sharp to be carried by helicopter nets remained.

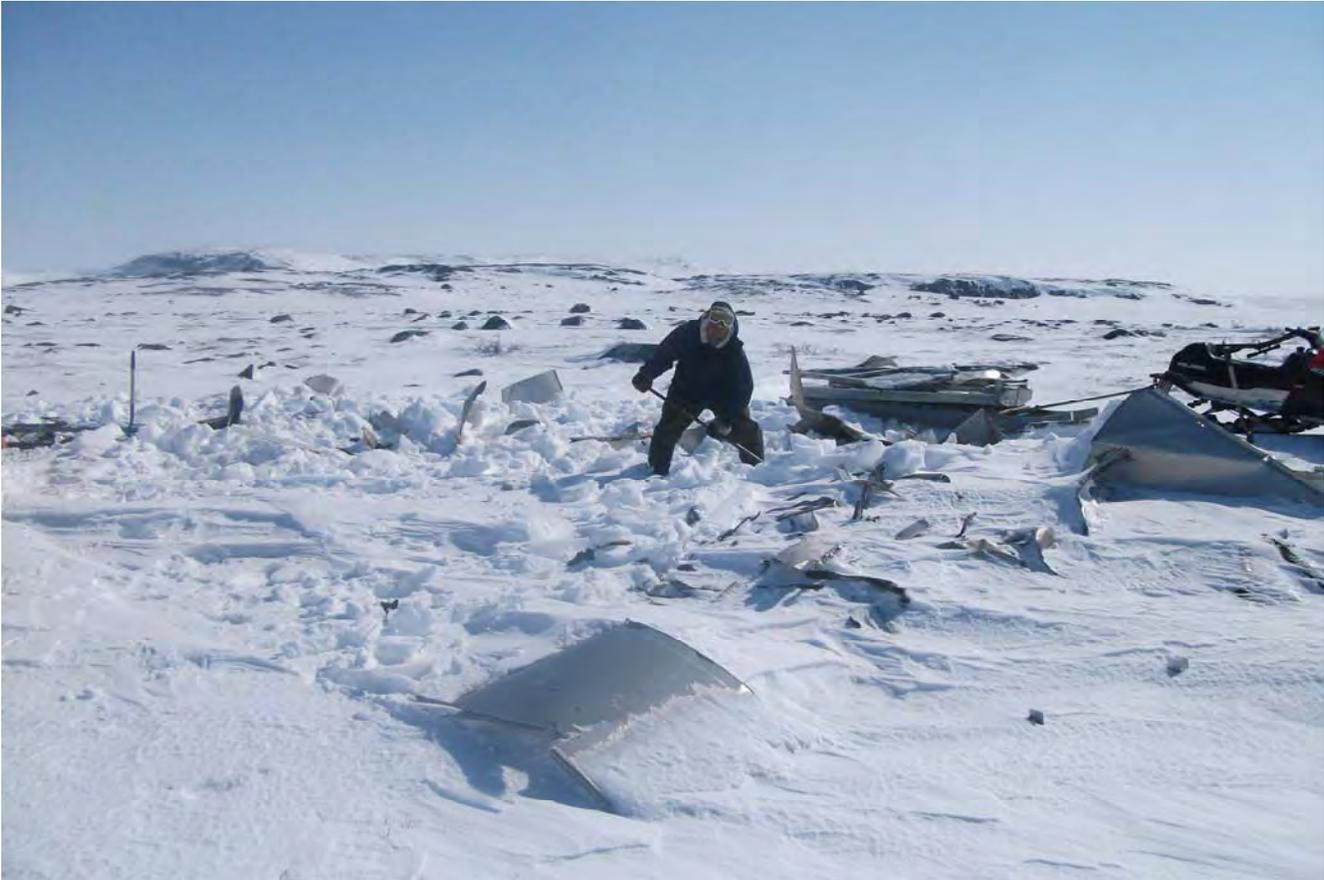
Figure 23: Worker removing snow to access material left on site PJ-10.

A team returned to the site in the winter of 2011 to remove some of the remaining items by snowmobile (Figure 23). This site will be considered as complete once this work is complete.

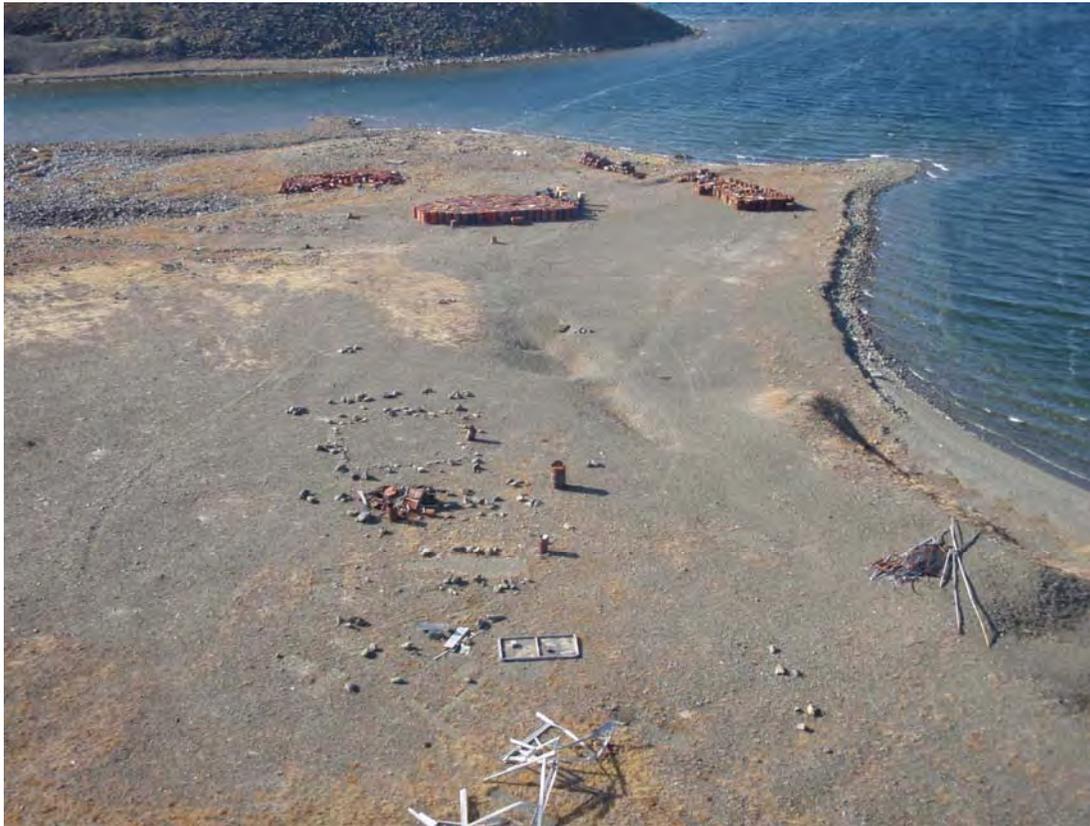
Figure 24: Site SW-34, Sector containing crushed barrels and propane tanks.

The site is spread across the properties of two mining companies: Xstrata Nickel operates north and east of Lake Esker and Goldbrook to the south and west. Most of the debris is located on the Goldbrook property. The 2001–2002 inventory identified a total of roughly 1500 barrels, chiefly on the Goldbrook property. In addition to barrels, the site contains not less than 40 propane tanks, batteries and used oil filters, equipment, etc. Figure 24 shows the site during a second inspection done in September 2009.

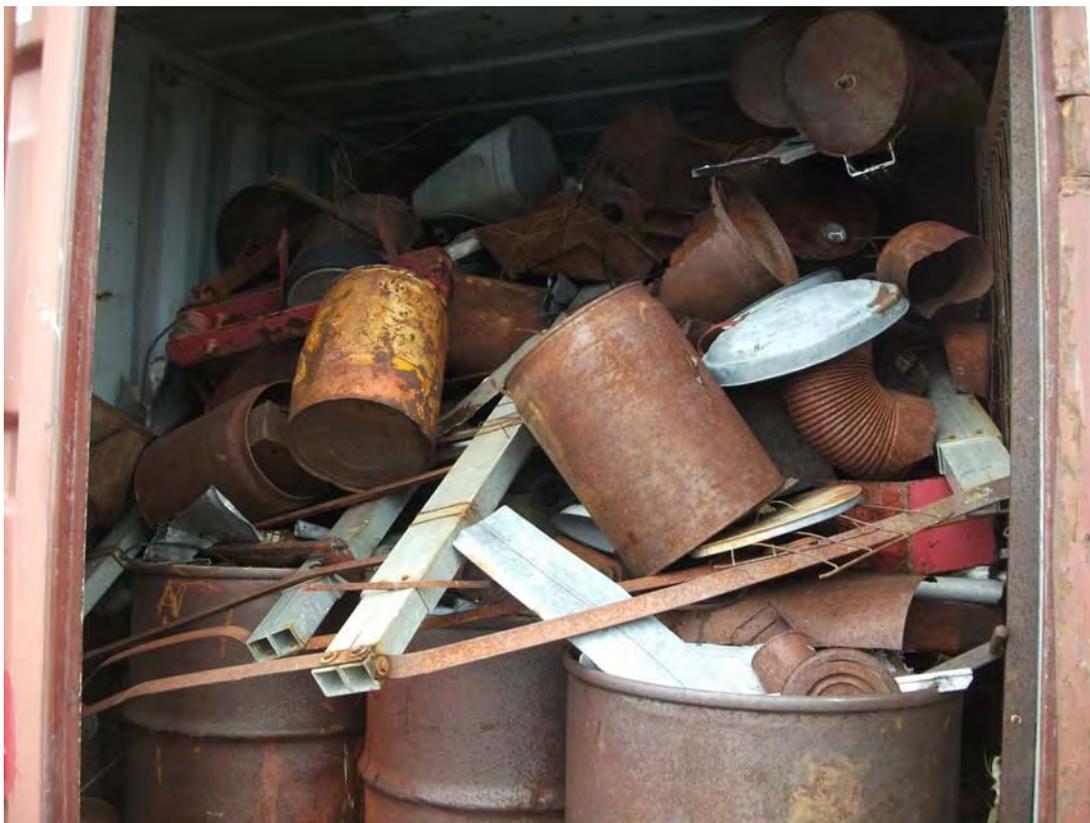
Figure 25: Photo of the inside of a loaded container located at the East Lake Xstrata site.

During the winter of 2009, Xstrata delivered 2 empty containers to their East Lake camp, approximately 10 miles from the site. In August 2010, the clean-up work consisted of transporting the remaining 300 crushed drums by helicopter to the nearby containers where they were stored inside. Approximately 70 propane, oxygen and acetylene tanks were also transported and stored inside the containers. Some of the scrap metal waste was also transported to the containers (Figure 25). Approximately 20,000 pounds of metal was removed from the site. The two containers will be removed from the area by Xstrata during the winter of 2010. Nearly 500 uncrushed drums and several piles of scrap metal remain on site (Figure 26).

It is recommended that during the winter of 2011, the Xstrata Exploration staff transport two or three more containers to their East Lake camp located relatively close to site SW-34. These containers can then be loaded with the debris as was done during the summer of 2010 and transported during the winter months.

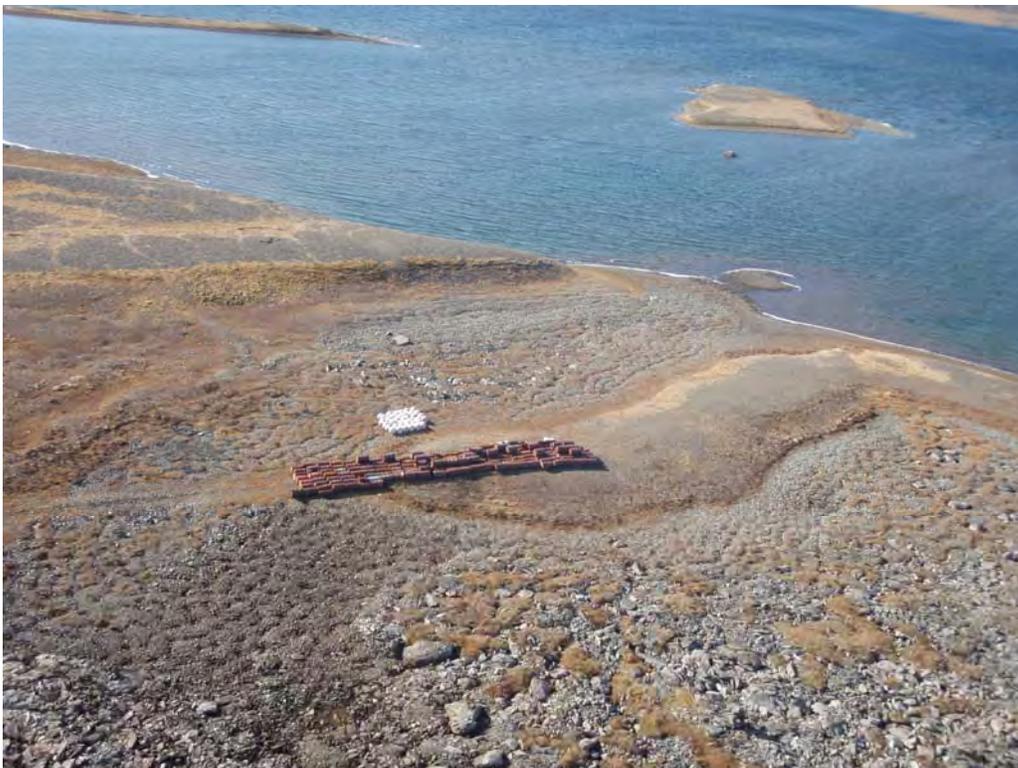
Figure 27: A second grouping of uncrushed barrels on site SW-34.

A second grouping of barrels is located along the shore of the same lake about one kilometre east of the main site and contains nearly 100 empty very rusty barrels and 19 full new barrels (Figure 27).

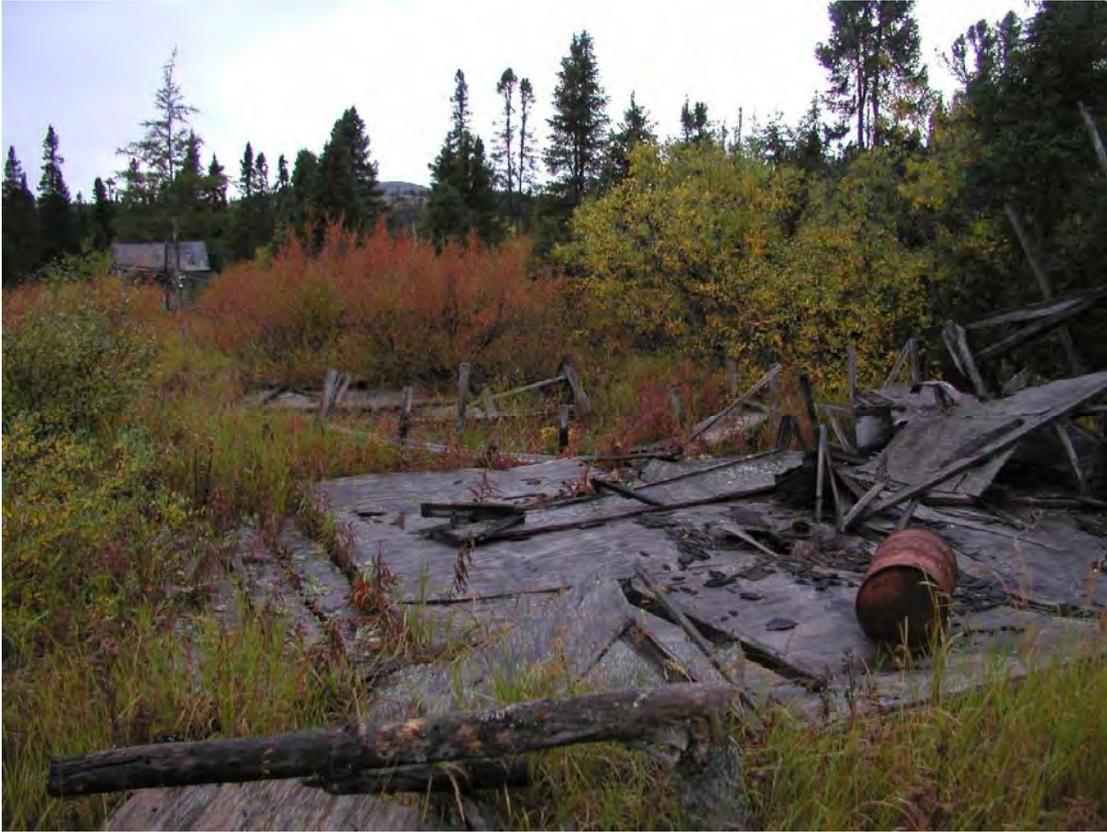
Figure 28: Photo of collapsed building at site WHA-1 (2002)

According to the 2001–2002 inventory, the site comprises a wooden building in poor condition, nine wooden bases, four 205-L barrels including one filled with diesel and the remaining three containing together roughly 30 L of diesel, 19 40-L barrels including four containing together 50 L of diesel residue, and less than 3 m<sup>3</sup> of metal debris. A 6 m<sup>2</sup> area inside the building is contaminated with petroleum hydrocarbons.

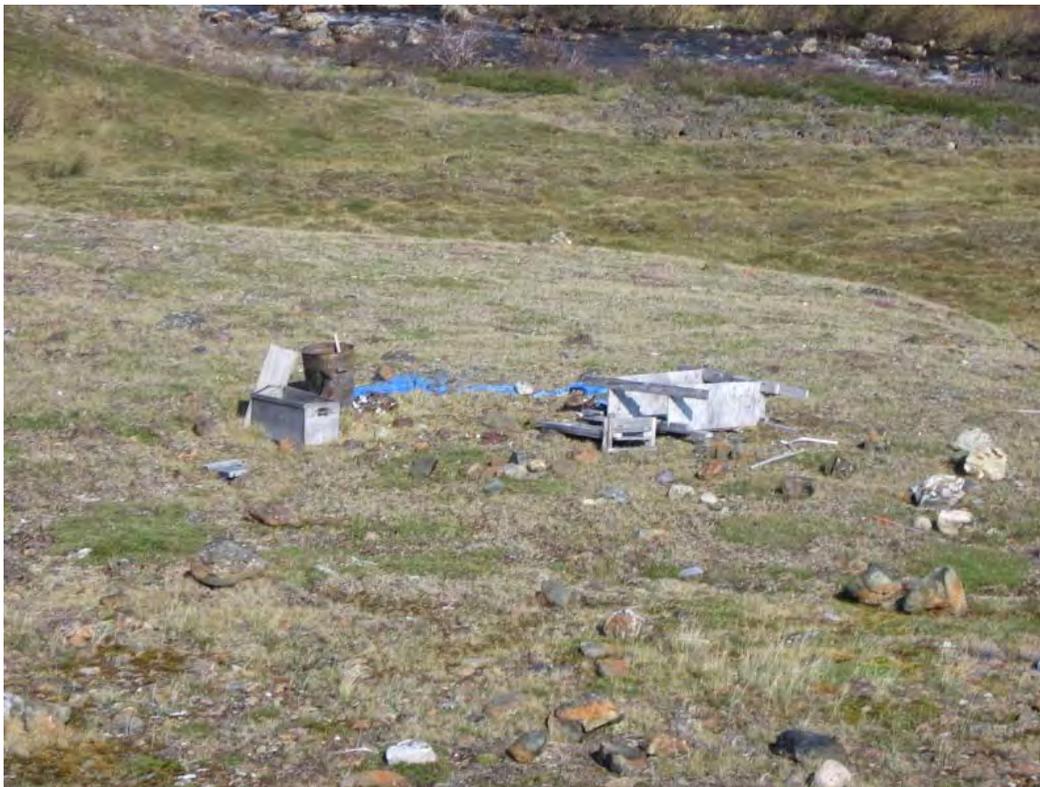
Figure 30: A photograph of KV-1 taken during the 2001-2002 inventory.

The site was inspected on July 5, 2007. The inspection revealed that the site matches the description prepared during the 2001–2002 inventory. Roughly 23 barrels are scattered around the site and on the opposite shore of the lake and 15 compacted barrels and two waste disposal areas are still present (Figure 30).

The site is located near site SW-27 and should be cleaned-up in conjunction to make the best of a work team and helicopter use. Work will most likely consist of gathering barrels and other debris for transportation, burning combustible materials on site and inspecting the waste disposal site.

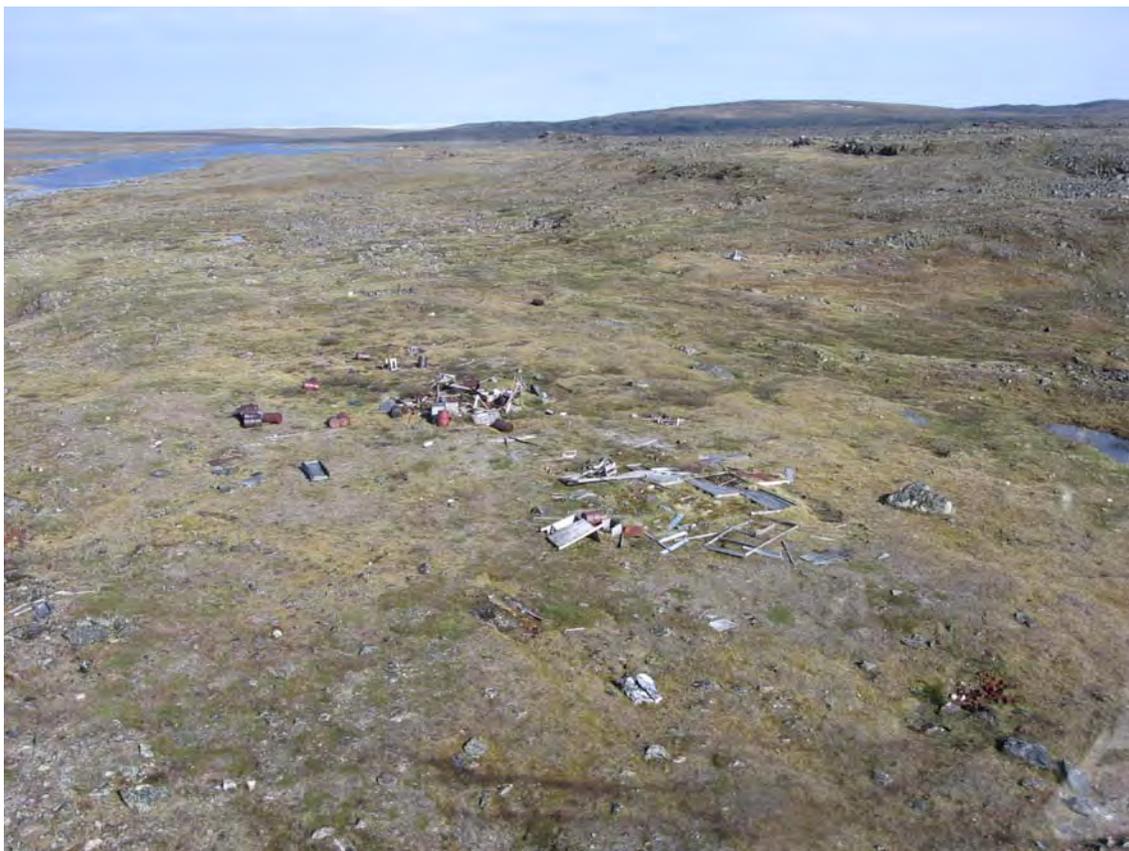
Figure 31: SW-27, Sector 1, taken during an inspection undertaken in 2007.

The site was inspected on July 5, 2007. Of all the abandoned mineral exploration sites still requiring clean-up, site SW-27 contains the greatest quantities of residue: roughly 1650 L of diesel, 260 L of grease and 26 L of oil. Although covering only 2.5 m<sup>2</sup>, petroleum-hydrocarbon soil contamination is still very evident. Open or damaged barrels of grease observed during the 2001–2002 inventory are still present. Figure 31 shows sector 1 of this site.

This site is located on Canadian Royalties property and a possible collaboration with this company could assist in the clean-up efforts.

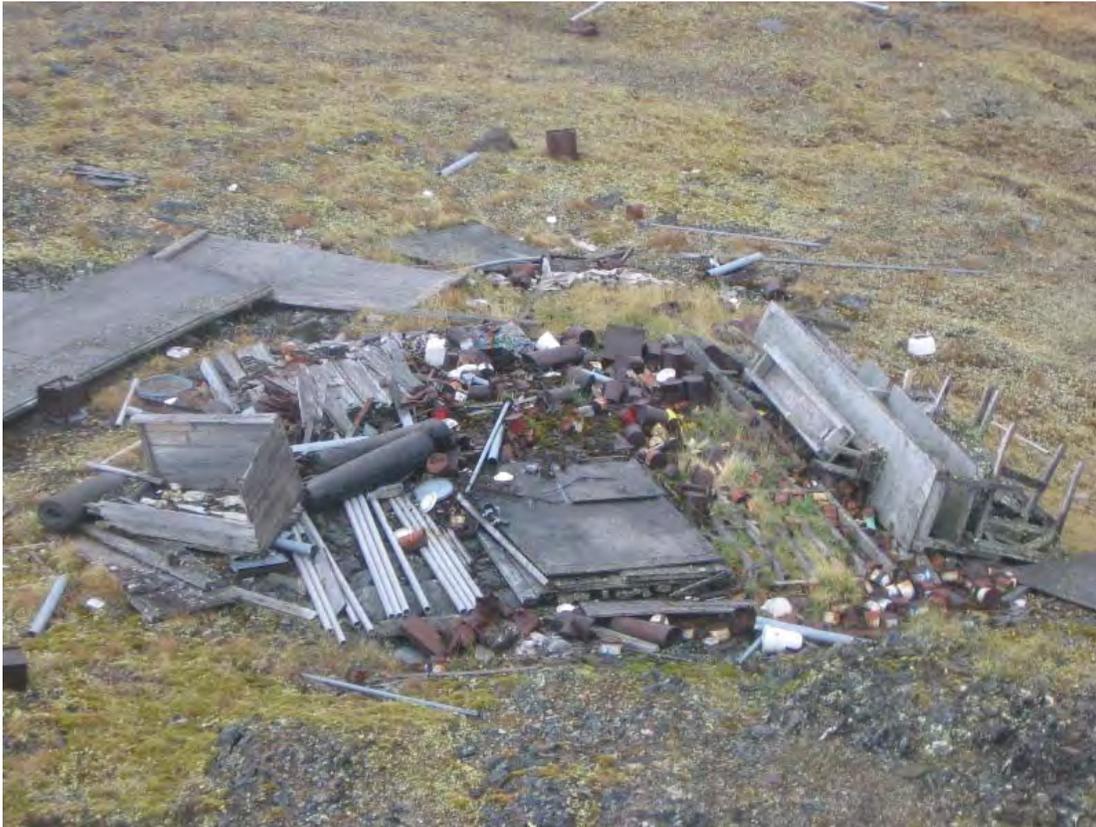
Figure 32: A photograph taken of site SW-42 during the 2001-2002 inventory.

The site was inspected on July 4, 2007. A wood roof and boards, metal debris, aluminium pipes, home-made stove, and exploration-shaft wood cover were all observed. The site also includes a pile of between 80 and 90 barrels and other barrels scattered along the shore of the lake. Finally, a pile of 1- to 20-L metal containers is located only a few metres from the lake. Figure 32 presents a photograph of the site taken during the 2001-2002 inventory.

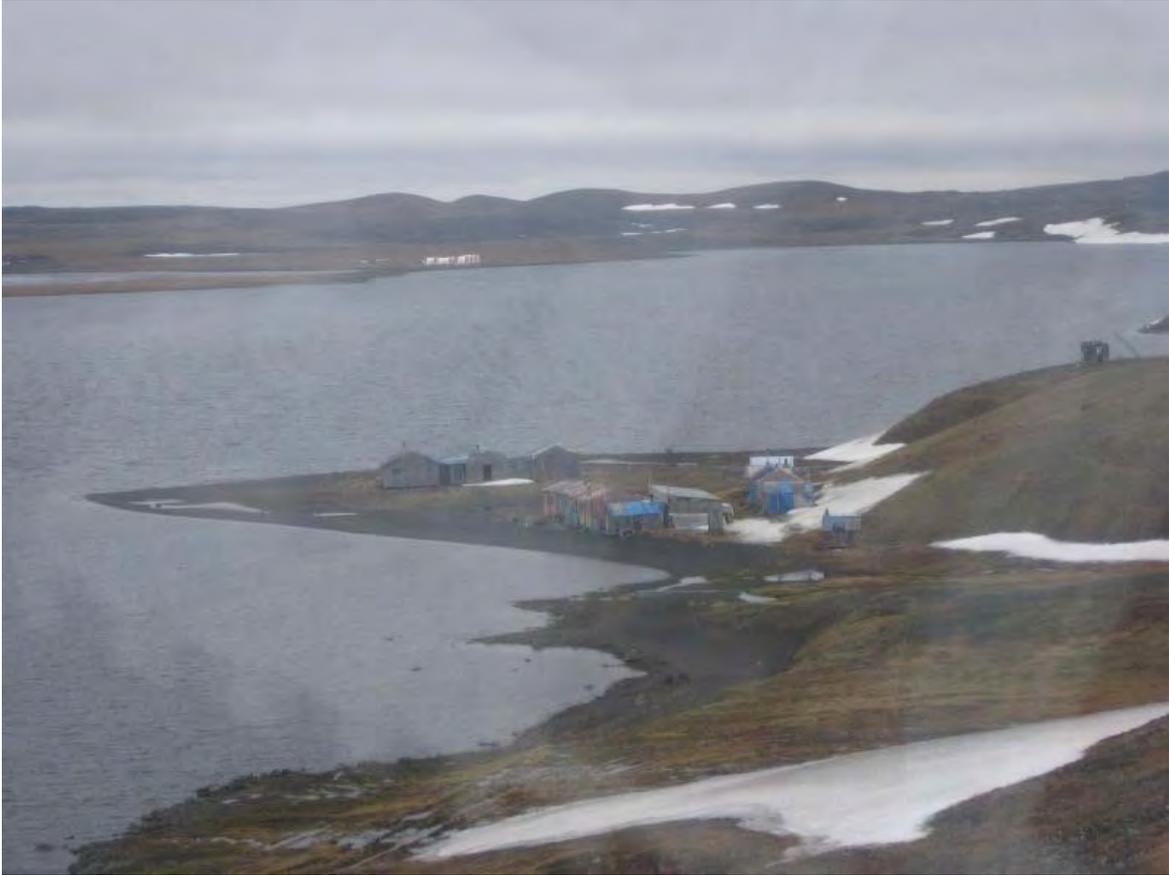
Figure 33: A photograph take on site WB-9 during the 2001-2002 inventory.

The site was inspected on July 4, 2007. The site comprises ten buildings and three small sheds, all of which have deteriorated since the initial inventory. The site contains a large quantity of non-hazardous debris, such as bed frames and damaged mattresses, a stove-oven, a washing machine, rock samples, etc. No heavy equipment was identified at the site. In total, 20 barrels were found scattered near the buildings. The barrels were not systematically verified, but might contain petroleum-hydrocarbon residue. A small amount of soil contamination was observed. As well, in a 1-km radius around the camp, 60 barrels divided in three groups were observed, but no verification was carried out to determine if they contained any residue.

This site is located between the properties of Golden Valley Mines Inc and Goldbrook Ventures and collaboration will be helpful when cleaning this site. All of the wooden structures will need to be emptied, stripped of metal and non-hazardous waste and burned on site. The barrels and other debris will have to be transported by helicopter to a temporary storage facility.
